<b>Date:</b>	June 9, 2022	<b>No. of Pages:</b>	5 + Encl.
<b>Project:</b>	60 Fife Road	<b>Project No.:</b>	TE-40480-22
<b>Address:</b>	60 Fife Road, Guelph	<b>Permit No.:</b>	n/a
<b>Client:</b>	Upbuilding Non-Profit Homes		
<b>Distribution:</b>	Howard Kennedy Ryan Taylor	Upbuilding Tim Welch Consulting Ltd.	howard.kennedy@gmail.com rtaylor@twinc.ca

### Background

Tacoma Engineers has been retained by Upbuilding Non-Profit Homes to carry out a structural condition assessment of a masonry tower located at 60 Fife Road, Guelph. Upbuilding Non-Profit Homes is in the process of planning for some site developments, including the construction of new housing units that includes the possible removal of an existing building.

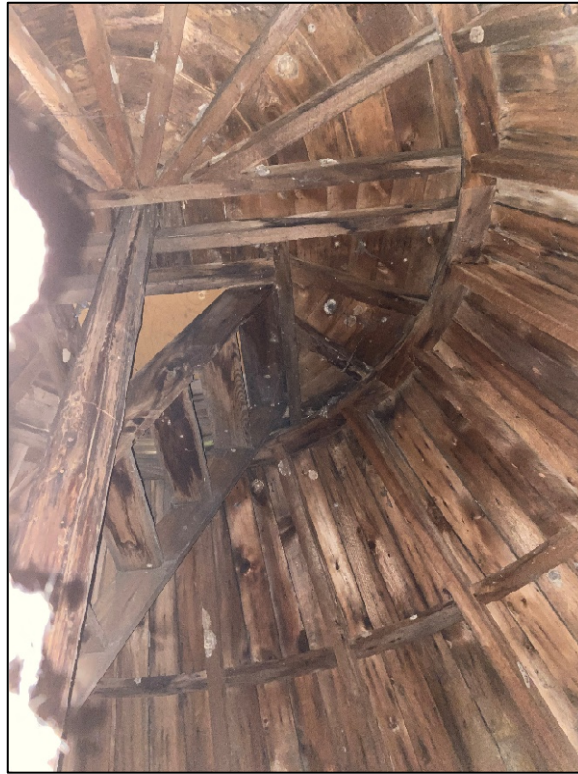
**Photograph 3: Roof framing (from hatch)**

Water staining is visible on many roof framing members. The stair visible in the photograph above leads to a roof hatch to the flat section at the top of the tower. It is not possible to comment on the condition of these members with the access available at the time of the review.
