<b>Date:</b>	June 9, 2022	<b>No. of Pages:</b>	5 + Encl.
<b>Project:</b>	60 Fife Road	<b>Project No.:</b>	TE-40480-22
<b>Address:</b>	60 Fife Road, Guelph	<b>Permit No.:</b>	n/a
<b>Client:</b>	Upbuilding Non-Profit Homes		
<b>Distribution:</b>	Howard Kennedy Ryan Taylor	Upbuilding Tim Welch Consulting Ltd.	howard.kennedy@gmail.com rtaylor@twinc.ca

## Background

Tacoma Engineers has been retained by Upbuilding Non-Profit Homes to carry out a structural condition assessment of a masonry tower located at 60 Fife Road, Guelph. Upbuilding Non-Profit Homes is in the process of planning for some site developments, including the construction of new housing units that includes the possible removal of an existing building.

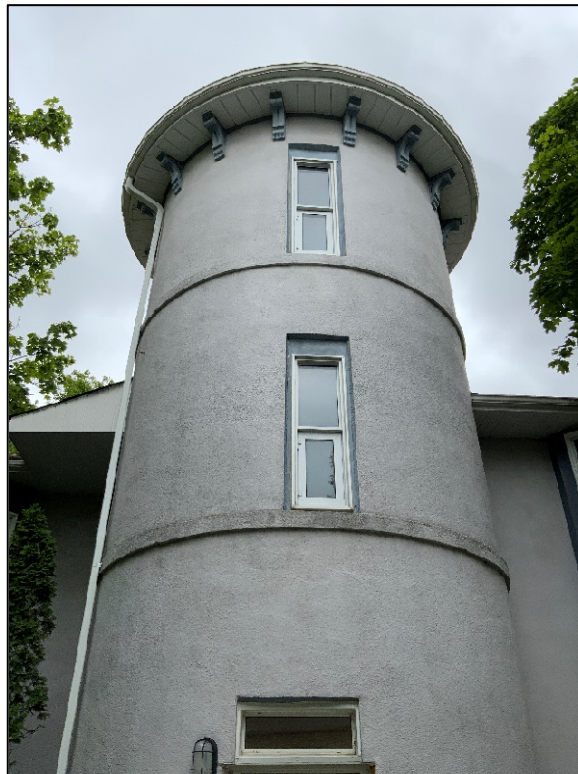
The exterior masonry appears to be in fair condition globally. There are no major step-cracks or other signs of structurally significant settlement or deflection that would indicate that the primary structure is not performing as required. However, it should be noted that the application of the cementitious parging coat has resulted in a non-reversible change to the masonry.

**Photograph 1: Exterior parge coat (typical)**

The cementitious parging will have bonded to the underlying clay brick, and it cannot be removed without significant damage to the brick. A similar condition will apply to the stone

banding, in that the stone cannot be exposed without significant damage to the original masonry.

As previously noted, the presence of cementitious parging finishes will likely result in significant damage to the brick and stone should they be removed. The softer brick units and limestone banding will likely lose much of the exterior face and as such will be at risk of significant deterioration due to water ingress and freeze-thaw action. It is likely that the mortar will also require a complete cut out and repointing once the parging has been removed. It should be expected that much of the original building fabric would be negatively impacted by this process.

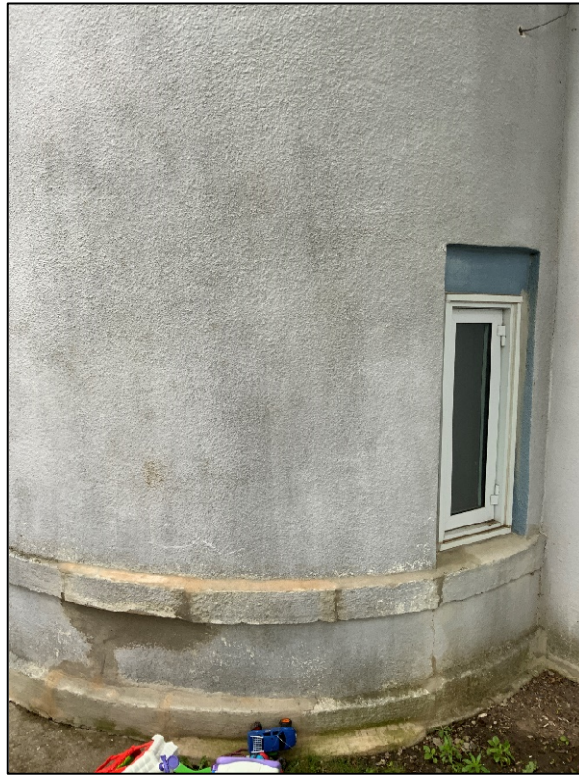
**Photograph 2: Deteriorating parge coat (typical)**

Cracking of the parging was noted in several locations, and conditions are expected to continue to deteriorate as water ingress will worsen and is expected to impact the underlying brick and stone by way of freeze-thaw damage. Limited repairs have been carried out at several locations around the perimeter of the tower with mixed results.

- removal of exterior parging;
- repair of all damaged brick and stone units;
- repointing and repair of all original mortar joints;
- review and repair/replacement of all flashings, terminations, and sealants around windows, doors, and other penetrations; and
- comprehensive review and repair/replacement of slate roof and all associated flat roof work and flashings.

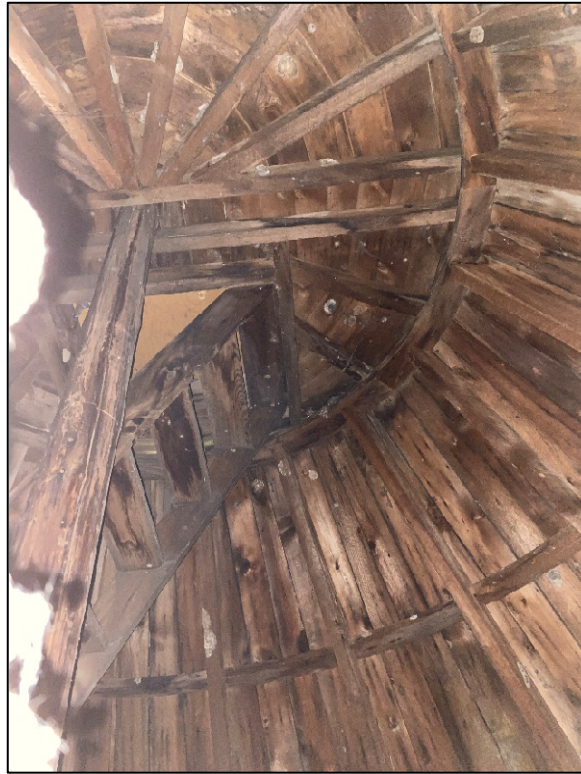
**Photograph 3: Roof framing (from hatch)**

Water staining is visible on many roof framing members. The stair visible in the photograph above leads to a roof hatch to the flat section at the top of the tower. It is not possible to comment on the condition of these members with the access available at the time of the review.
