Heritage Conservation Plan
Isolation Hospital
65 Delhi Street, Guelph
Final Report March 30, 2023

+VG ARCHITECTS
THE VENTIN GROUP LTD.

Heritage Conservation Plan Introduction

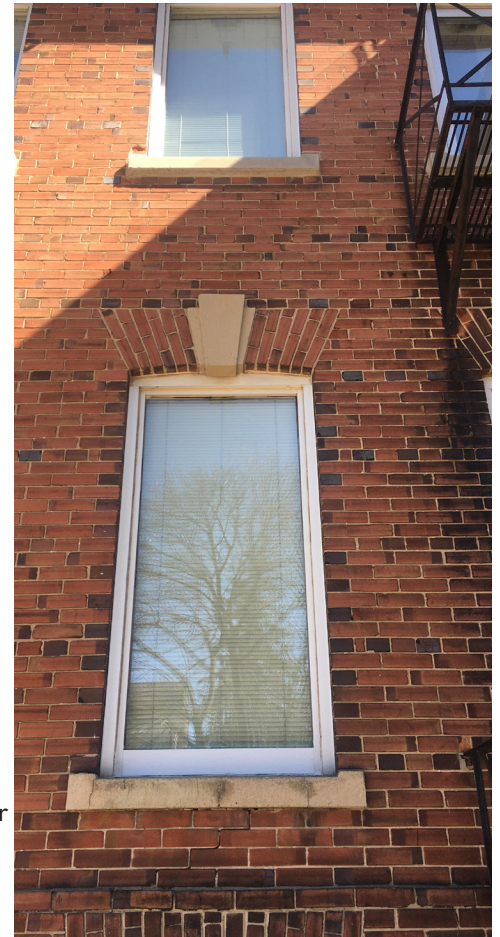
View showing original limebased mortar on the brick wall with repairs and cracked joints below the lower window sill.

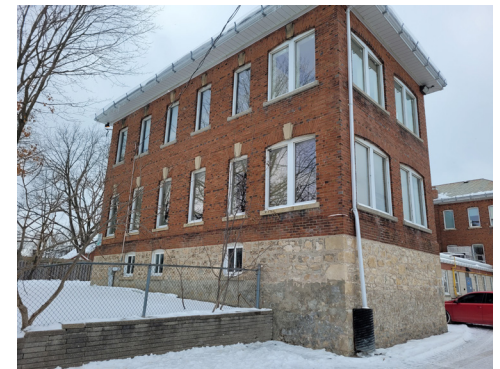
View of the south-west building corner showing the projecting brick coursing with blackened top edge becoming prominent.

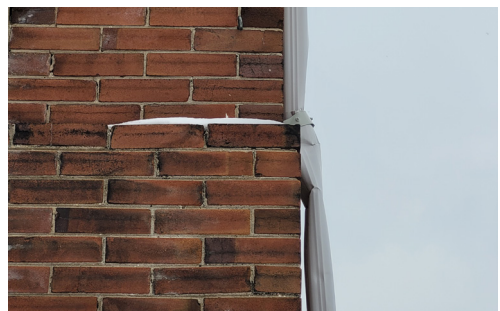
Detail view of the projecting brick coursing with deteriorated and missing mortar below the snow accumulation.

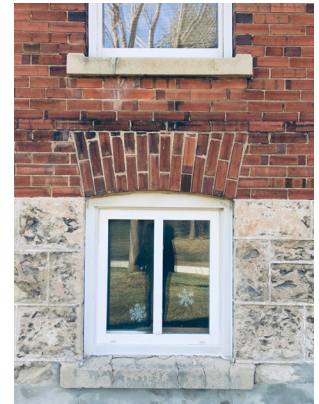
View of 'squared stonework' with ribbon mortar joint. Cracked stone sills of both windows show the path of water and deterioration.

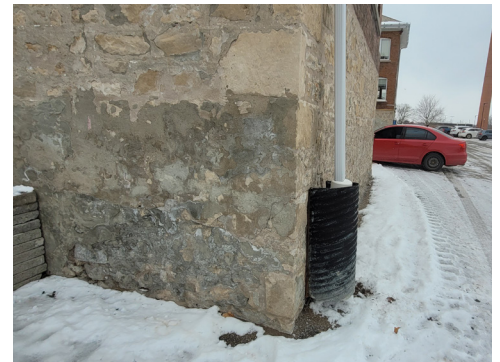
Stone foundation wall repair at the south-east building corner. Cement-based mortar causes water to migrate to more permeable areas and vulnerable to freeze/thaw

- Remove cement-based mortars and patching which are causing deterioration especially at stone walls.
- Clean and repoint masonry with lime-based mortar to protect brick and stone from deterioration, especially at the lower brick banding with exposed skyward-facing joints.
- Review subgrade masonry conditions and provide adequate drainage away from the masonry face to protect the stone and building envelope.
- Replace broken window sills with stone lug sills.
- The maintenance strategy be included in the Maintenance Manual issued to the Owner at the end of construction.

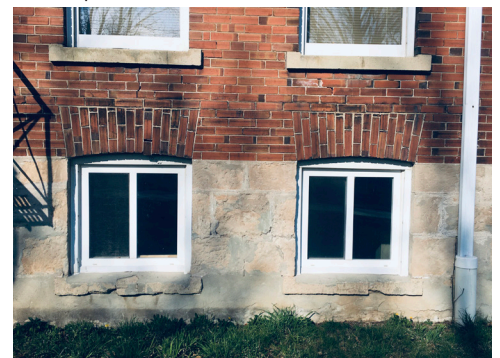
Stone foundation wall repairs and missing stone lintel sections on the lower windows.

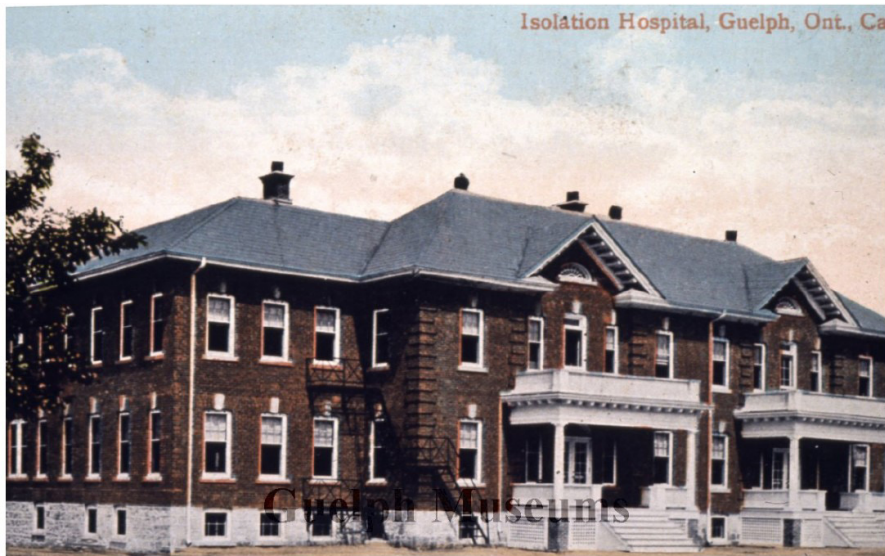
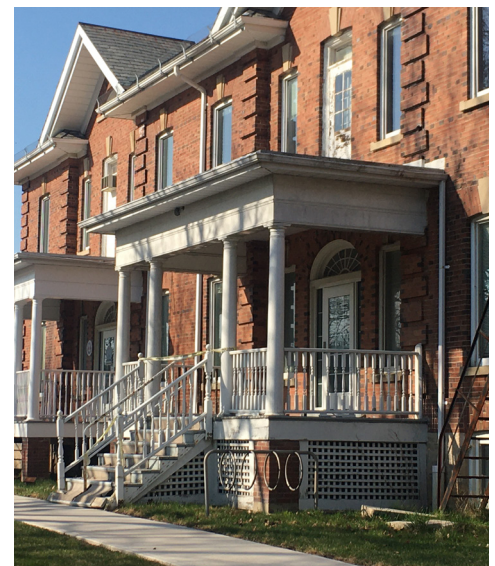
View of porches showing changes from original design.
Note the new turned spindle profile on the porch railing which extends down the stair.

- Inspect and repair existing woodwork.
- Replace existing railing with design in keeping with historic details, such as a lower height profile with additional guard rail above to meet OBC requirements.
- Repair/provide wood screening around porch base to protect building materials from intrusion of environmental elements and animals.
- Maintain the characteristic white finish details, which have been similarly done on the adjacent Nurses' Residence.
- The maintenance strategy be included in the Maintenance Manual issued to the Owner at the end of construction.

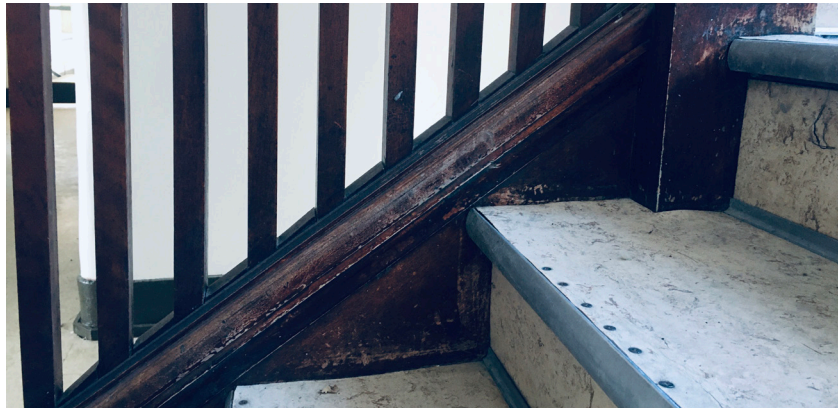
Whether composite sheet or linoleum, the flooring and nosings on the steps and landings are heavily worn and likely not original to the building. The wood baseboard and trim on each side of the stair is also well-worn. The stair is not in compliance with current building code but would likely be subject to Part II exemptions as it is no longer an exit stair in the proposed design. Staircase floor treatment should be replaced.

Left Image: showing conditions of handrailing woodwork and stair

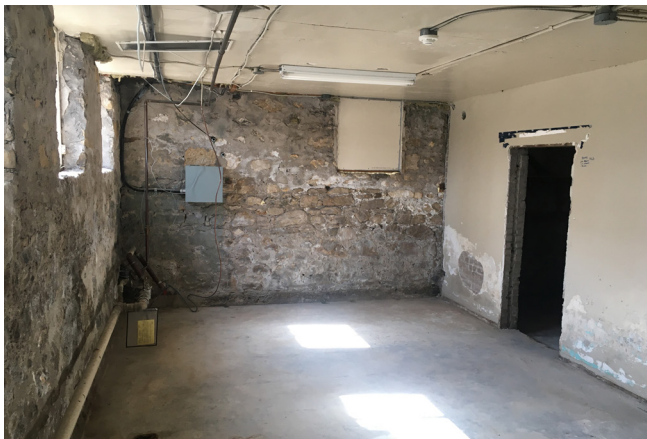
Various types of mortar repairs including cement-based, are visible at the north-east walls where the grade slopes from front to back. It's likely water has migrated to the wall center where original conditions are permeable and causes damage to the stable stonework.

View of north-east wall (end) with mortar covering the stone on the left corner and across the wall top and bottom. The white sloped band indicates efflorescence where water has leached minerals from the stone and mortar work along the line between subgrade and above grade conditions.

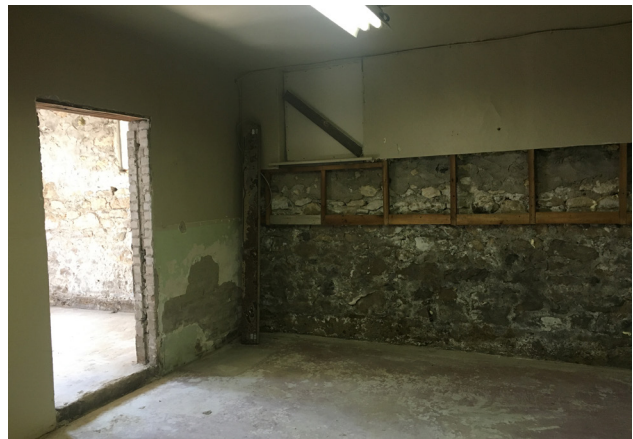
View of east wall section with mortar repair behind the added partial furring with insulation of the top section. Load-bearing brick masonry wall on the left shows some failing plaster but is otherwise in solid condition.

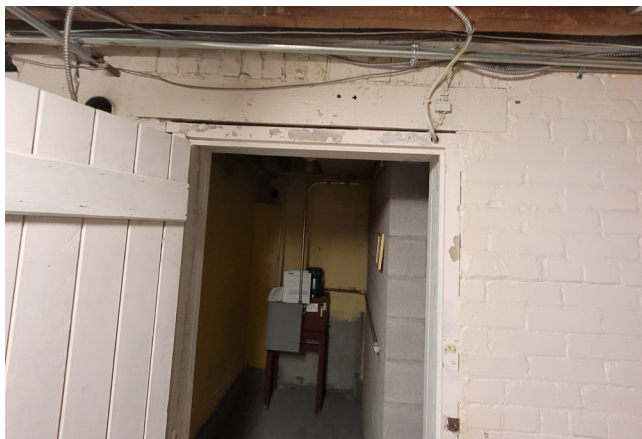
View into the elevator room with the concrete block elevator shaft on the right. The elevator capacity is for 2 people according to the posted certificate, and not in compliance with current accessibility codes.

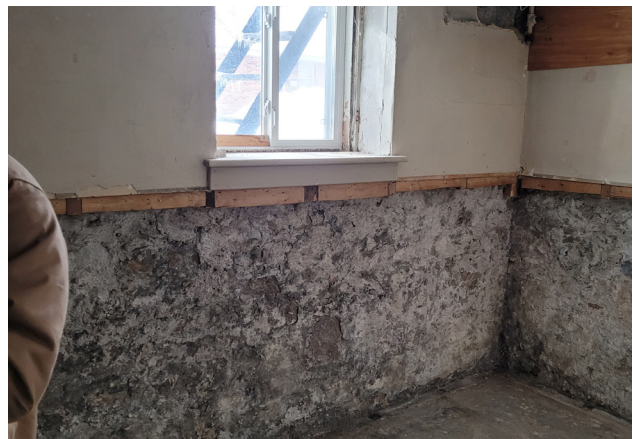
View of north wall section with fire escape visible outside the window. The north wall has been heavily parged likely intended to stop moisture on the surfaces below grade.

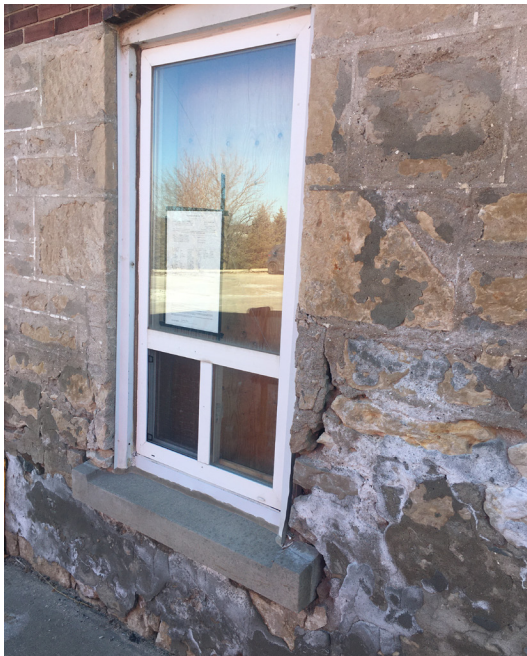
Image showing build up of efflorescence (white area) on the stone caused by use of impermeable mortars which should be removed and repointed with lime-based mortar.

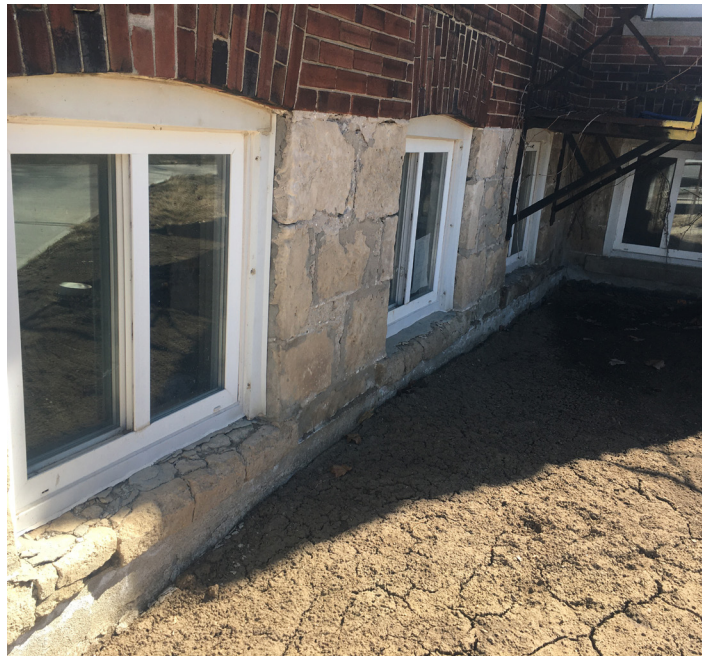
Image showing example of deteriorating masonry conditions. Foundation walls should be repointed with lime-based mortar and the broken stone sills replaced to protect the building from water infiltration.
