Attachment-1 Property location and photos taken by Heritage Planning staff

2023 July 27 – Photos taken by S. Robinson of Heritage Planning during site visit with Property Standards staff.

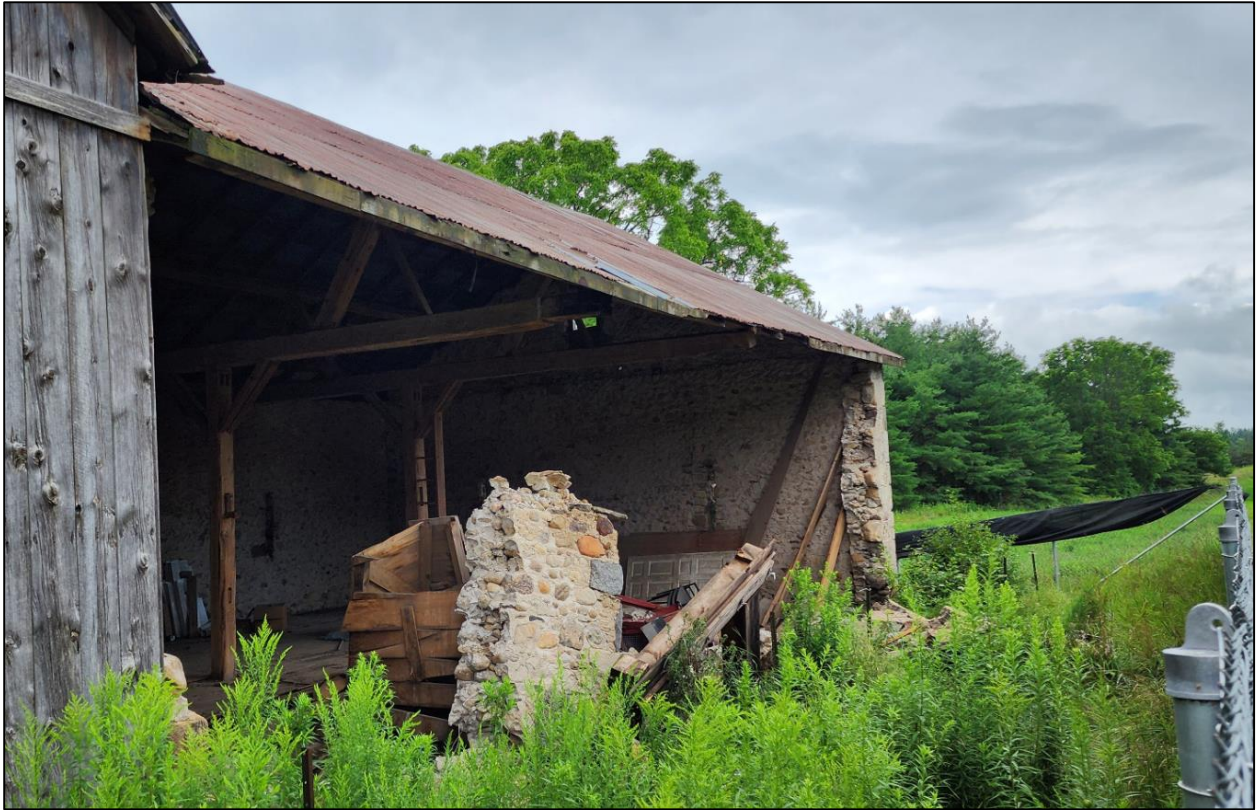
Figure 7: Photo of collapsed barn wall. Taken July 27, 2023, by S. Robinson.

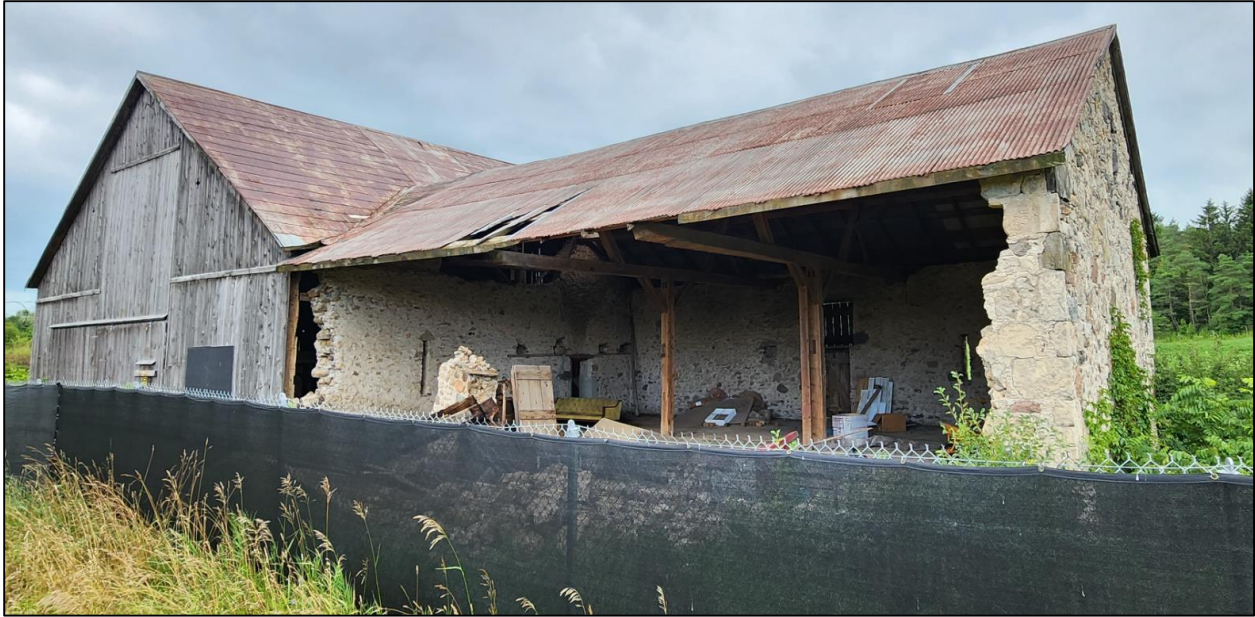
Figure 8: Photo of collapsed barn wall. Taken July 27, 2023, by S. Robinson.

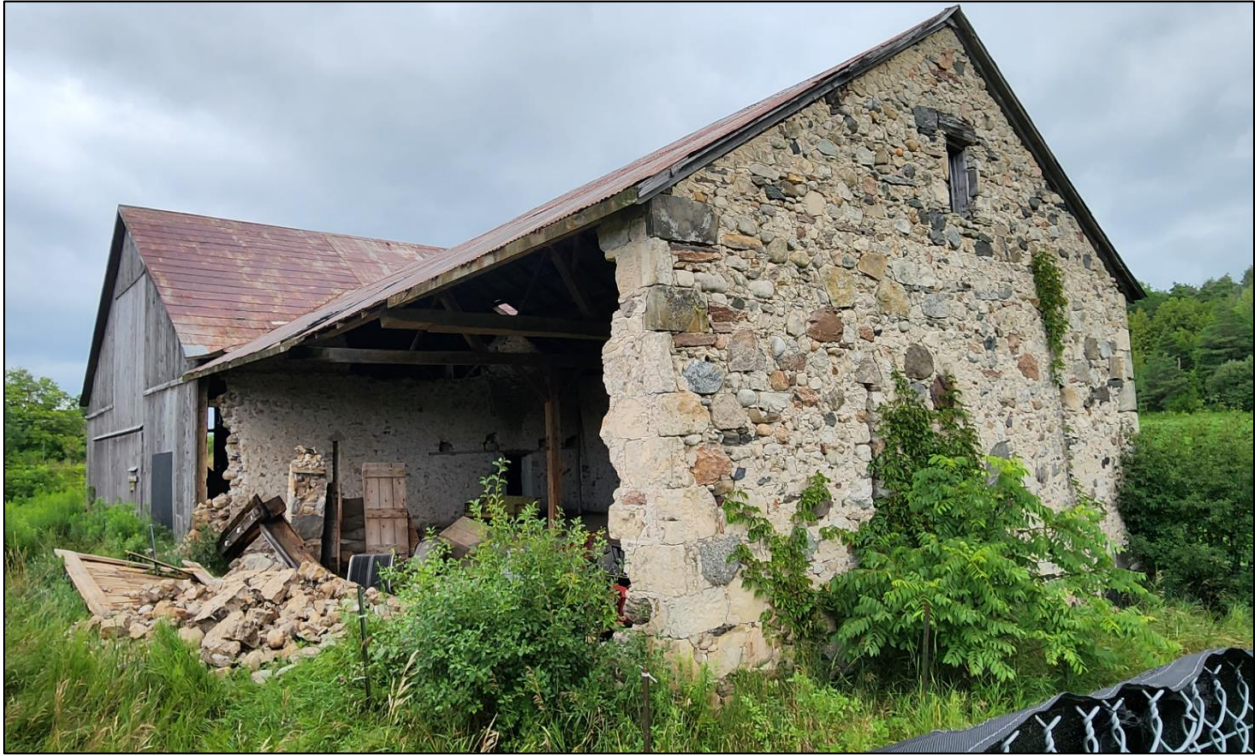
Figure 9: Photo of collapsed barn wall. Taken July 27, 2023, by S. Robinson.

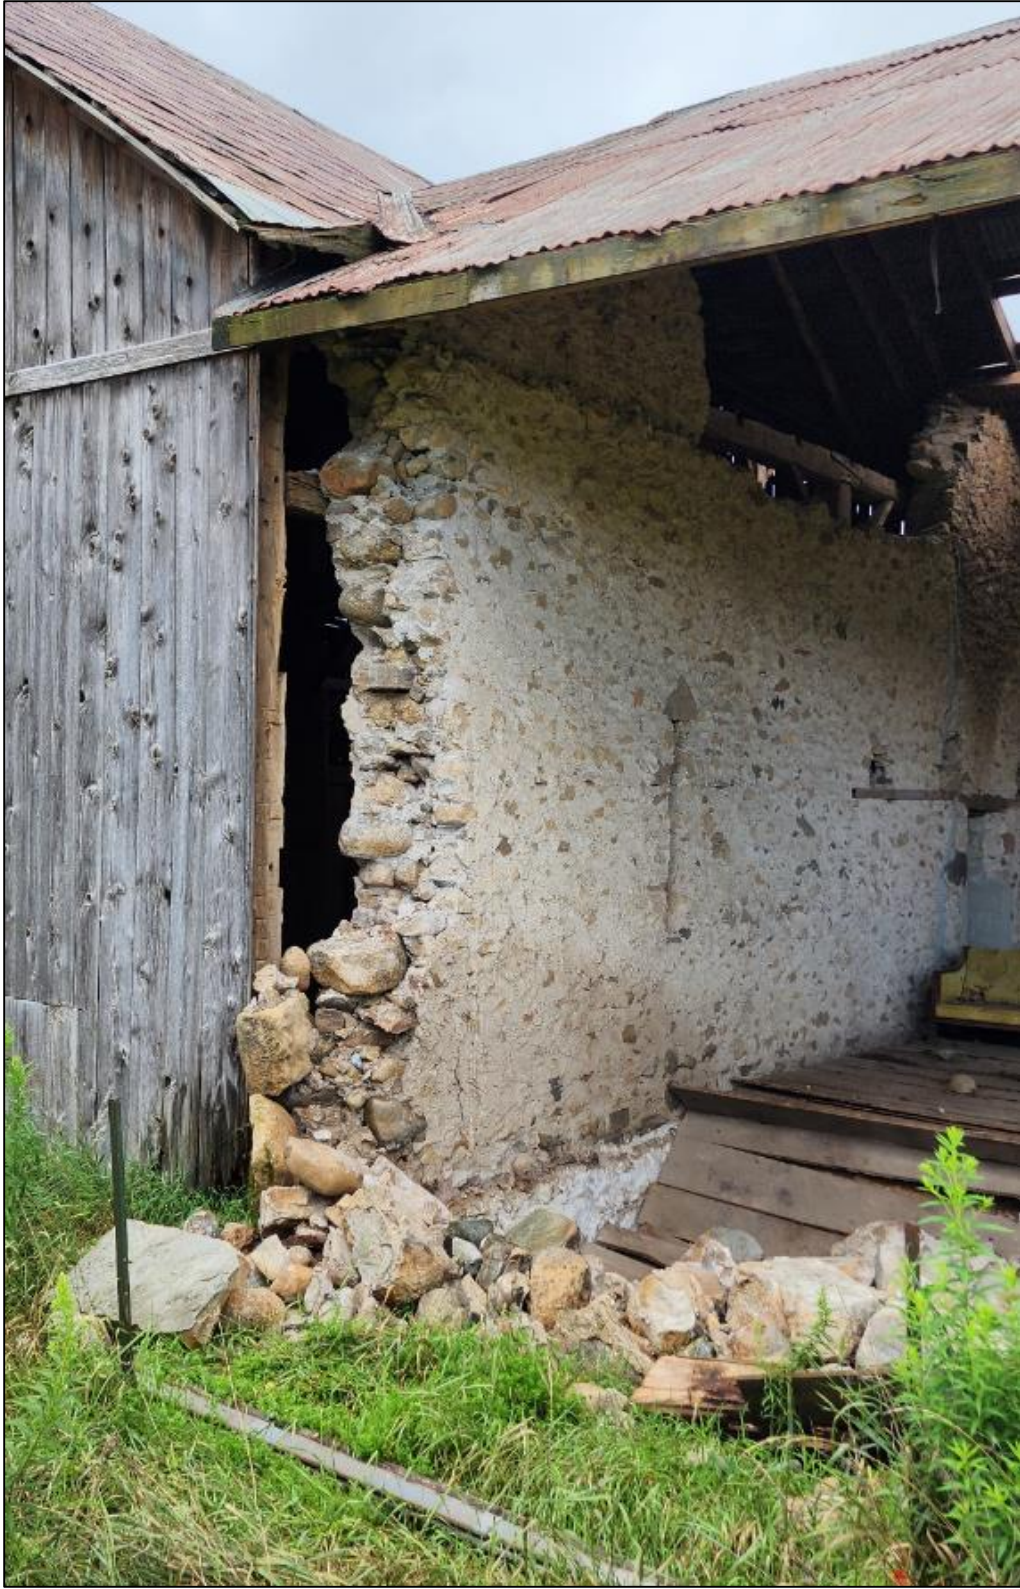
Figure 10: Photo of collapsed barn wall. Taken July 27, 2023, by S. Robinson.

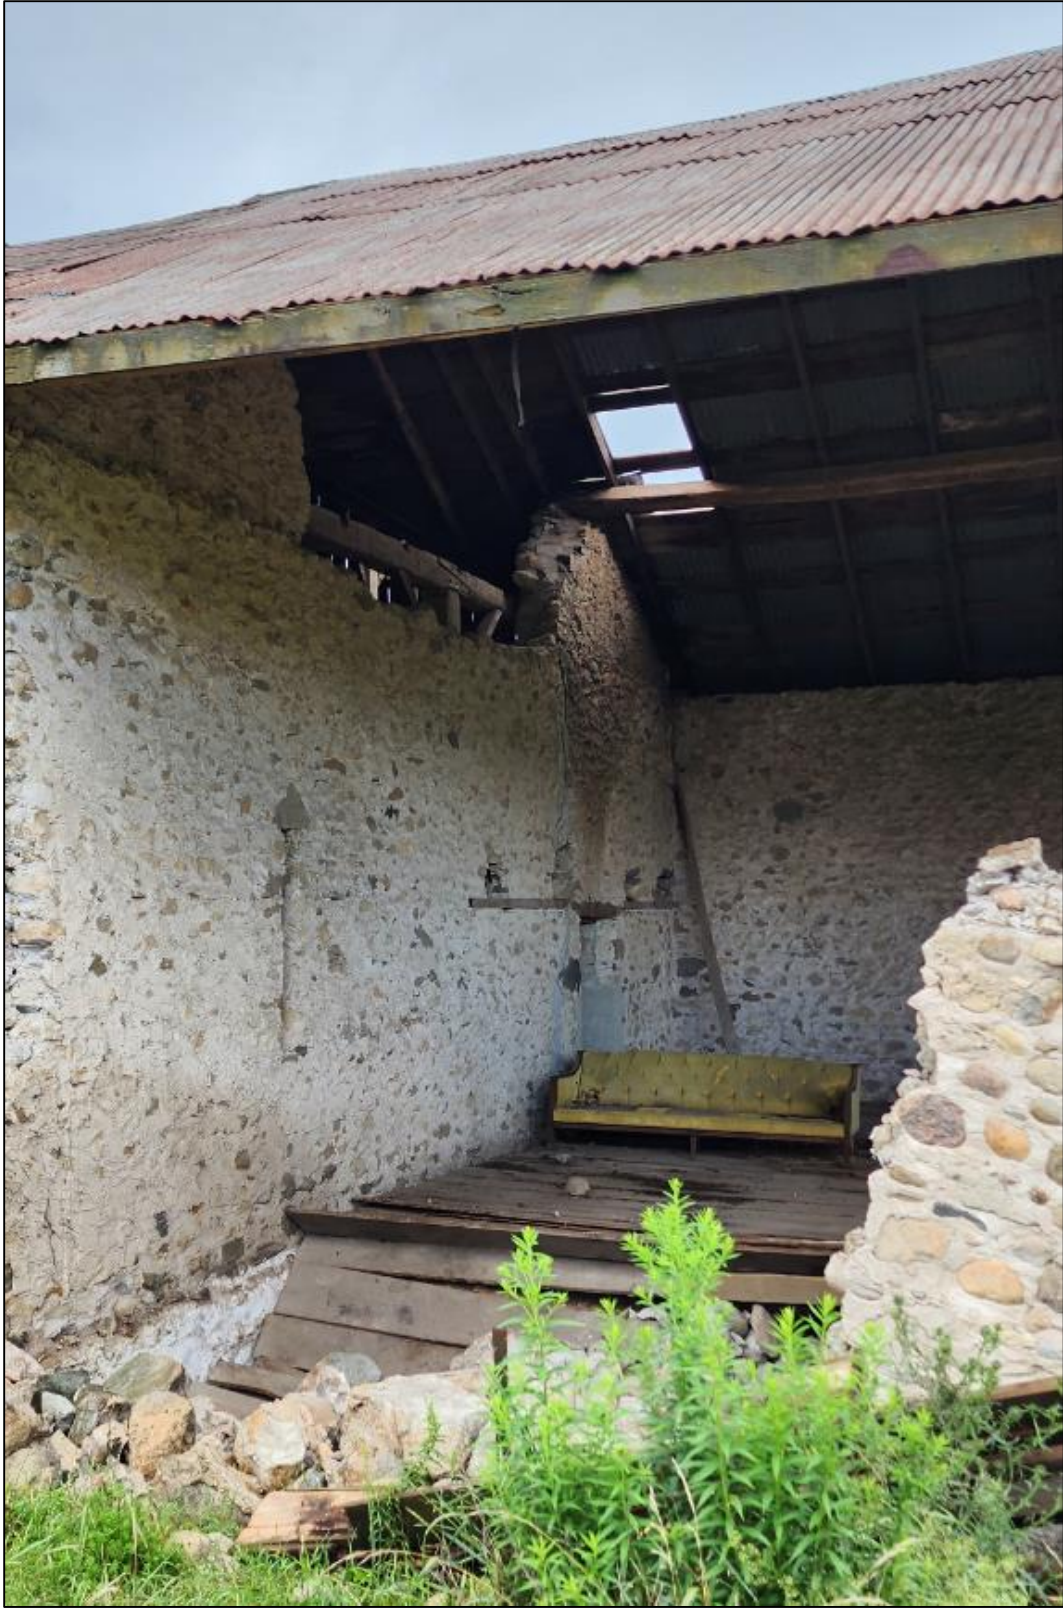
Figure 11: Photo of collapsed barn wall and compromised connecting corner. Taken July 27, 2023, by S. Robinson.

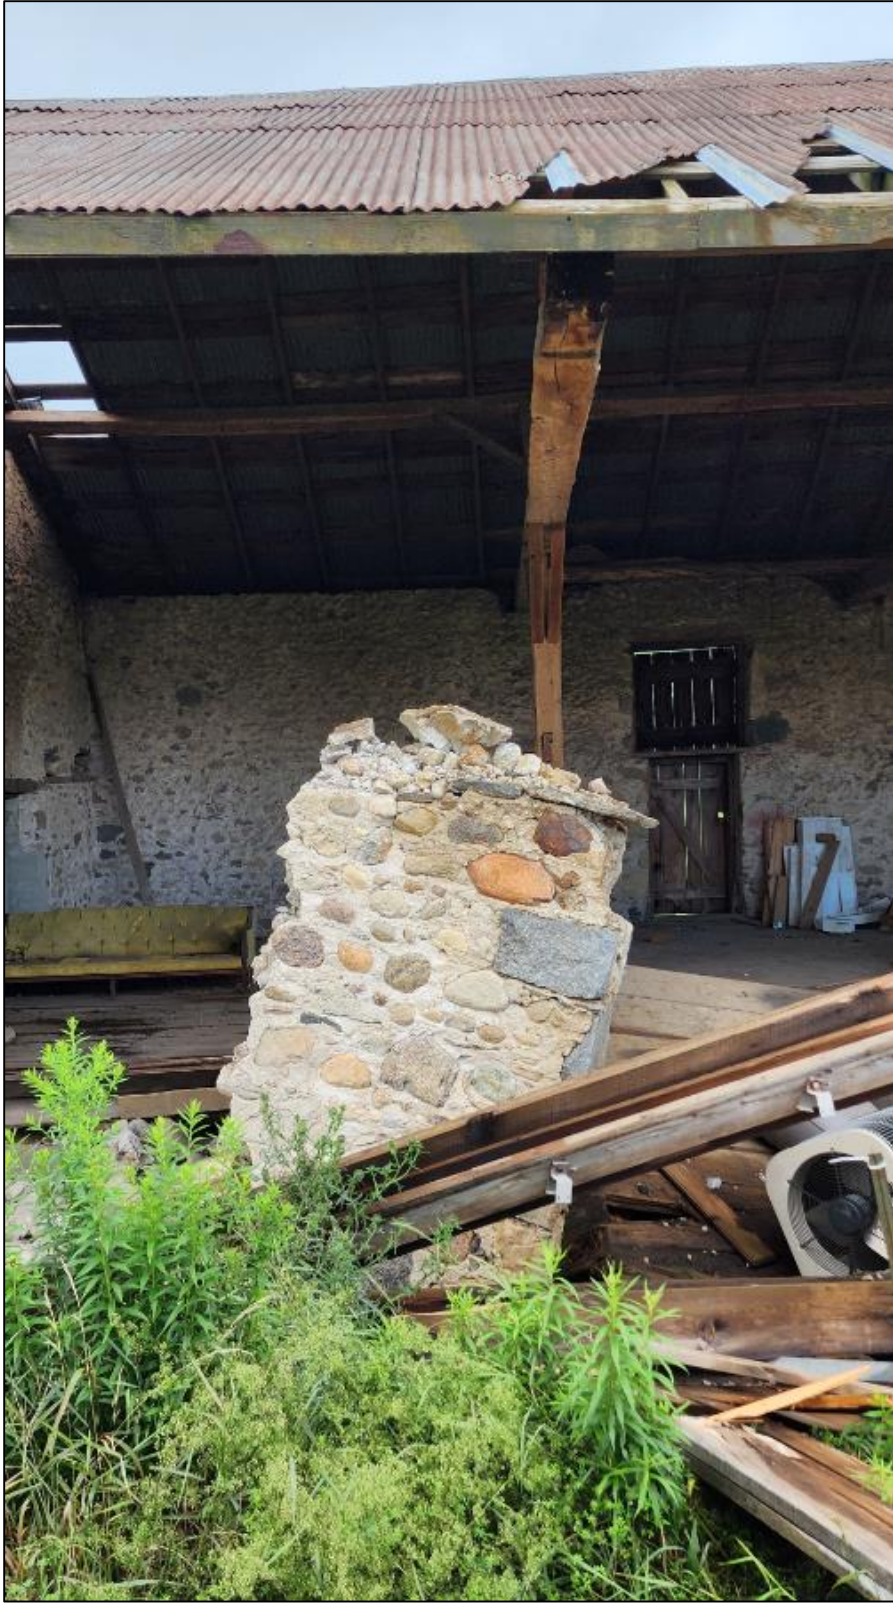
Figure 12: Photo of collapsed barn wall and interior of barn. Taken July 27, 2023, by S. Robinson.

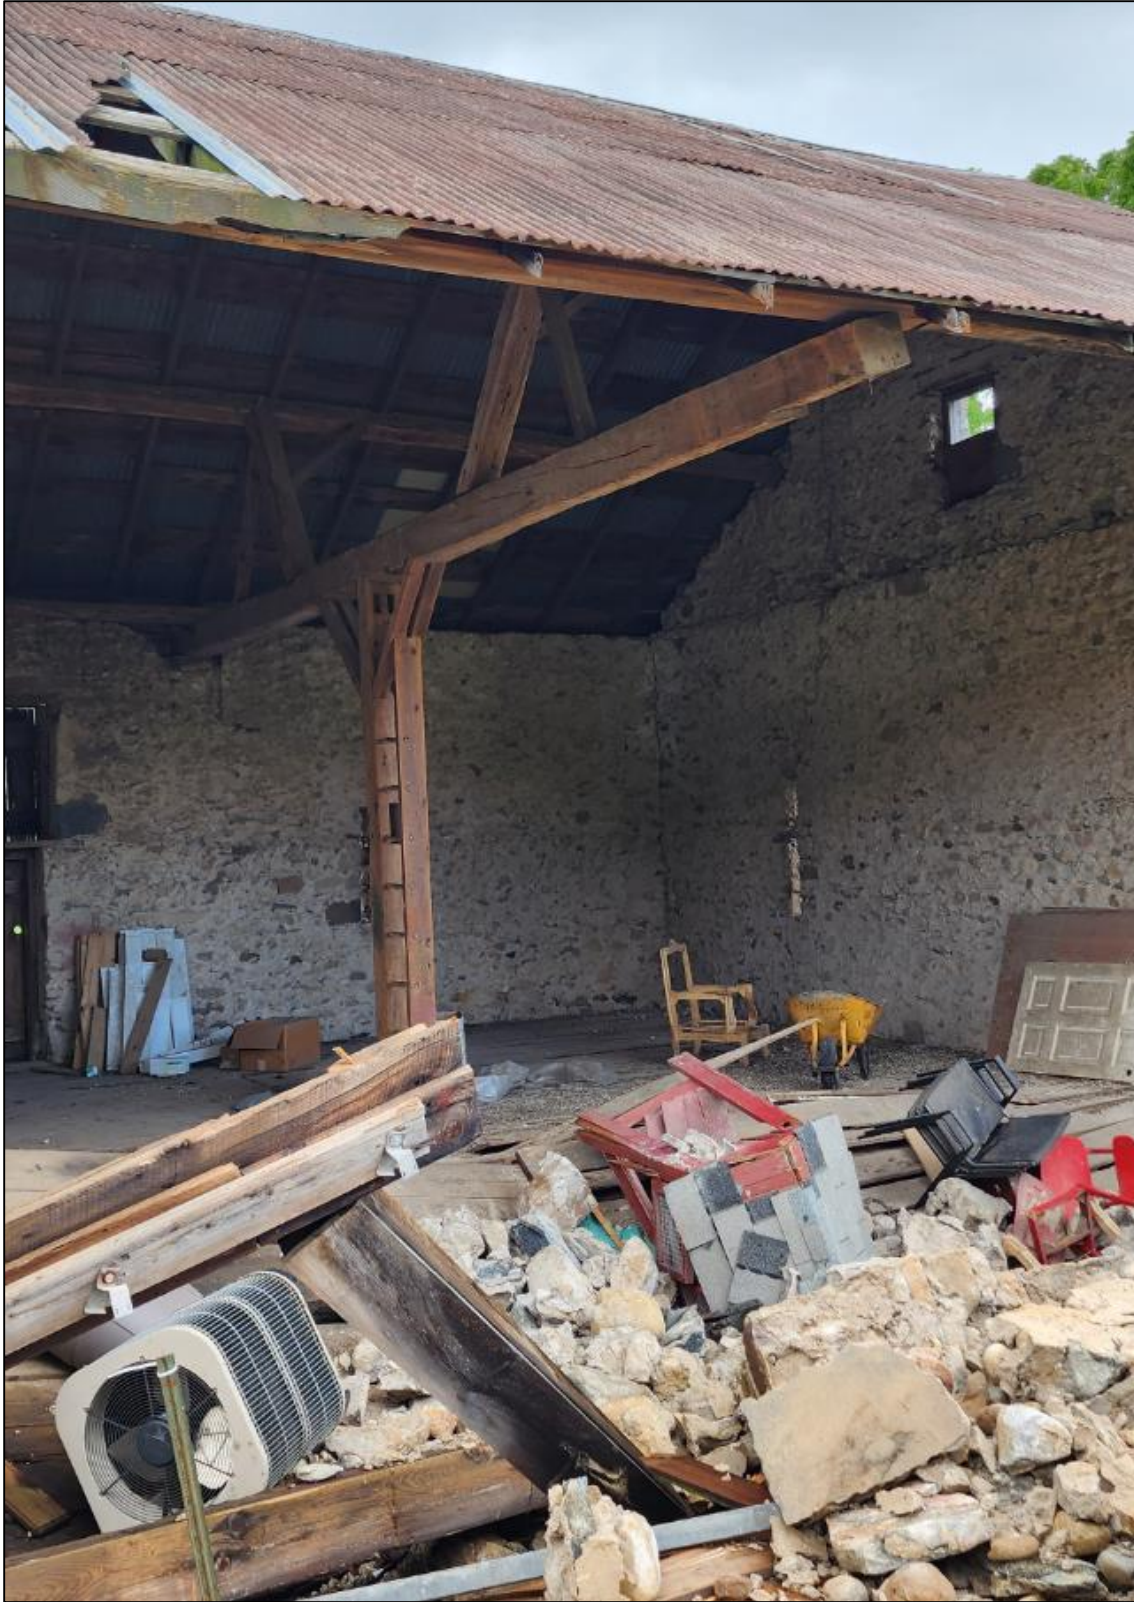
Figure 13: Photo of collapsed barn wall and barn interior. Taken July 27, 2023, by S. Robinson.

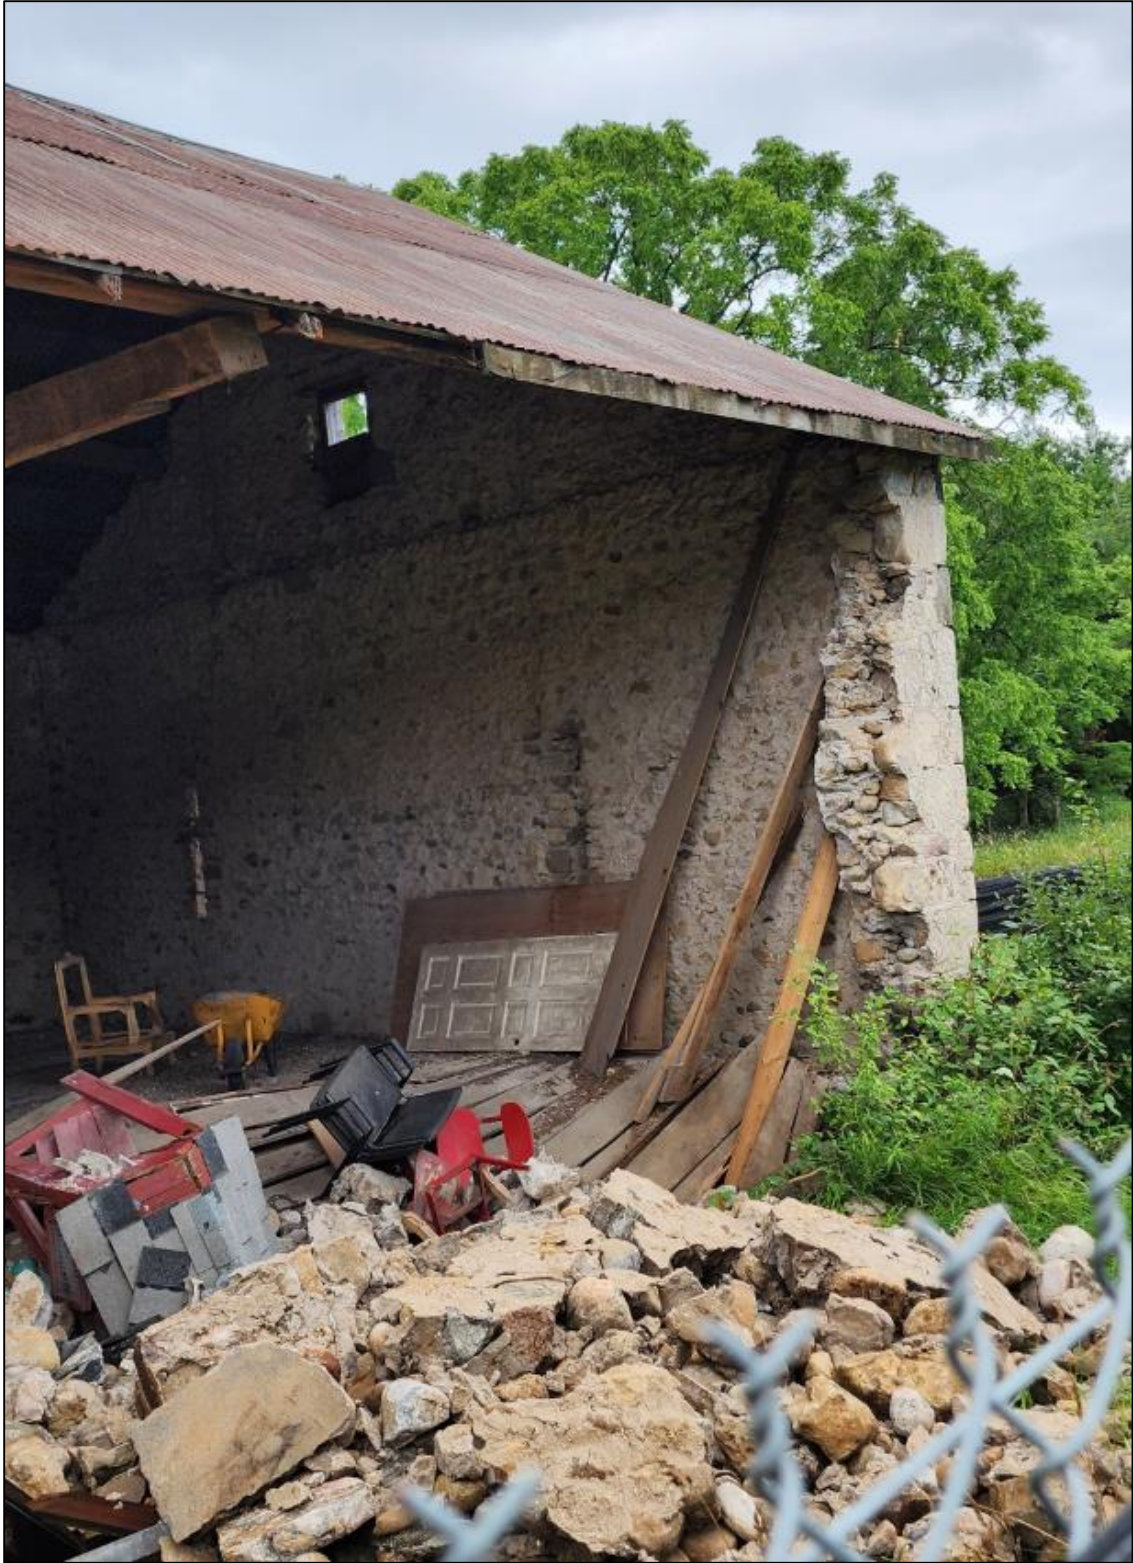
Figure 14: Photo of collapsed barn wall and interior. Taken July 27, 2023, by S. Robinson.

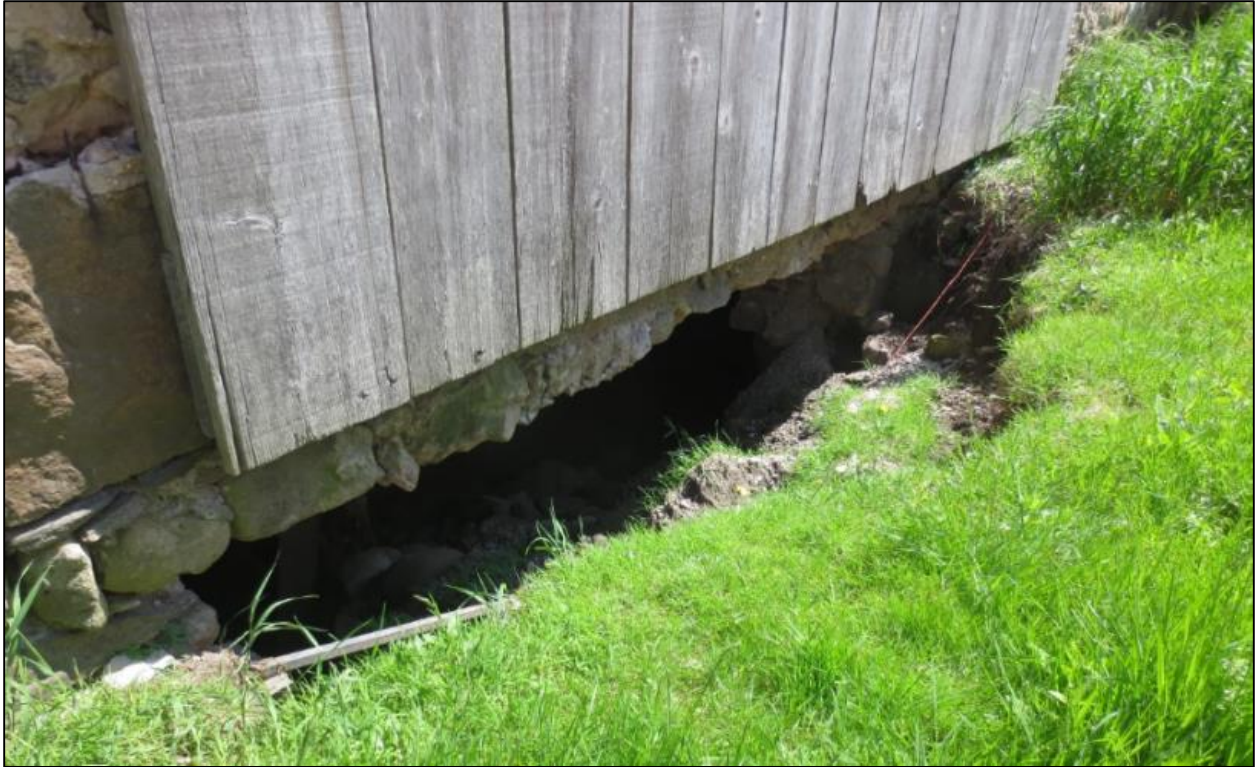
Figure 27: Photo of the barn's main door and failed foundation. Taken June 17, 2019, by S. Robinson.

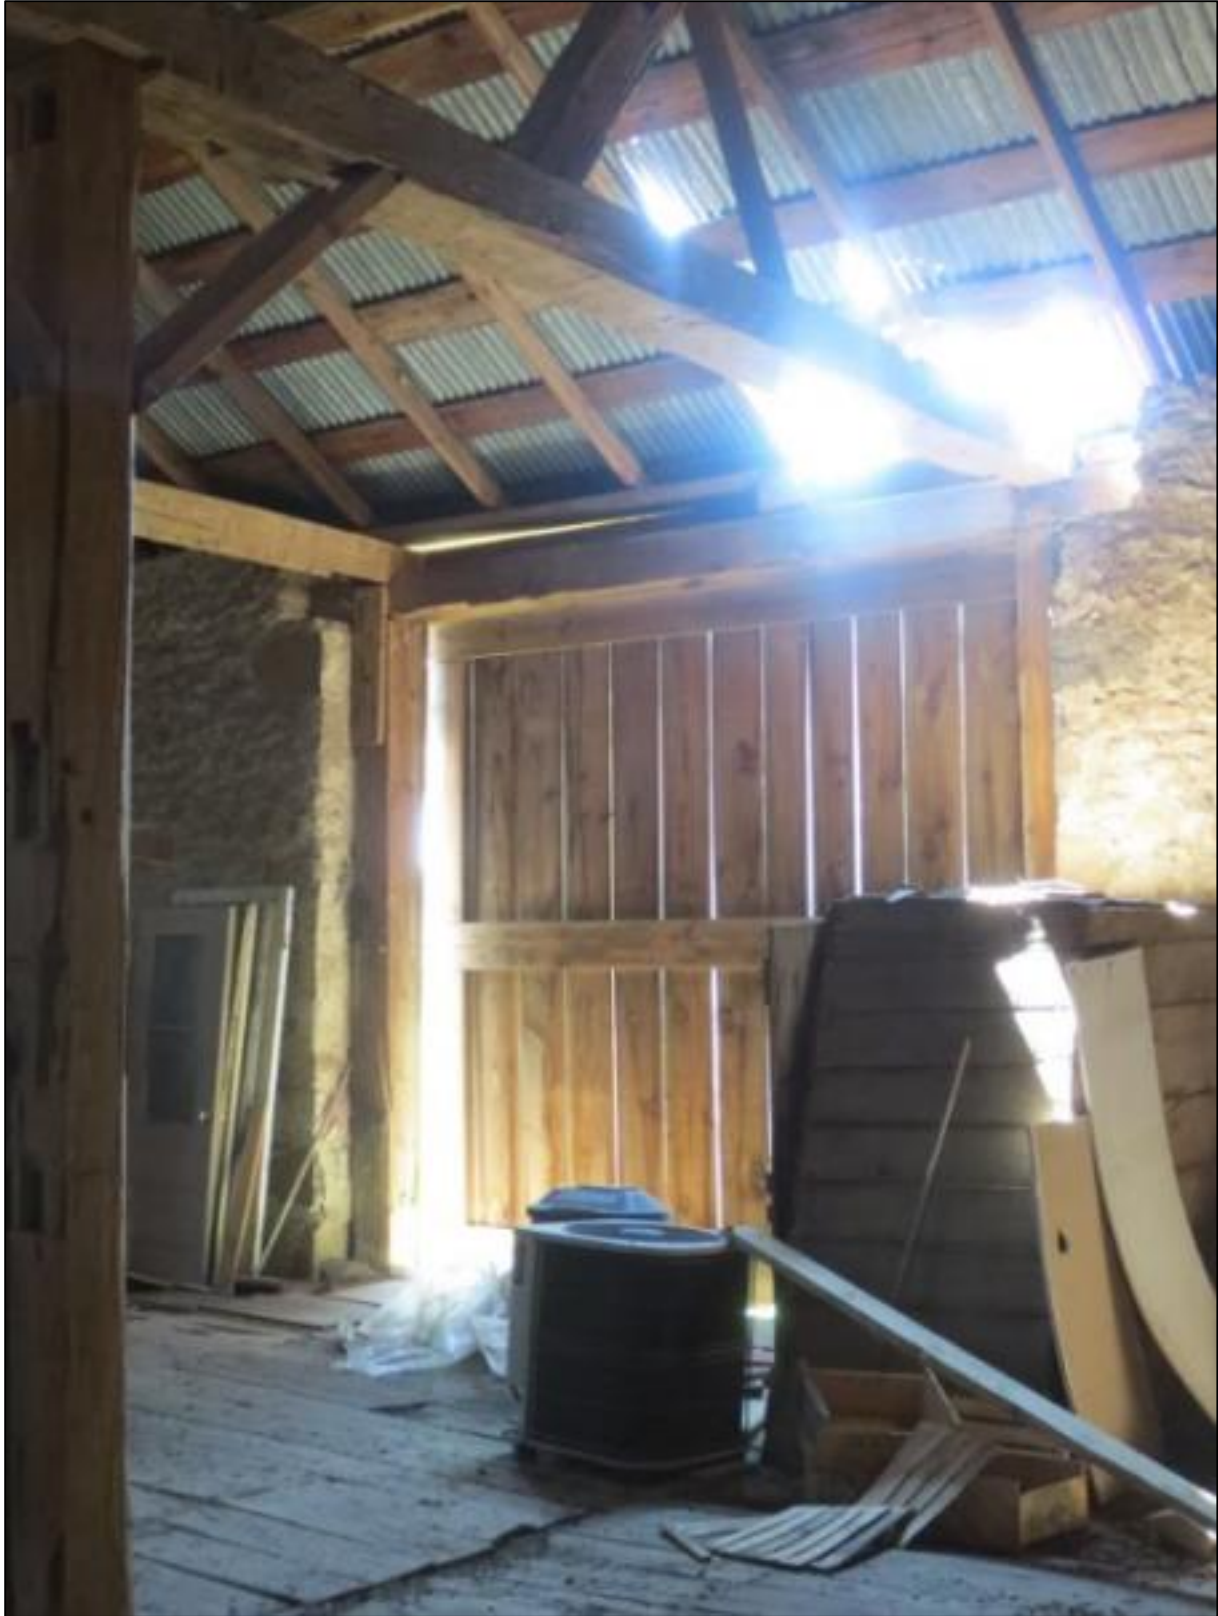
Figure 28: Photo of the barn's main door and failed foundation. Taken June 17, 2019, by S. Robinson.

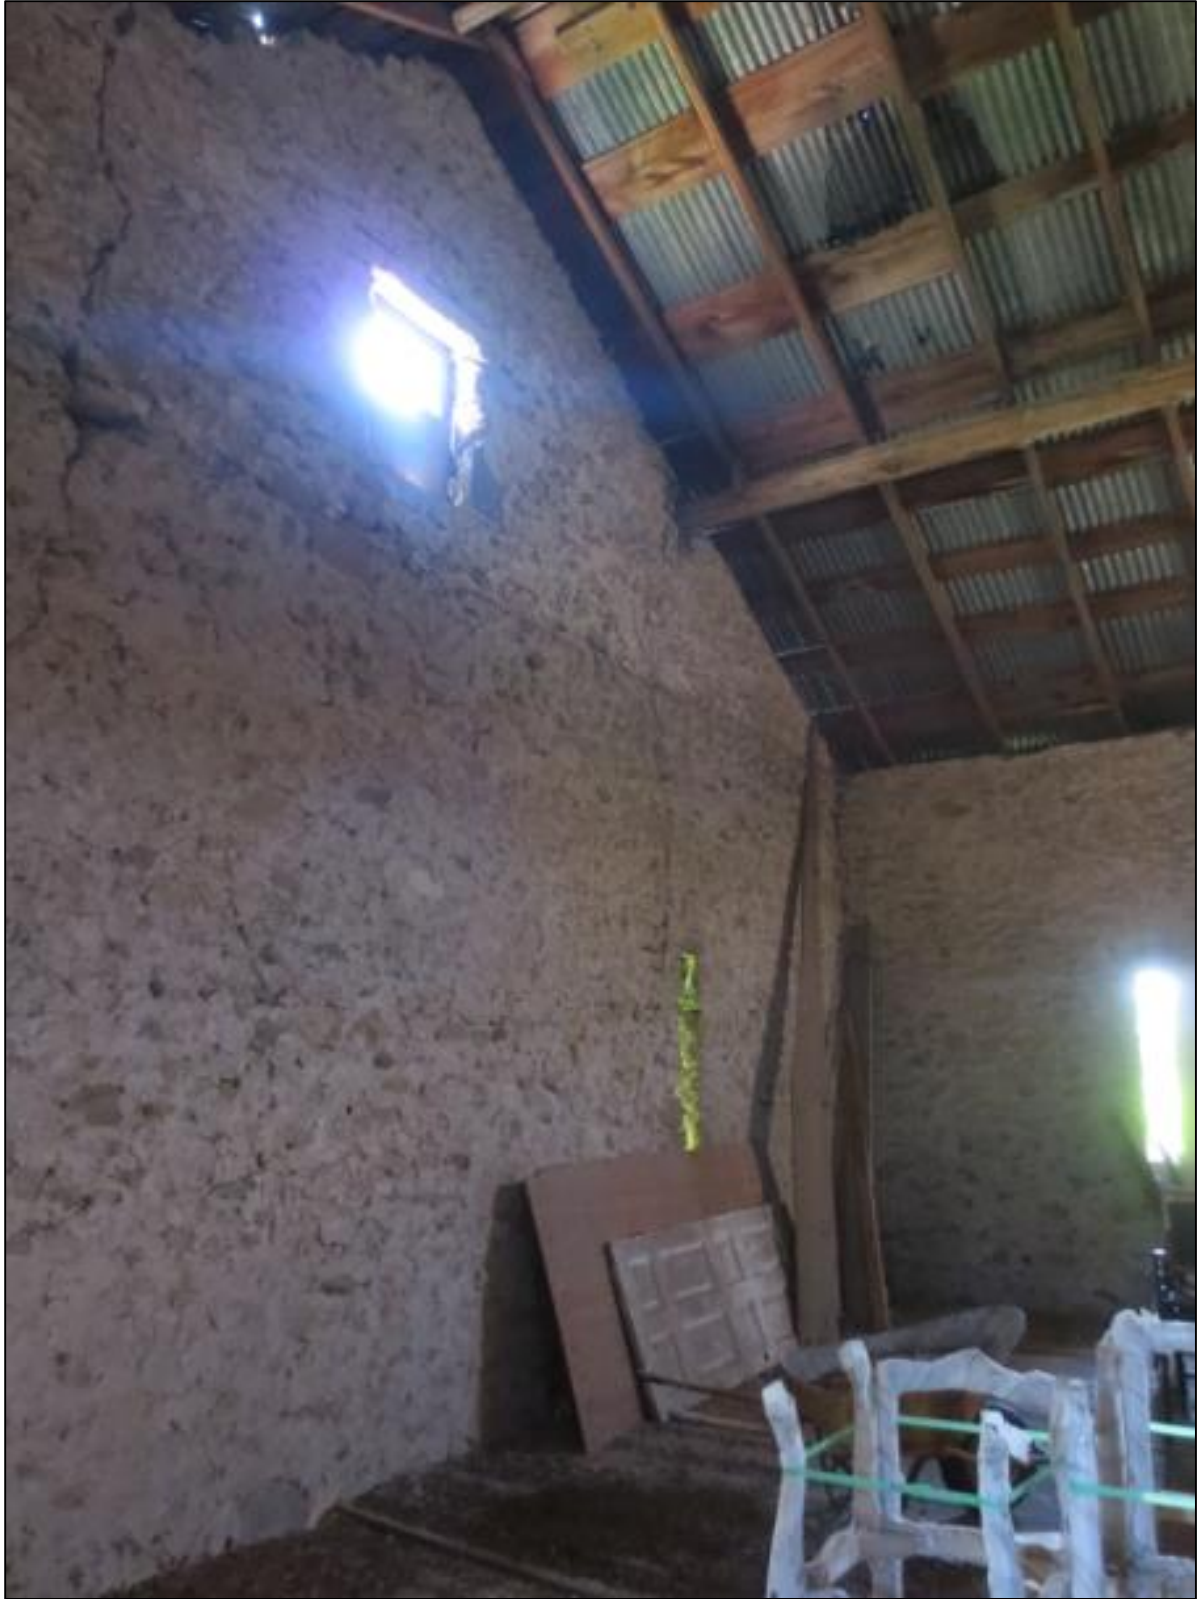
Figure 30: Photo of an internal crack in the exterior wall. Taken June 17, 2019, by S. Robinson.

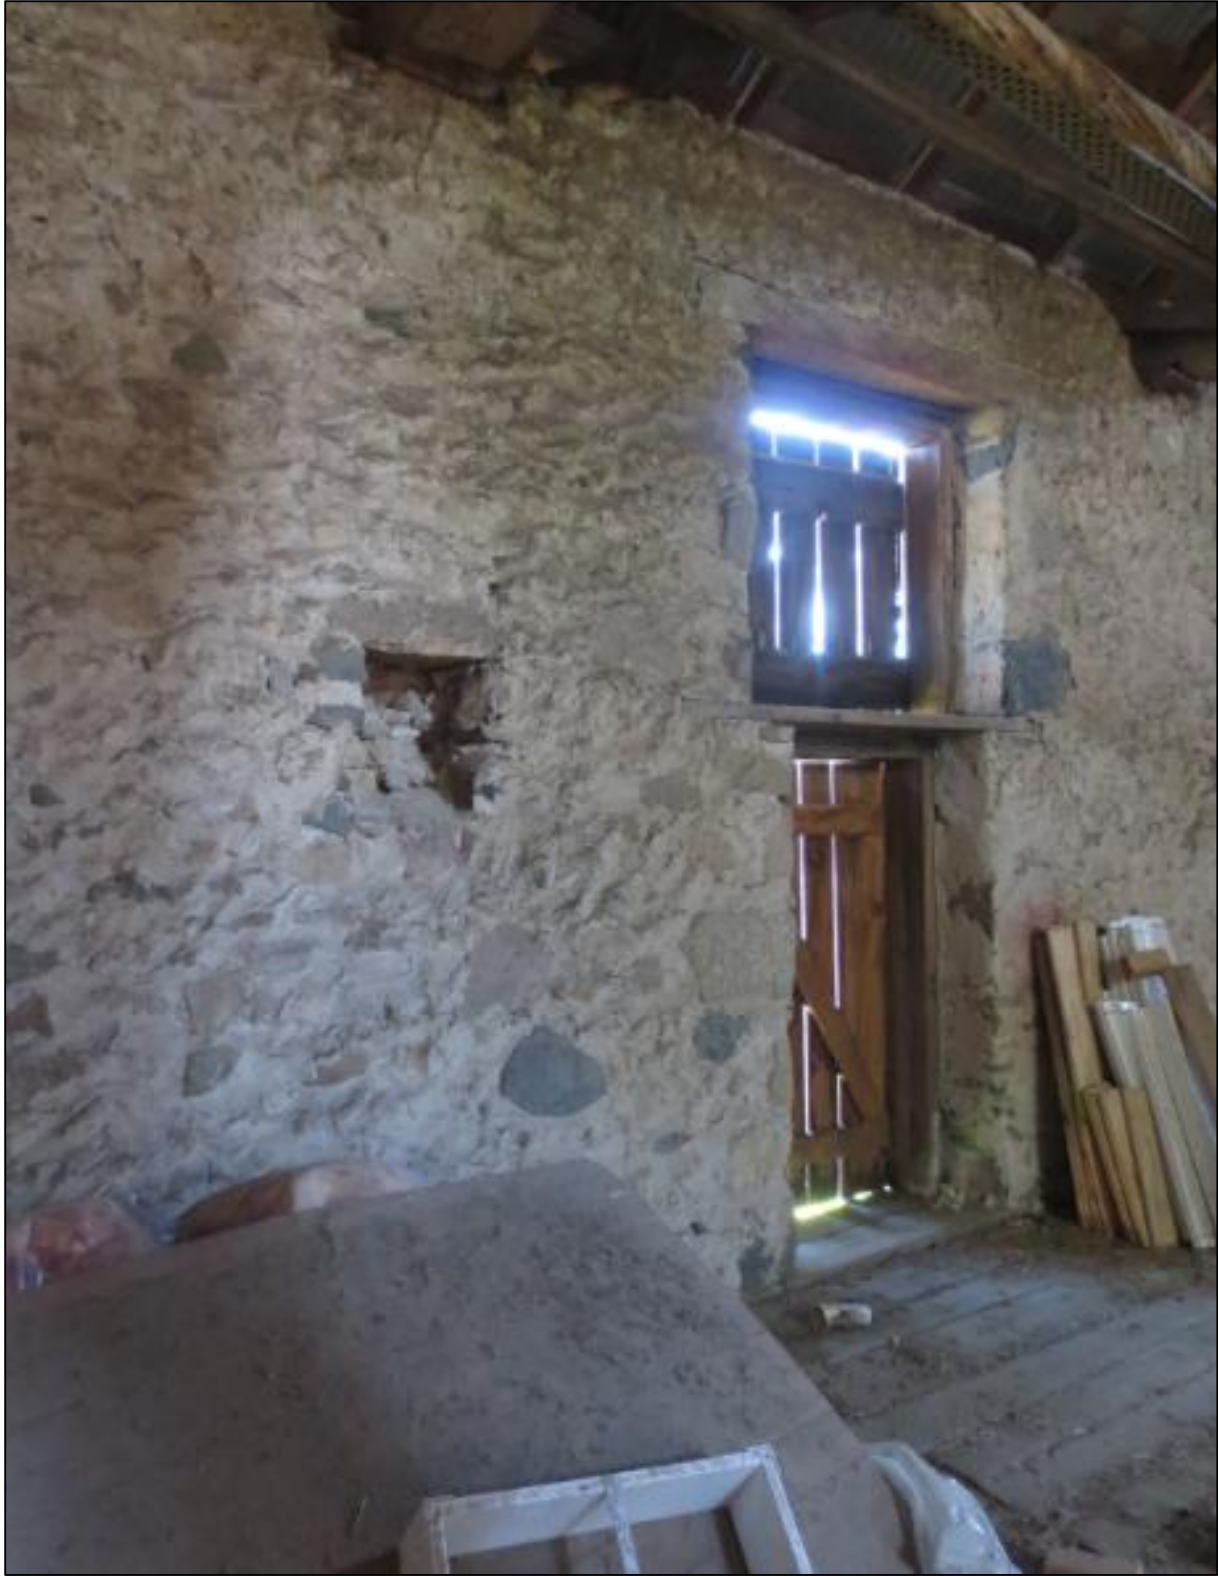
Figure 31: Photo of the barn's interior and the metal roof. A crack can be seen in the upper left corner. Taken June 17, 2019, by S. Robinson.

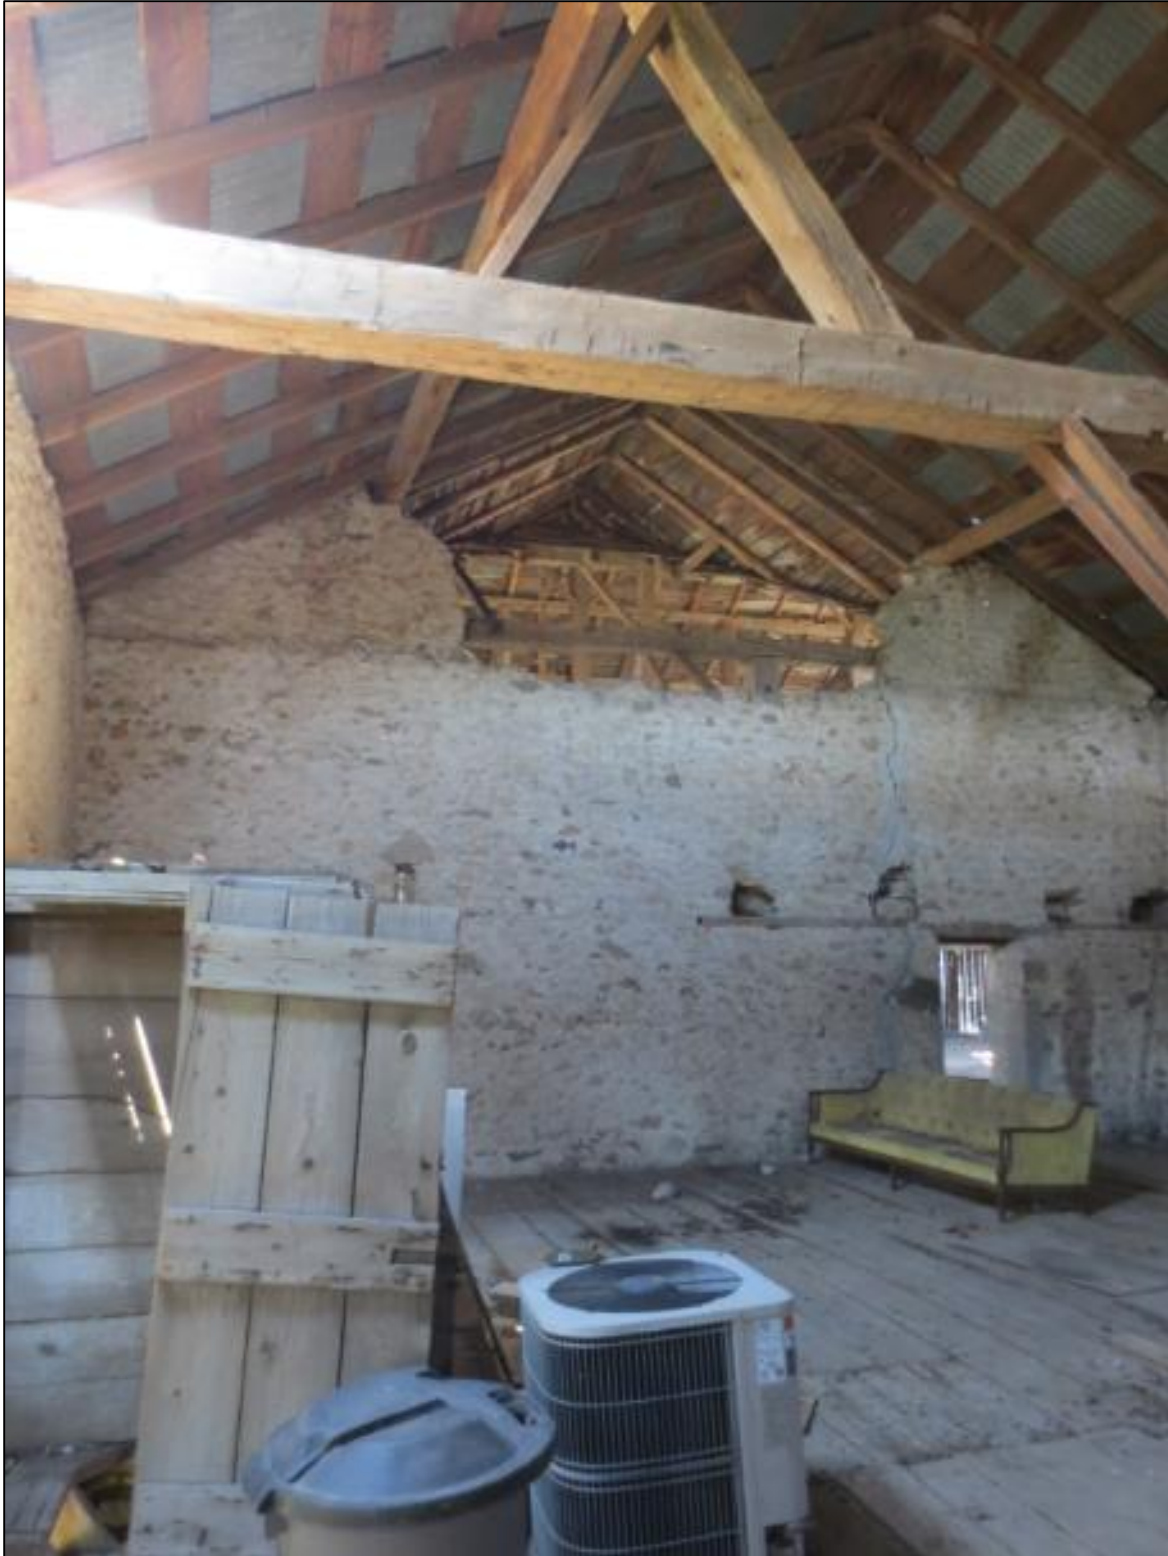
Figure 33: Photo of the stone barn's interior. Four people stand on either side of a large crack in the internal stone wall next to the internal doorway. Taken June 17, 2019, by S. Robinson.

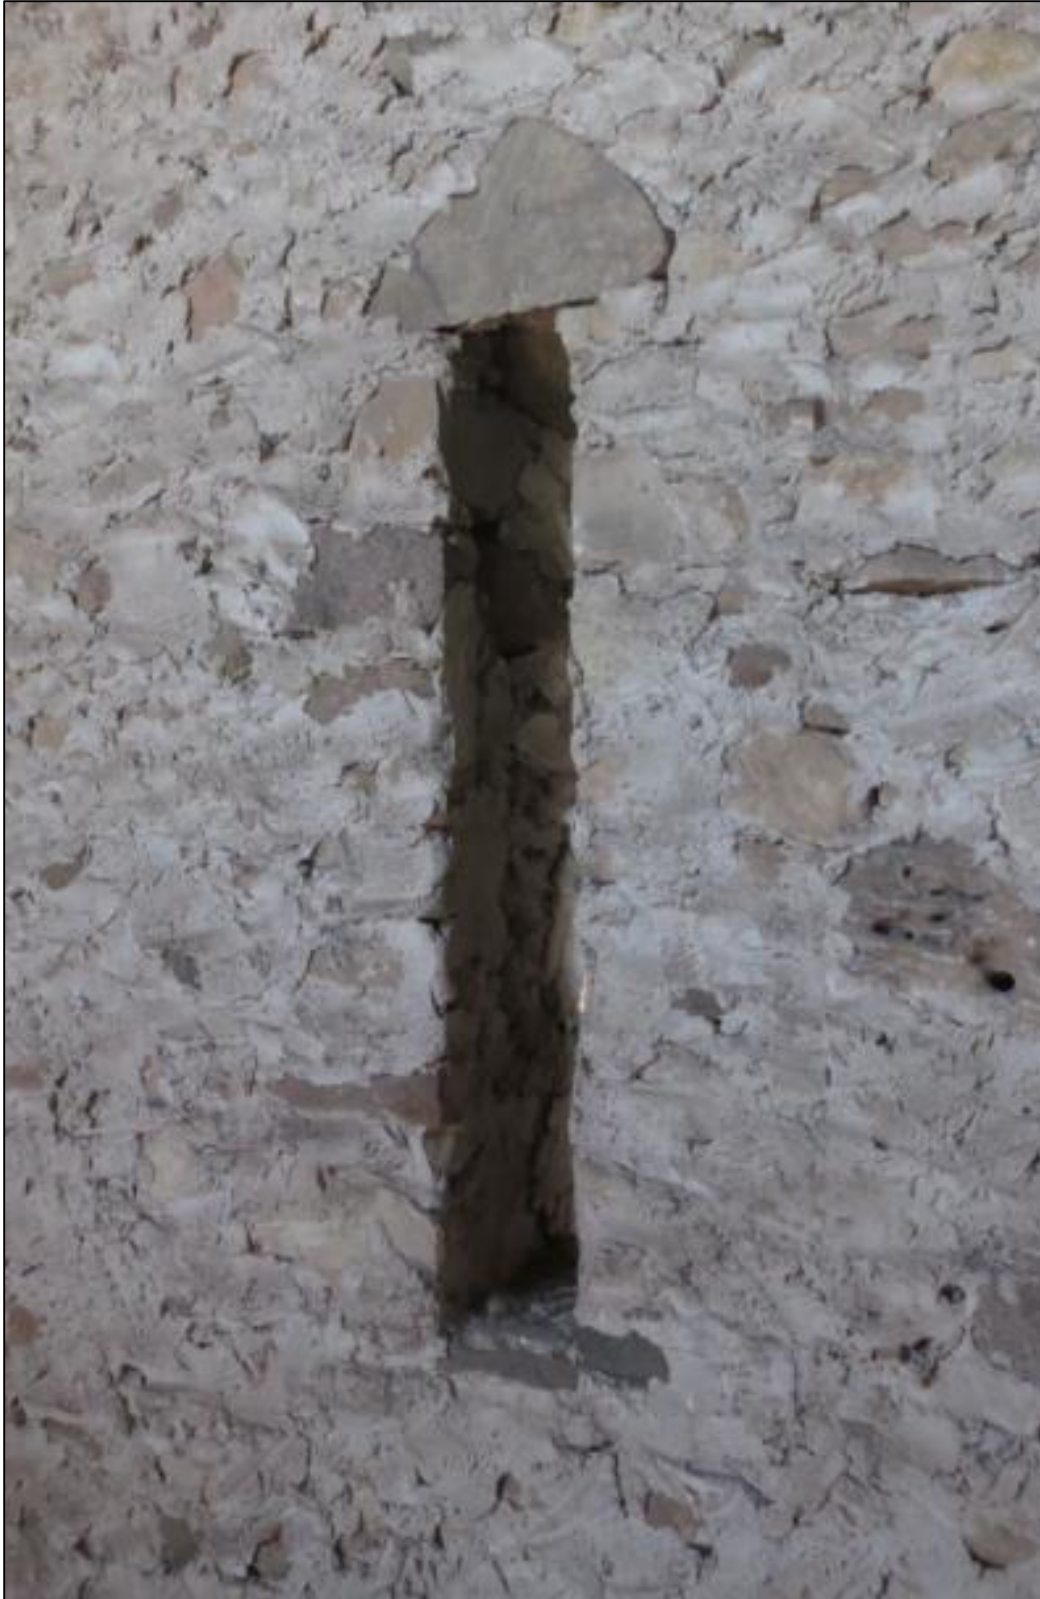
Figure 35: Photo of the section removed from the barn's interior wall. The ceiling of the wooden addition is visible through the space, and a crack is visible down the wall to the right. Taken June 17, 2019, by S. Robinson.
