Attachment-1 Property location and photos taken by Heritage Planning staff

2023 July 27 – Photos taken by S. Robinson of Heritage Planning during site visit with Property Standards staff.

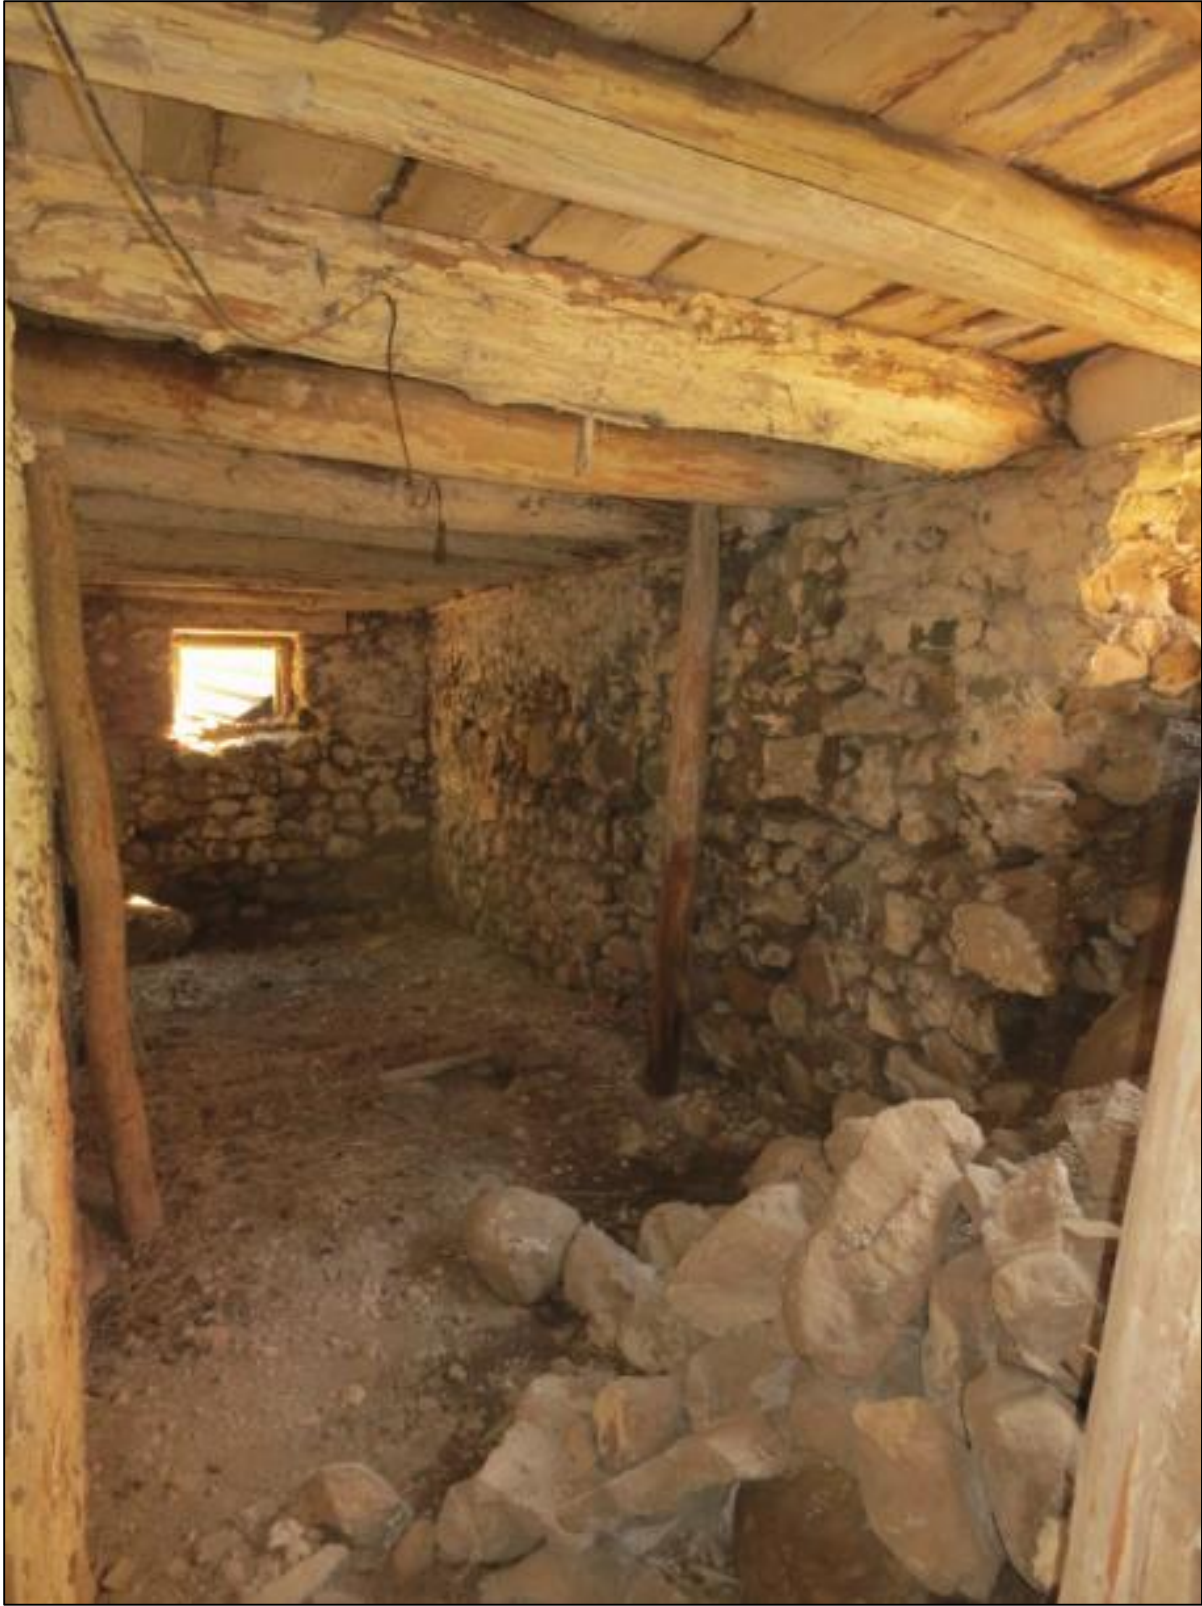
Figure 44: Photo of the root cellar and partially collapsed foundation. Taken June 17, 2019, by S. Robinson.

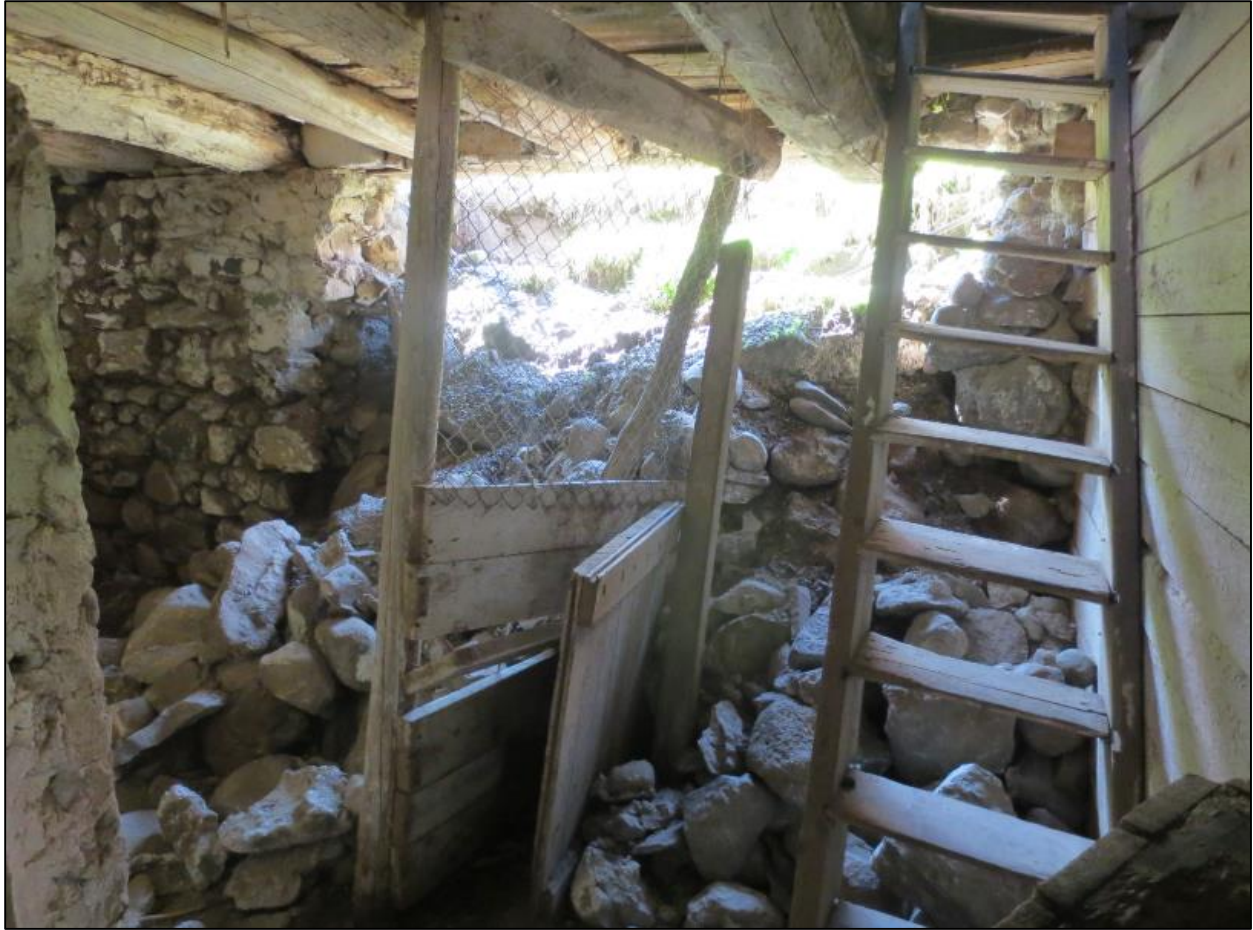
Figure 45: Photo of stone rubble in the basement of the stone barn. Taken June 17, 2019, by S. Robinson.

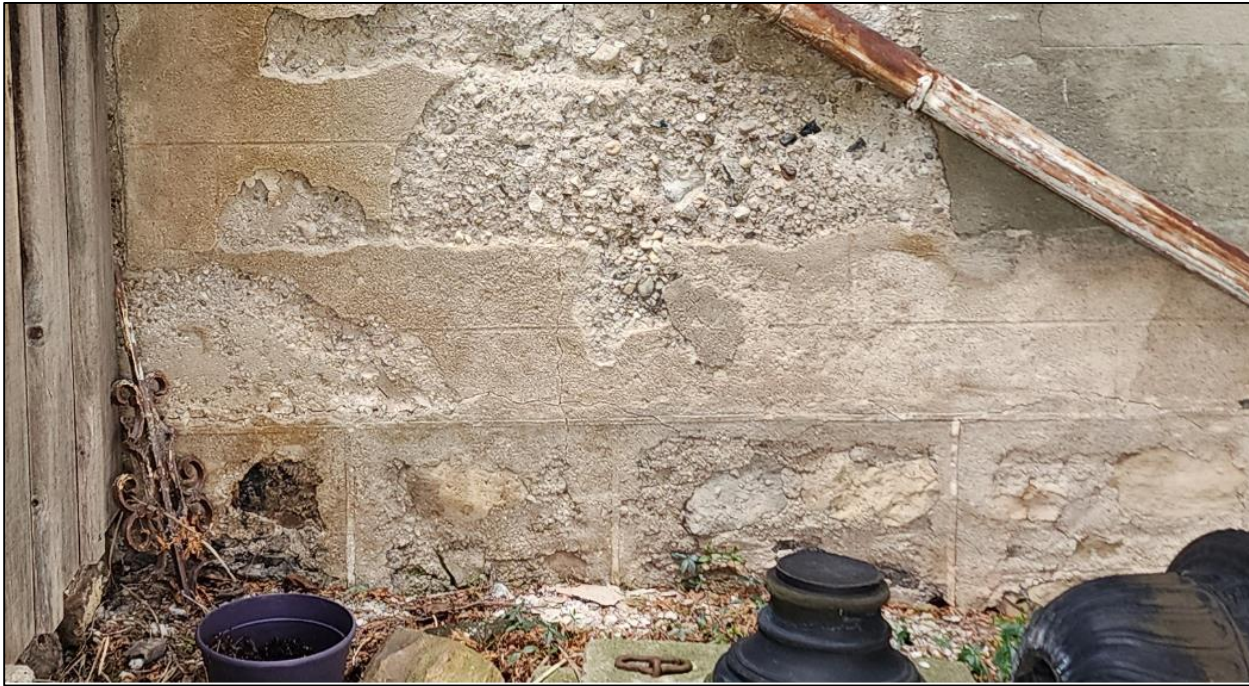
Figure 80: Photo of failing façade on exterior the farmhouse. Taken April 25, 2023, by S. Robinson.
