Attachment-1 Property Location and Photos Taken by Heritage Planning staff

2019 June 17 – Photos taken by S. Robinson of Heritage Planning during site visit with owner (Mattamy Homes).

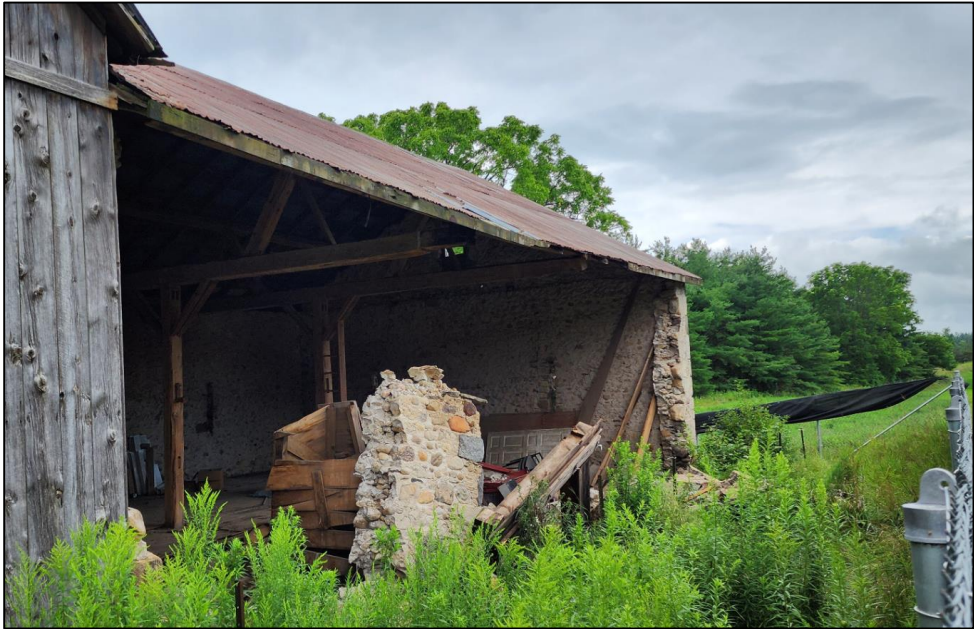
Figure 6: Photo of collapsed north stone wall. Taken July 27, 2023, by S. Robinson.

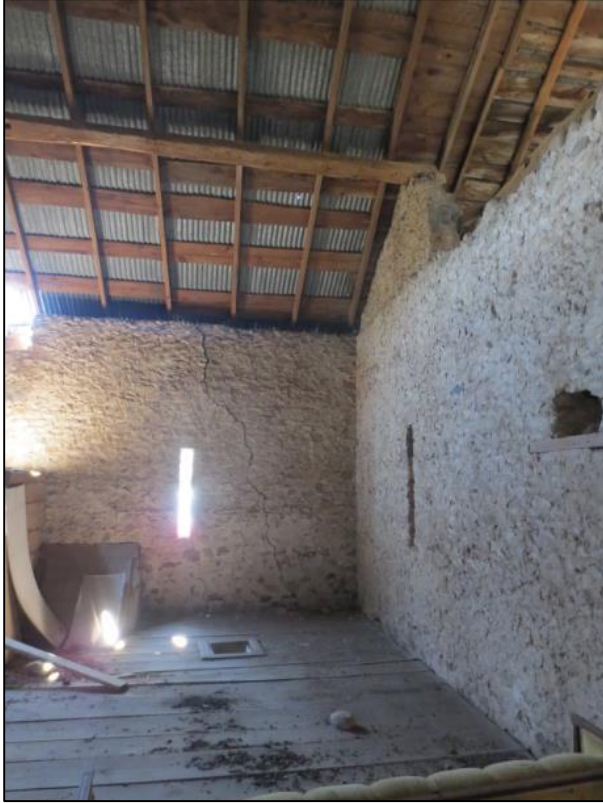
Figure 9: Photo of interior corner of north and east stone walls. Taken June 17, 2019, by S. Robinson.

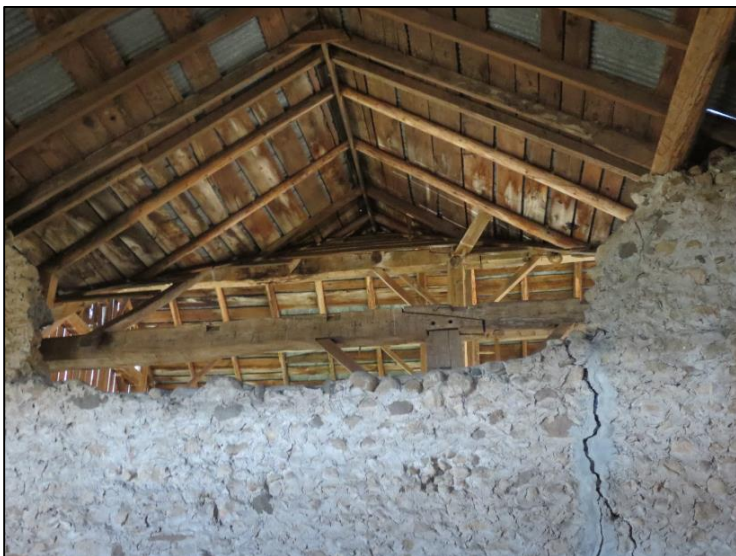
Figure 10: Photo of the upper section removed from the barn's east interior wall. The ceiling of the wooden addition is visible through the space. Taken June 17, 2019, by S. Robinson.
