**2187 Gordon Street, City of
Guelph, Ontario, Cultural
Heritage Resource Impact
Assessment**

Final Report

March 13, 2024

Project Number: 161423769

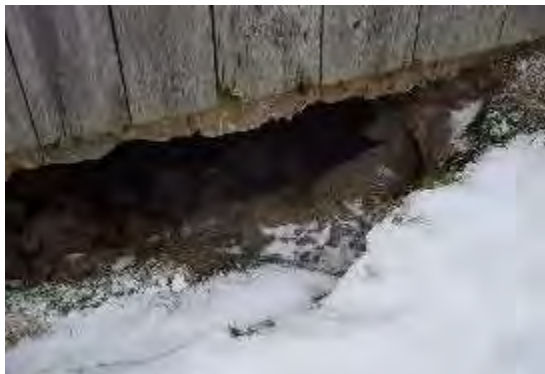
Plate 80: Close-up of collapsed north elevation foundation wall

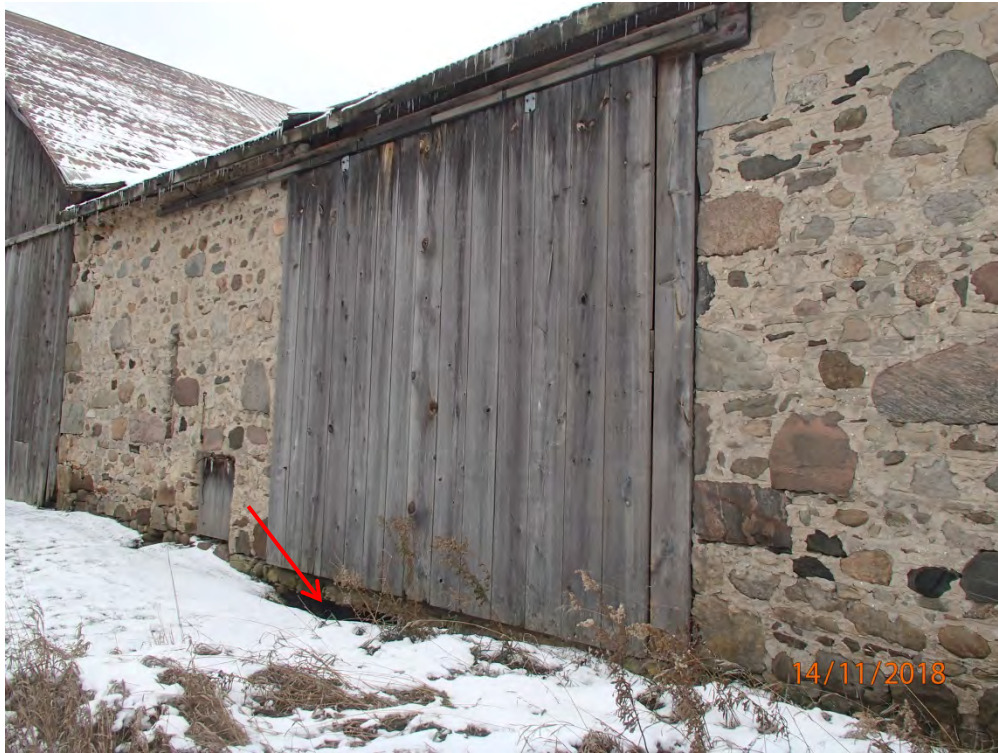
Photograph No. 1 – North wall at failed foundation wall.

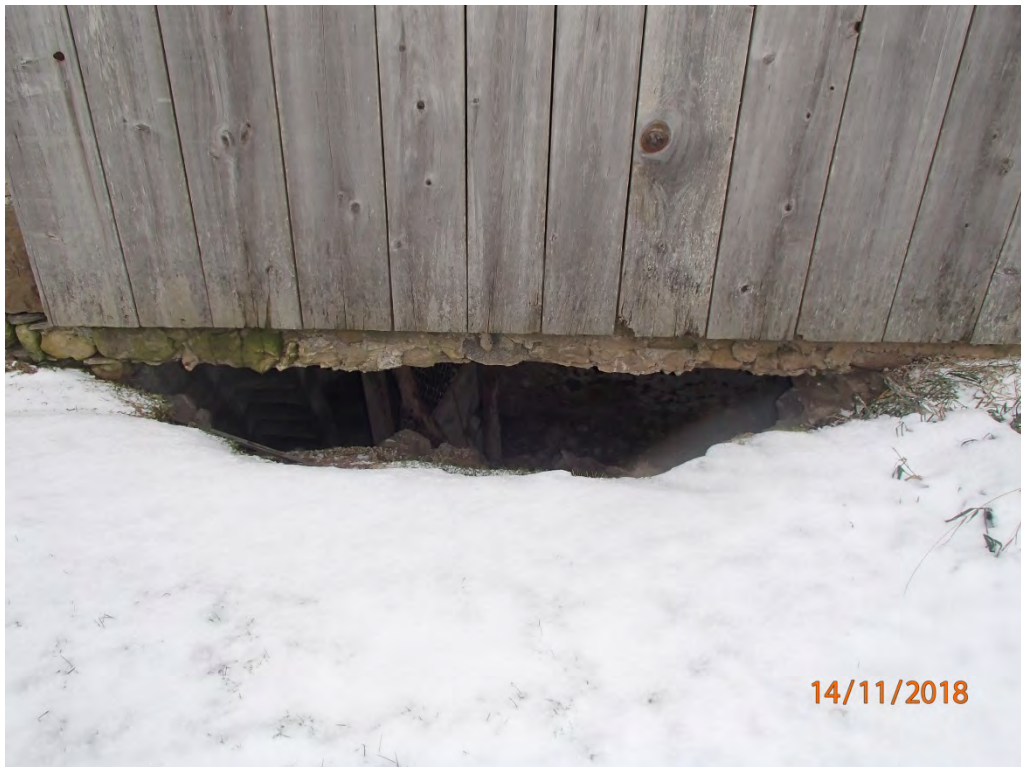
Photograph No. 2 – North foundation wall failure

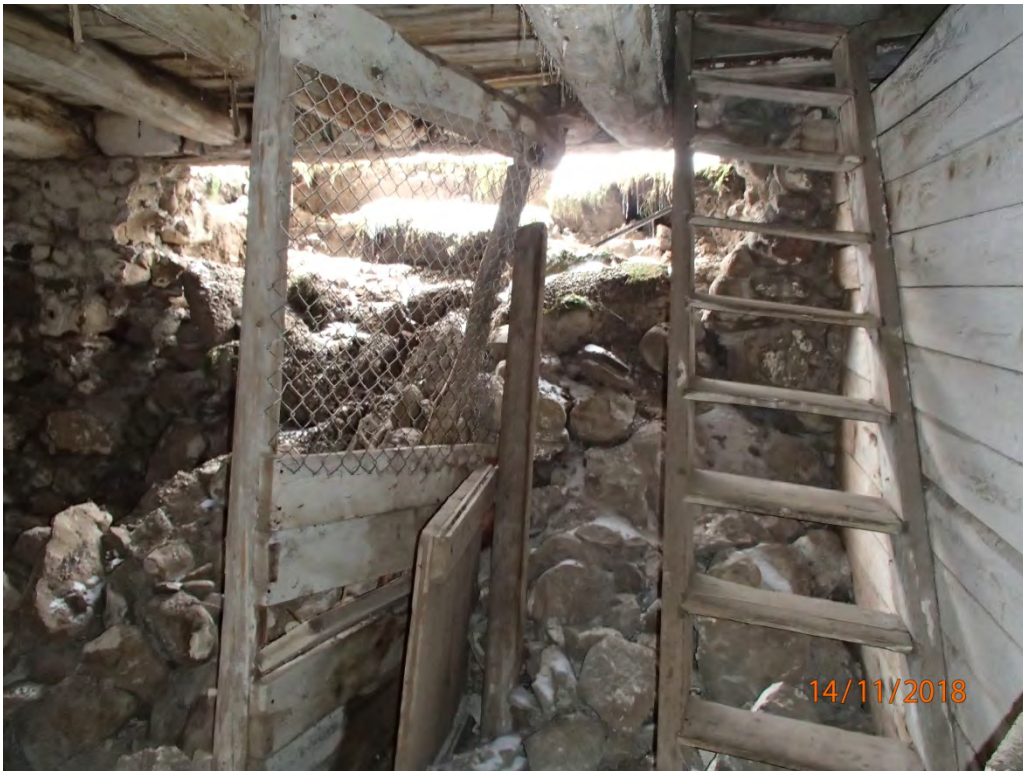
Photograph No. 3a – Failed foundation wall, floor beams unsupported

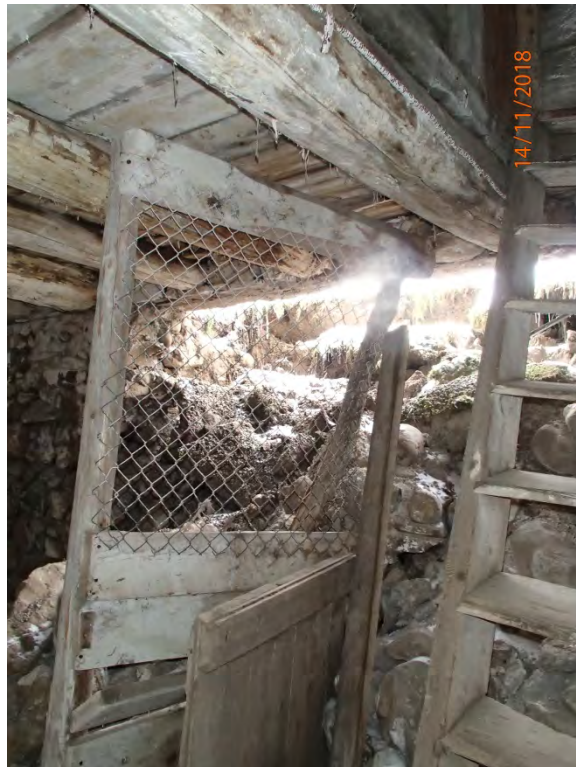
Photograph No. 3b – Failed foundation wall, floor beams unsupported

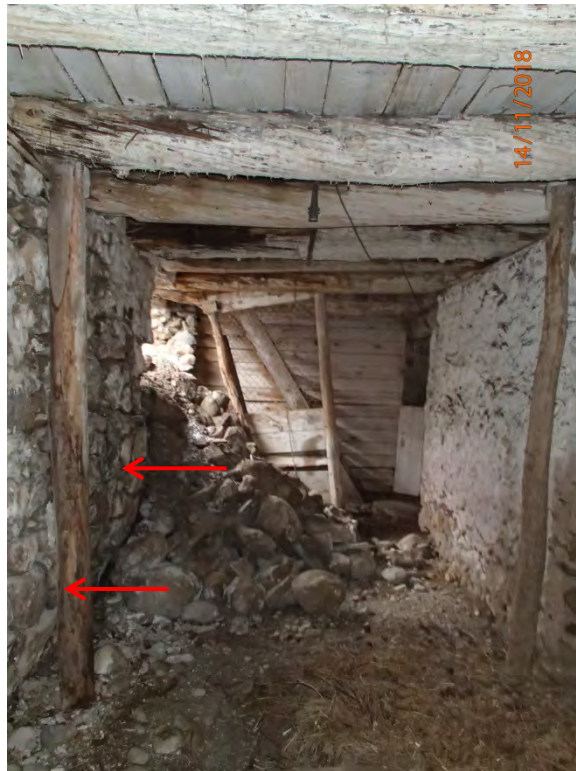
Photograph No. 4 – Bowing of North foundation wall

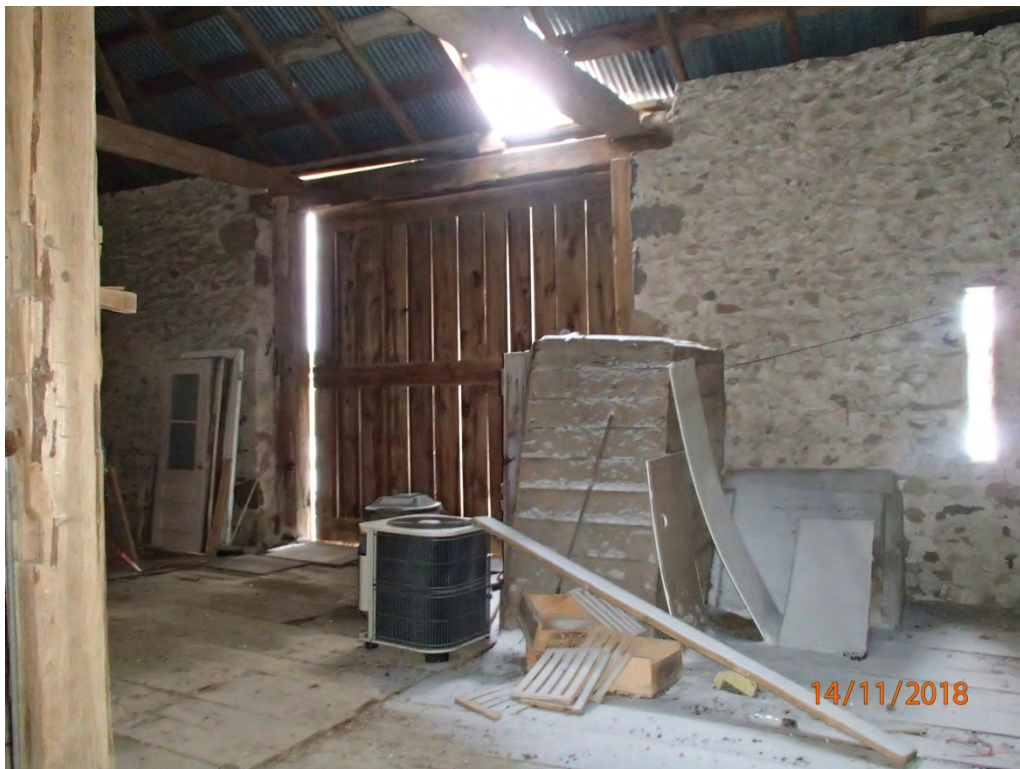
Photograph No. 5 – Door framing above failed foundation wall (interior view of north wall)

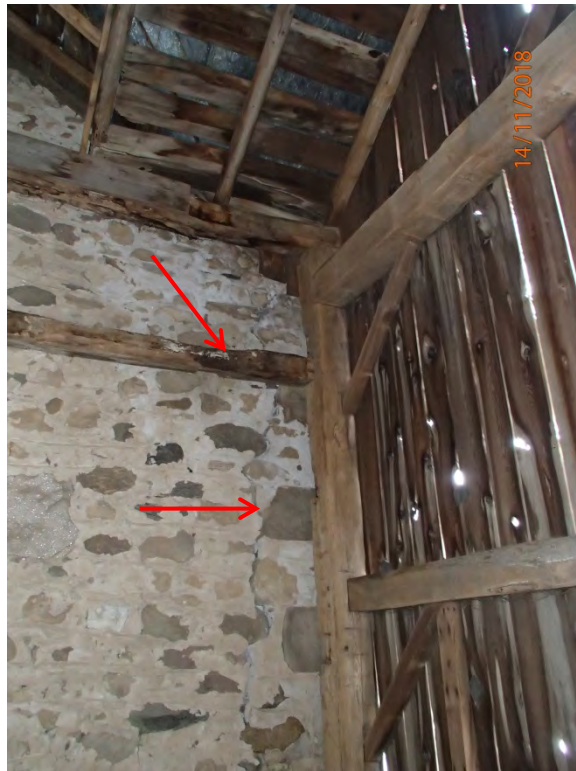
Photograph No. 6 – East Stone wall cracked, timber rot

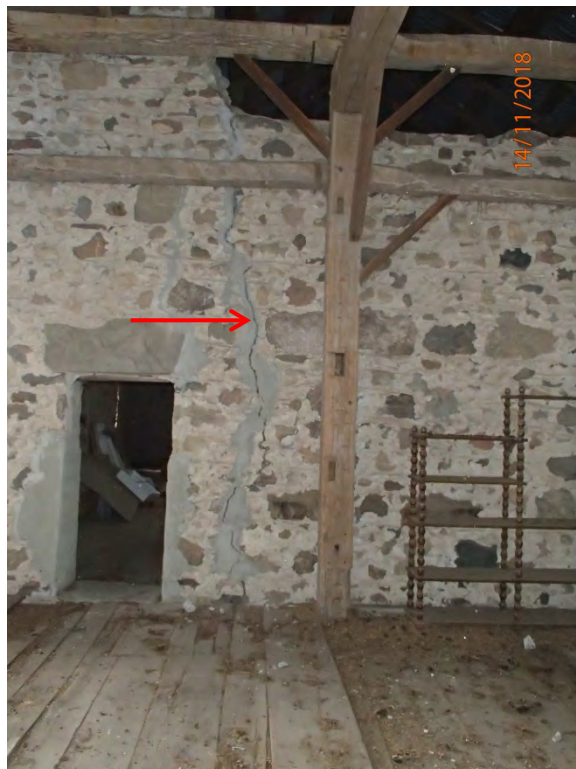
Photograph No. 7 – East Stone wall of Original Building (now interior wall), cracked

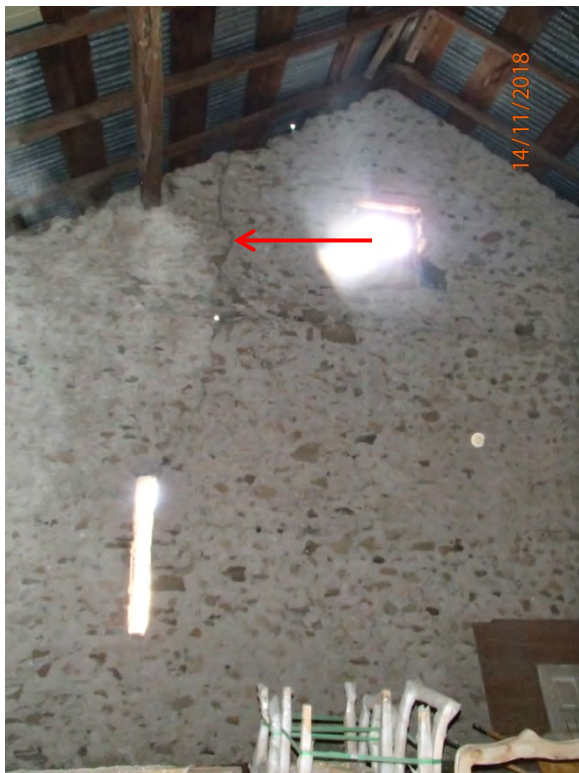
Photograph No. 8 – West Exterior Stone wall (interior view), cracked

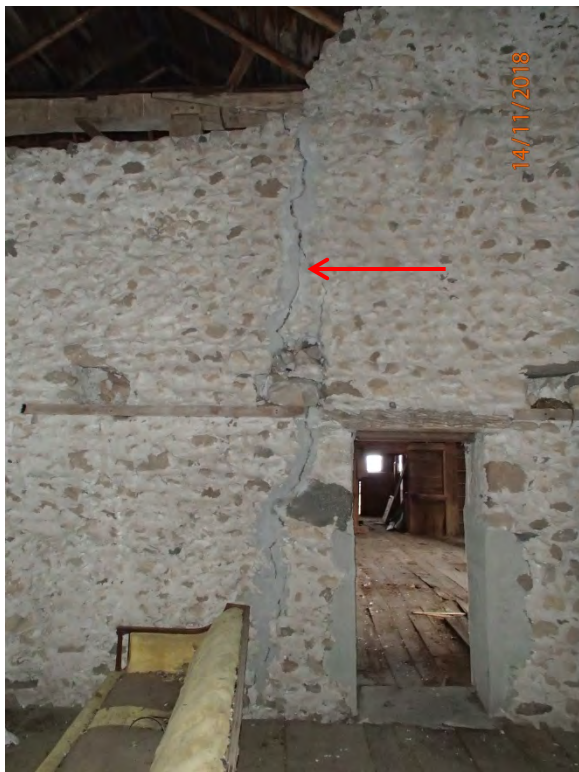
Photograph No. 9 – East Stone wall of Original Building (now interior wall), cracked

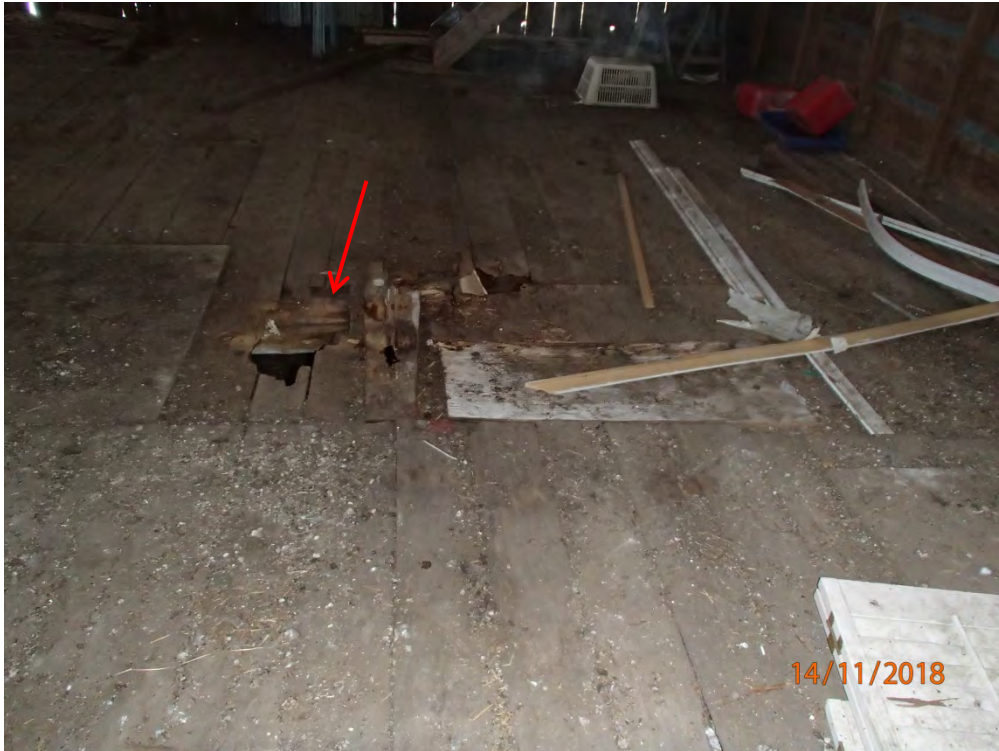
Photograph No. 10 – Unsafe, damaged floor boards

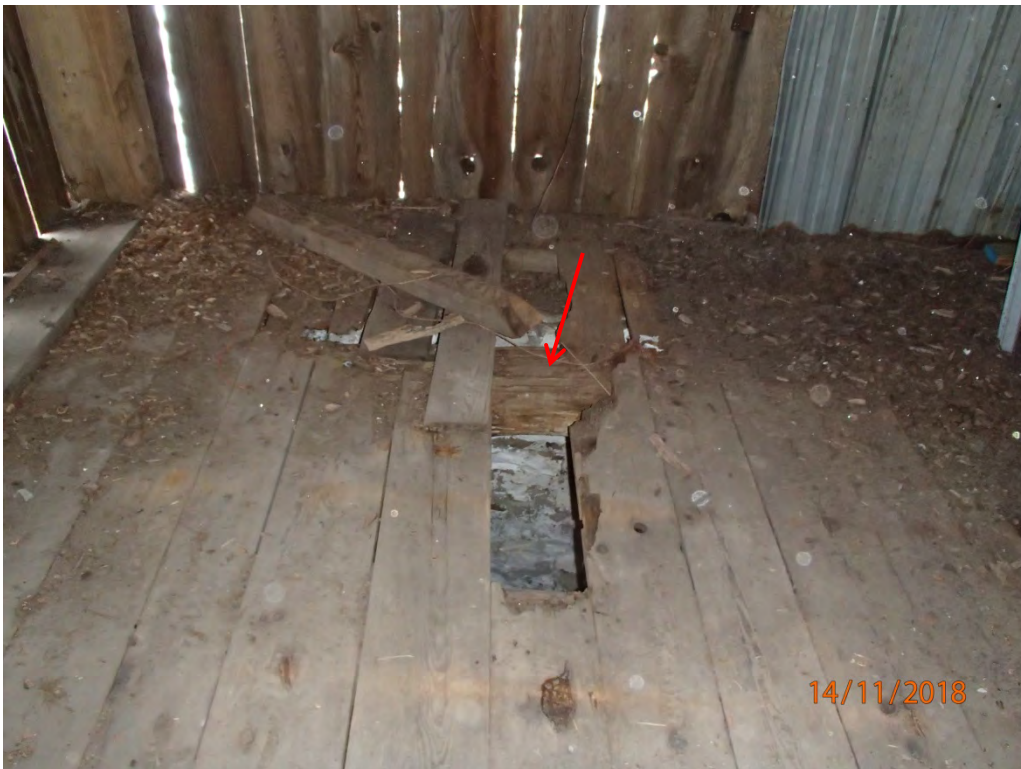
Photograph No. 11 – Unsafe floor boards, rotted floor beam

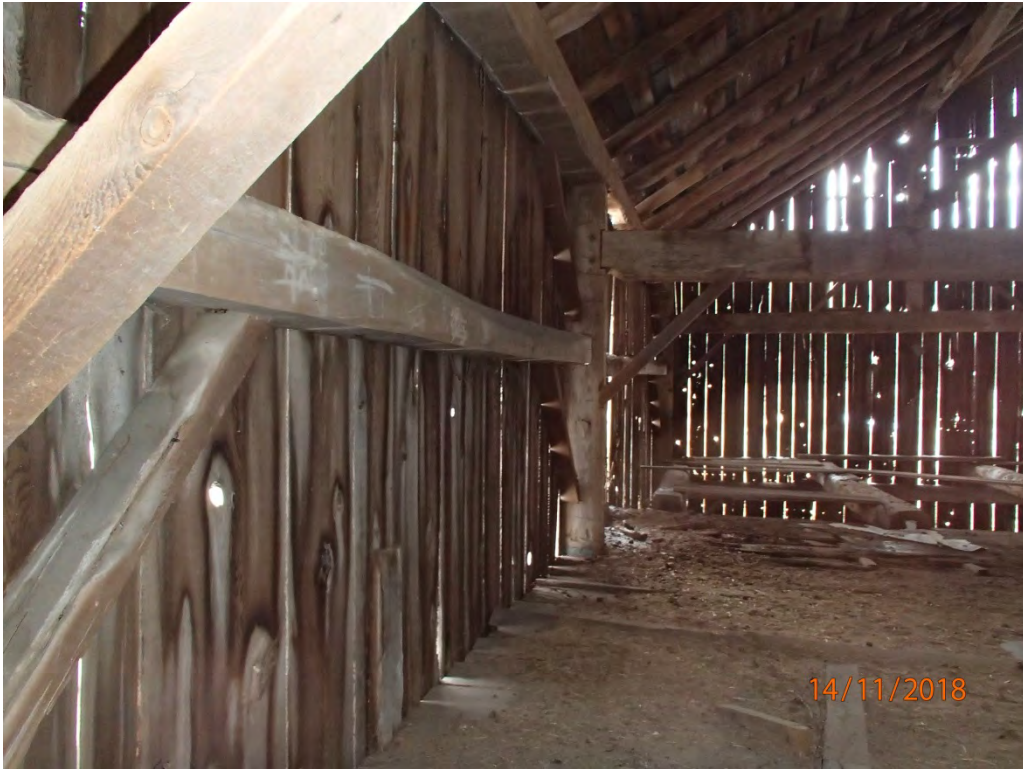
Photograph No. 12– Mezzanine and West wall framing (fair condition)

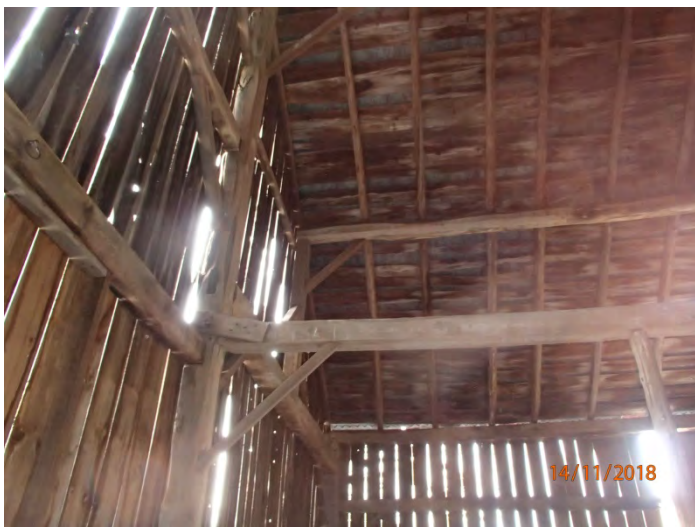
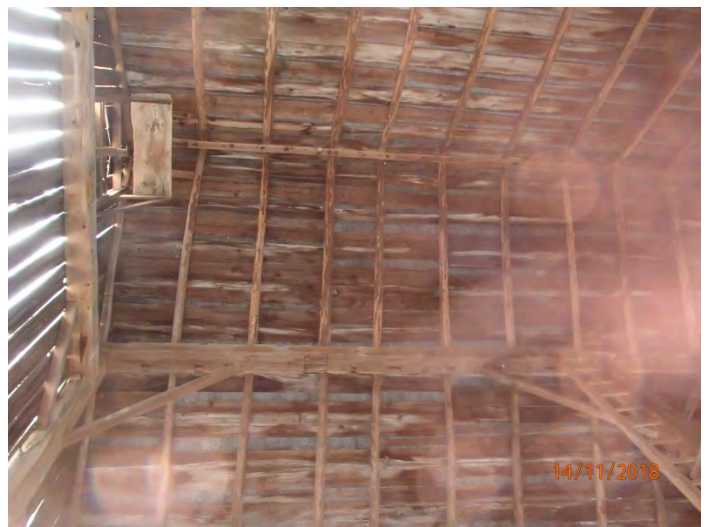
Photograph No. 13 – Superstructure barn roof framing (fair condition)

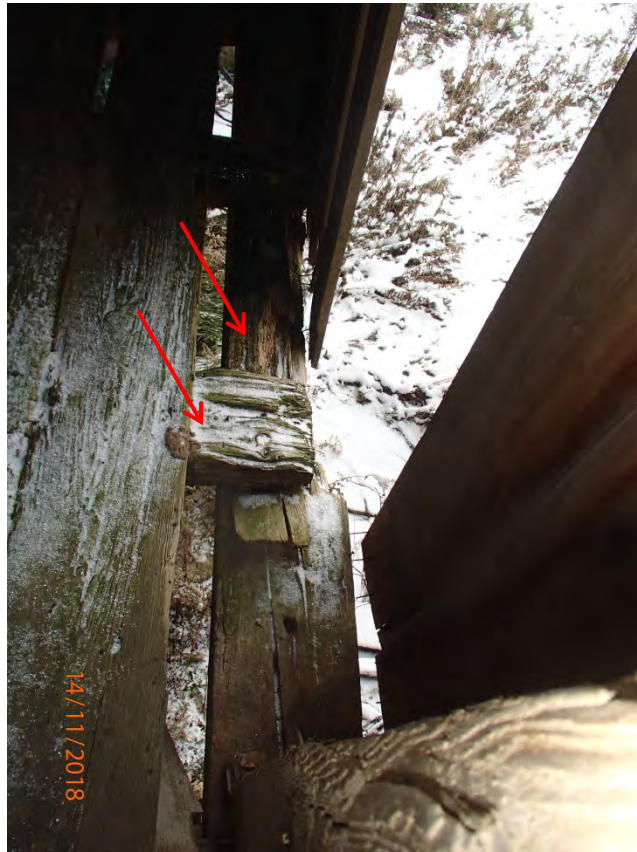
Photograph No. 14 – Rotted floor beam, potential fall hazard

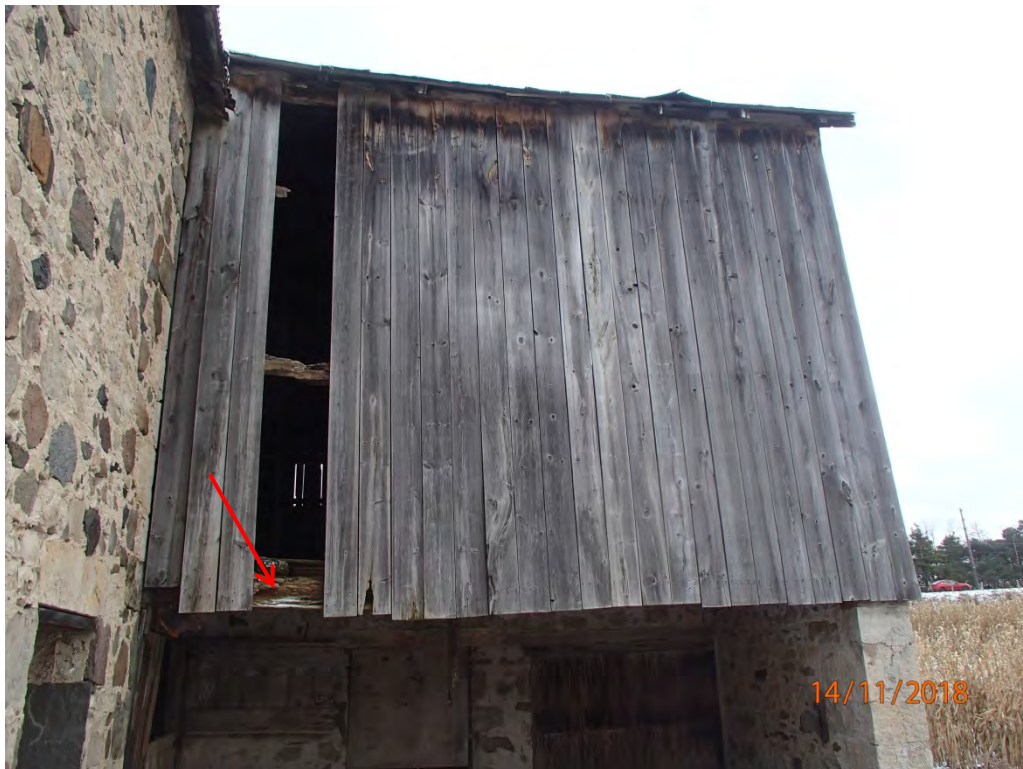
Photograph No. 15– Partially rotted floor beam, missing wall boards

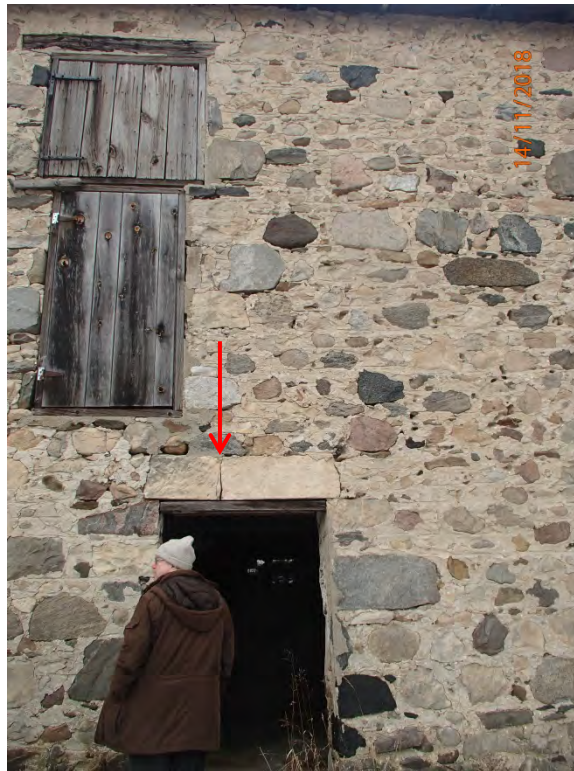
Photograph No. 16– Cracked lintel stones (South wall)

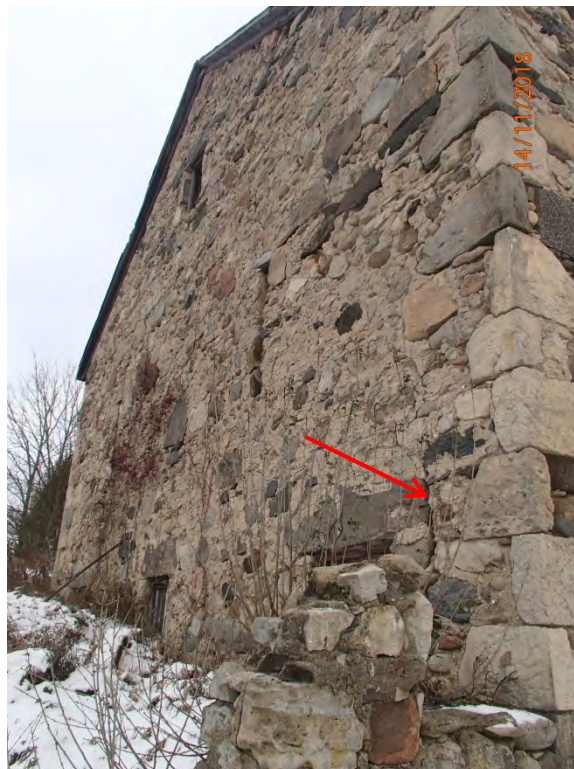
Photograph No. 17– West stone wall, cracks present but true (vertically plumb)

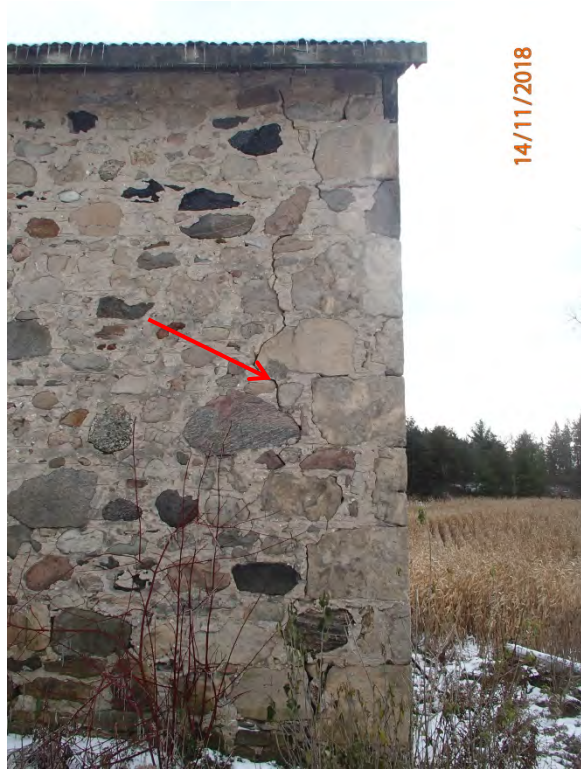
Photograph No. 18 – Northwest corner, thru crack in stone wall

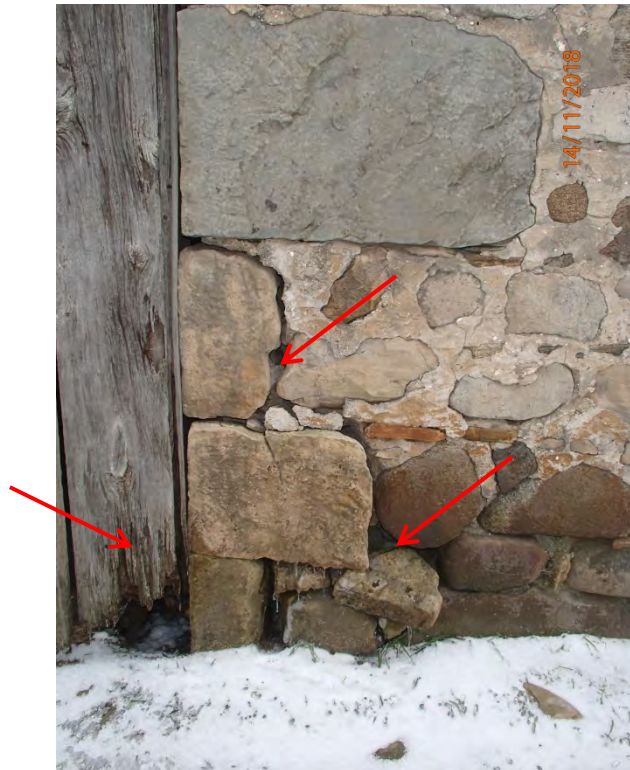
Photograph No. 19 – Stone wall mortar deterioration (North), rotted barn boards

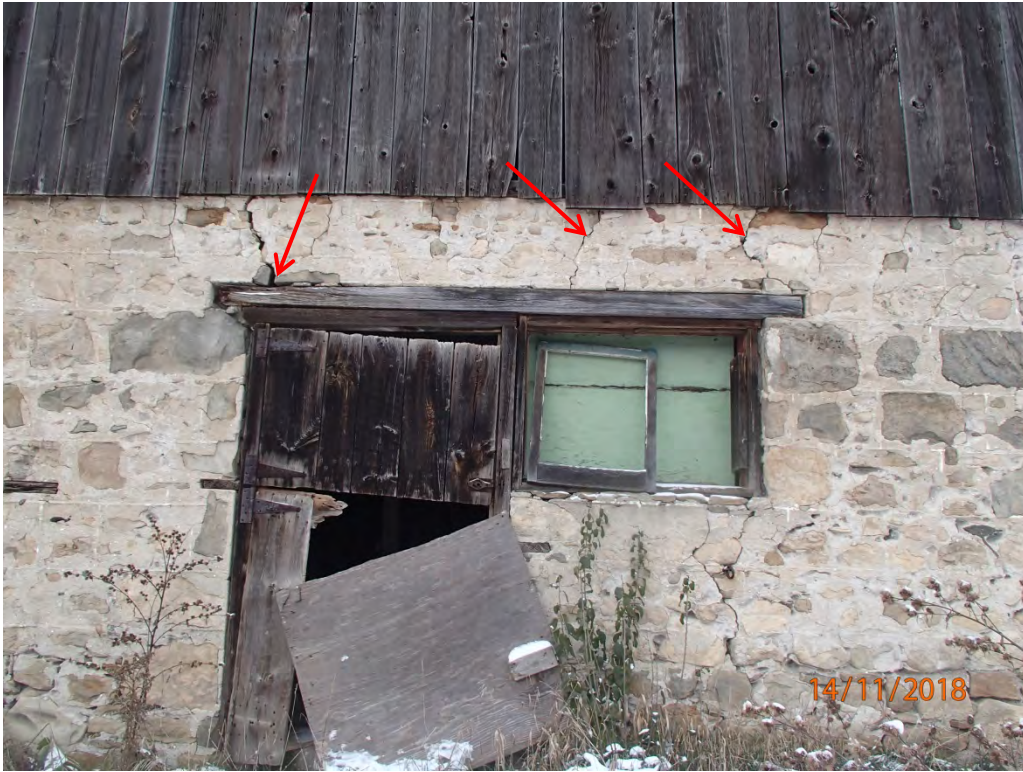
Photograph No. 22 – South wall, cracked stone over wood lintel

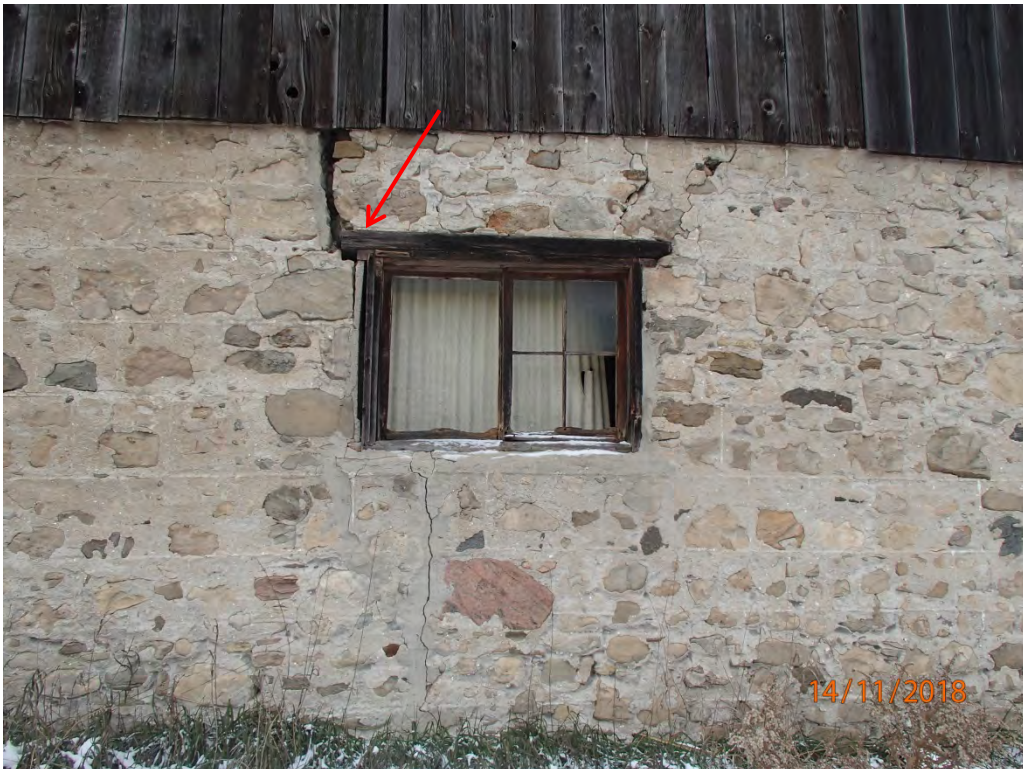
Photograph No. 23– Crack at lintel, inadequate bearing (south wall)

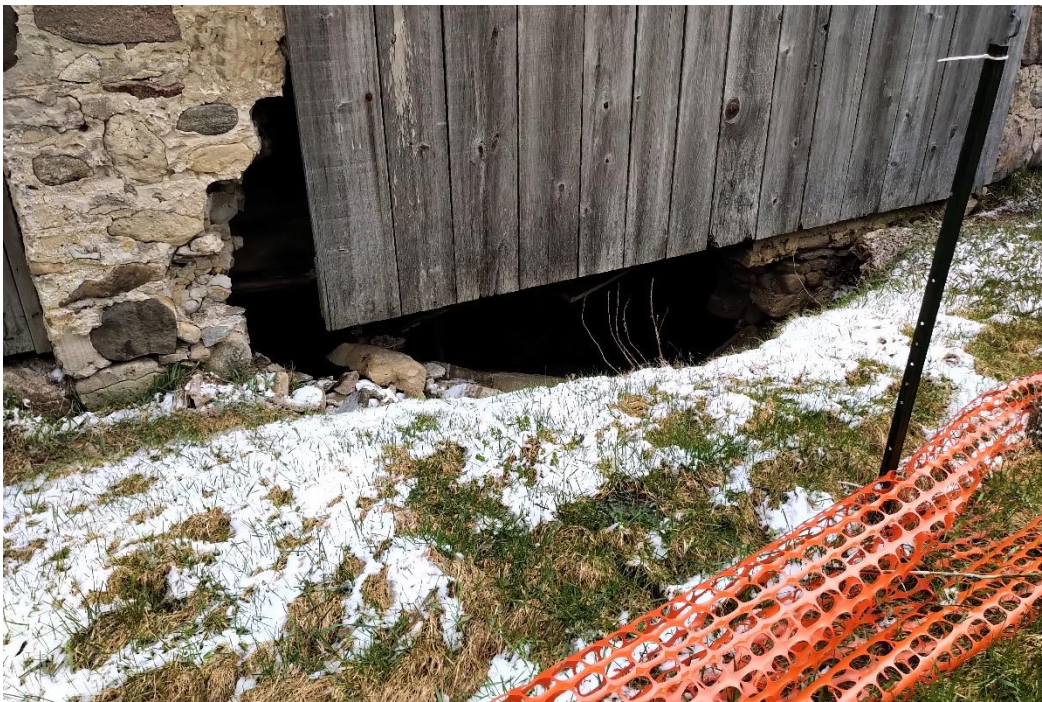
Photograph No. 2 – Foundation wall condition in 2021

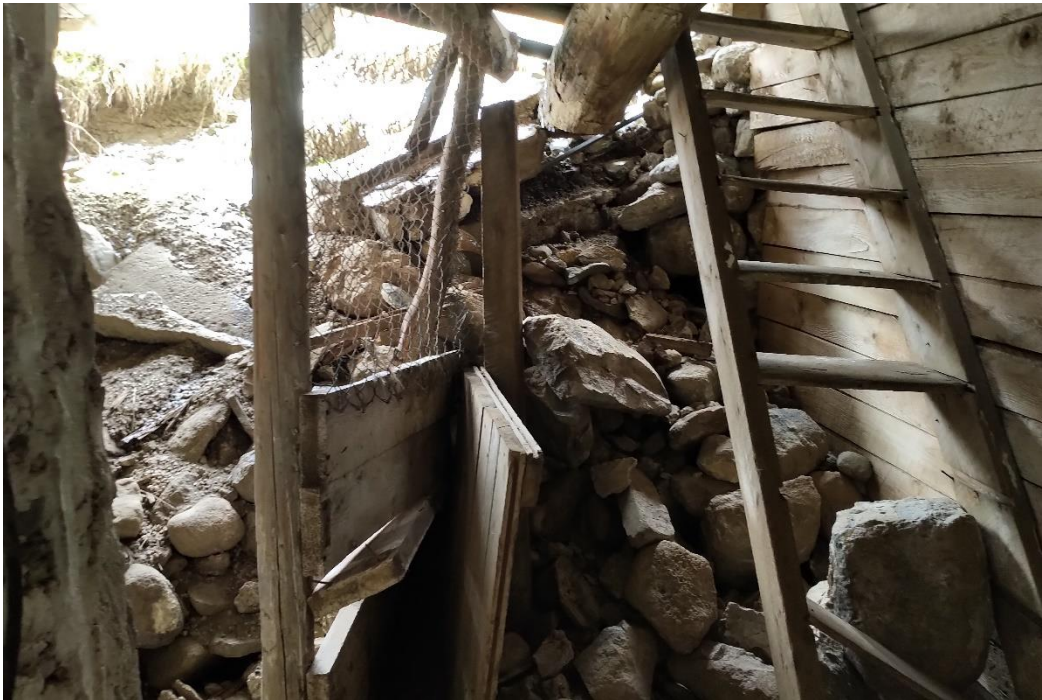
Photograph No. 4 – North wall (lower level) condition worsened: loss of more stone wall; floor support

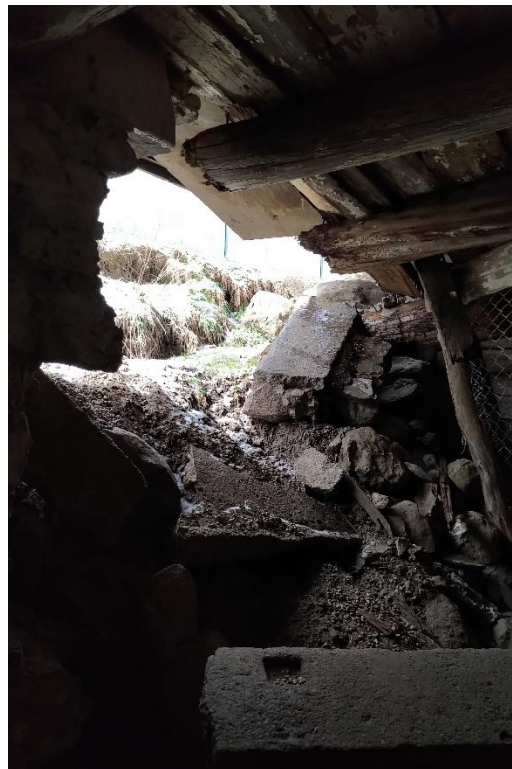
Photograph No. 6 – North wall (lower level – Left bearing) condition worsened: loss of more stone wall; floor support

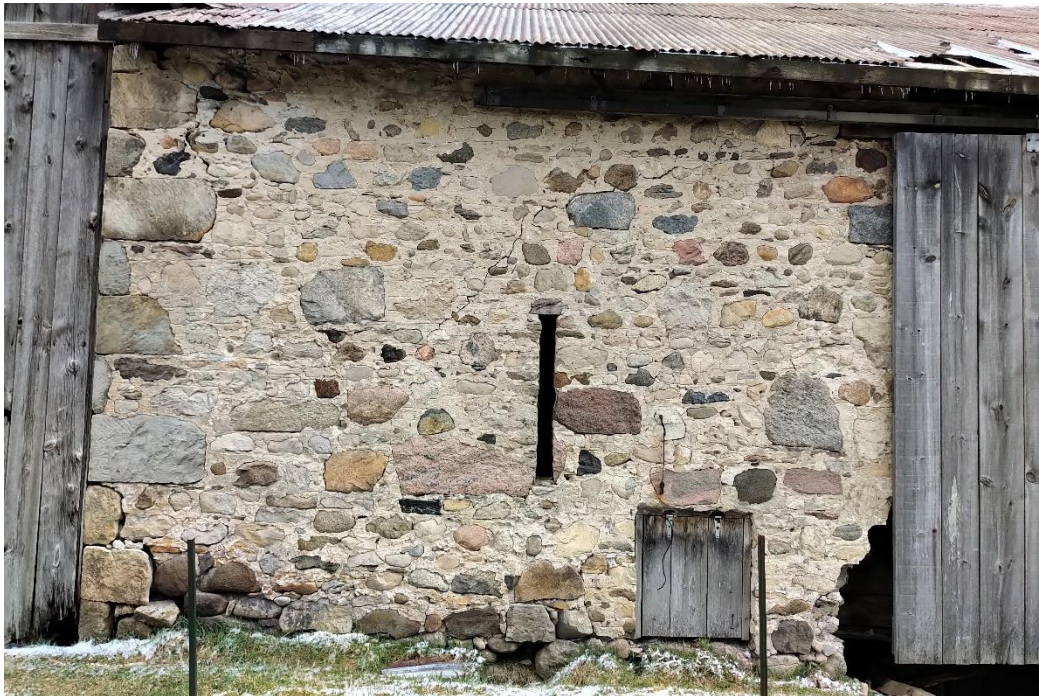
Photograph No. 8 – North Stone wall (upper) further Deterioration and loss

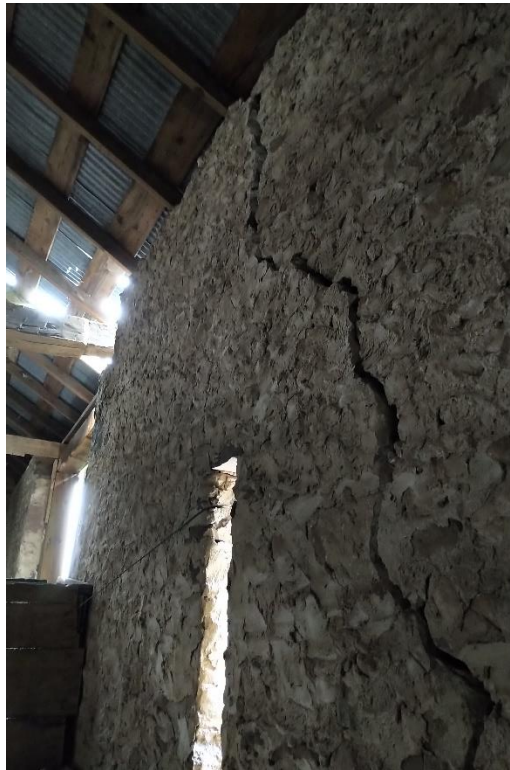
Photograph No. 10 – North wall (main floor) has moved in; crack worsened, opening up

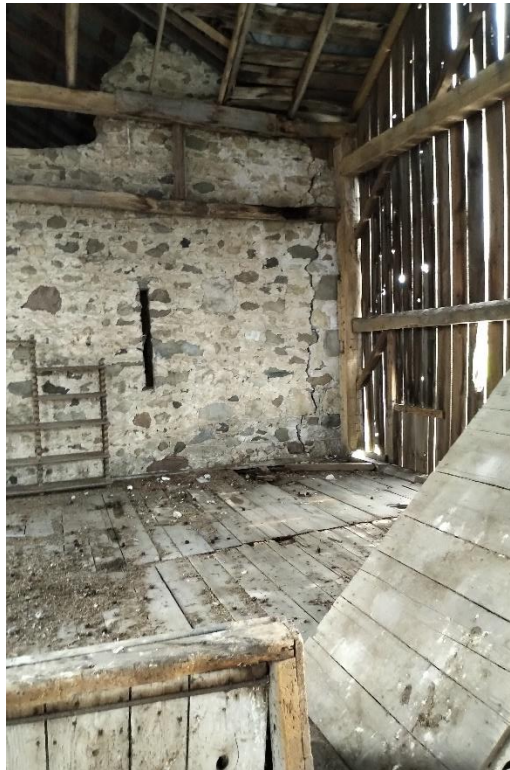
Photograph No. 12 – Crack opened wider due to north wall rotation inward

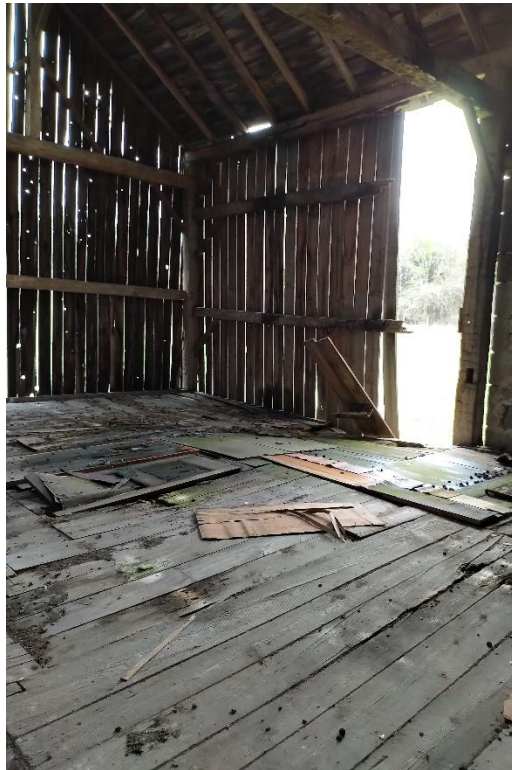
Photograph No. 14 – More wall boards lost; floor condition worsened

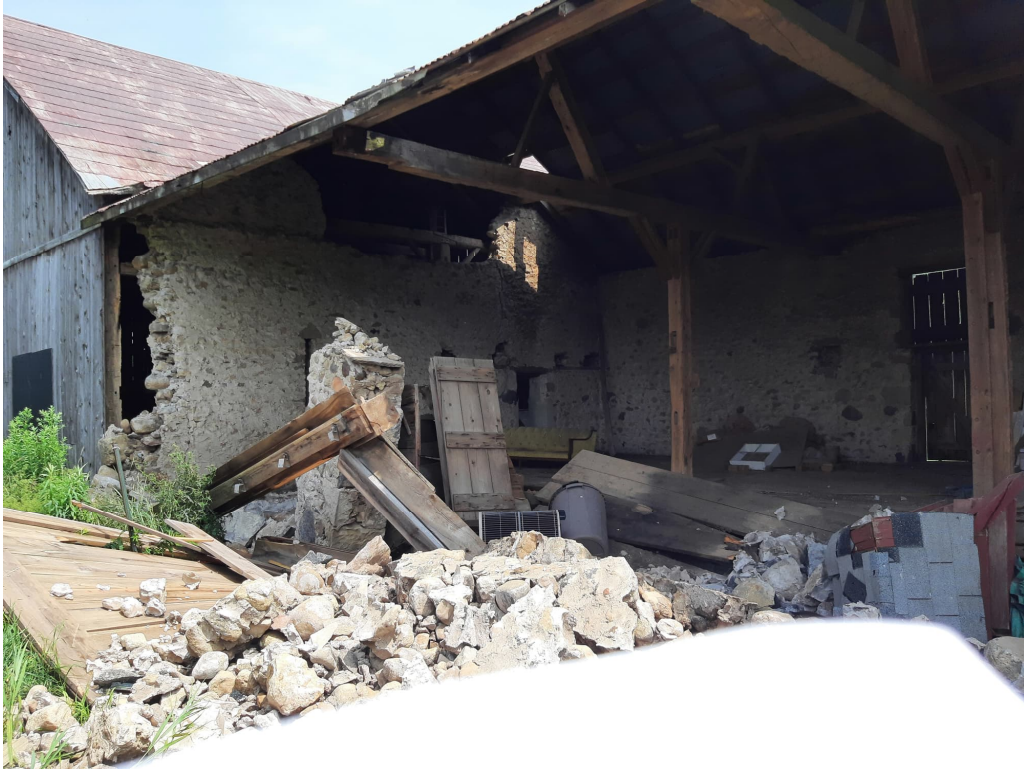
Photograph No. 1 – North Wall Collapsed – unsafe to shore

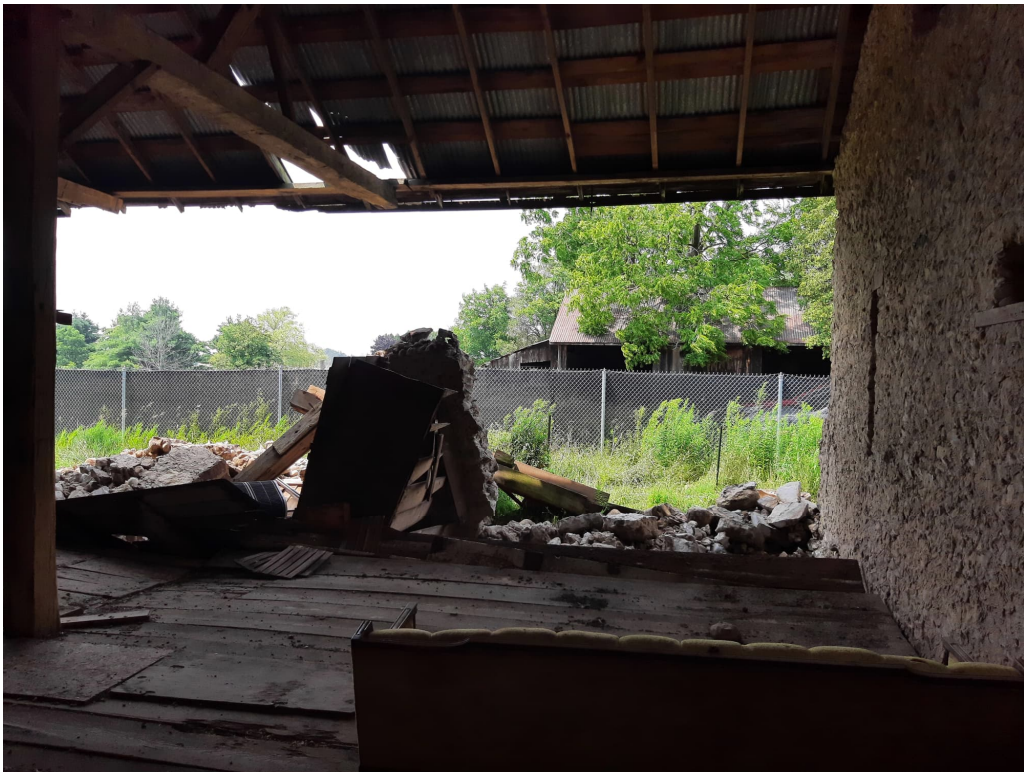
Photograph No. 2 – Unsafe to Shore or work under – Steel Roofing missing

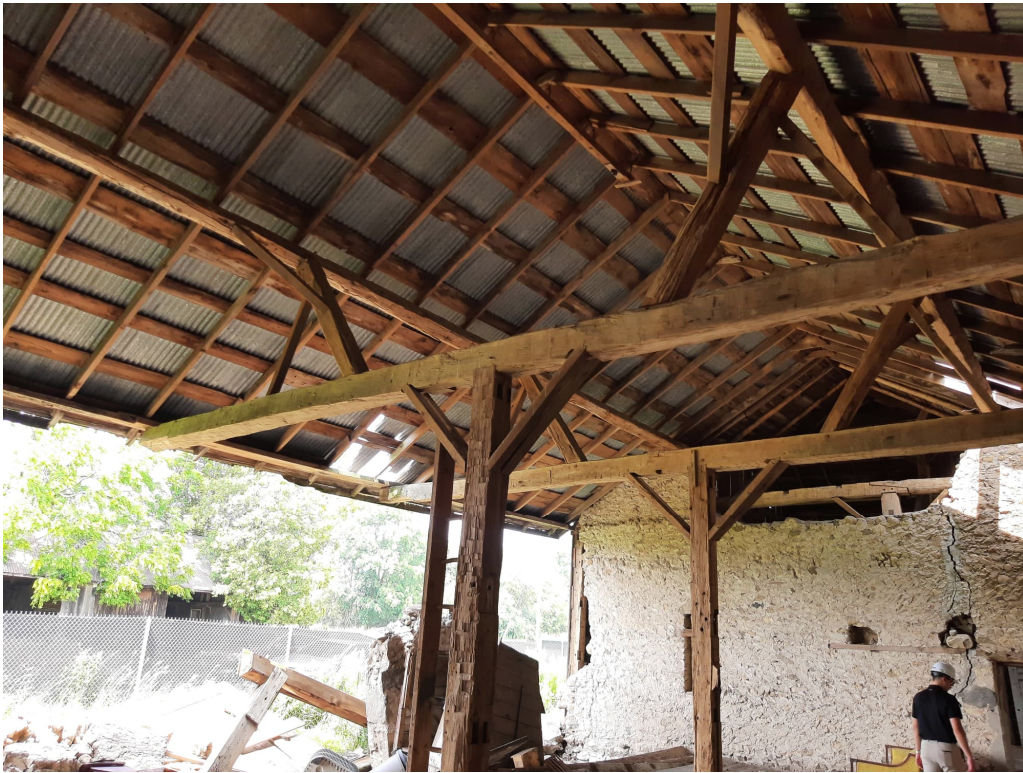
Photograph No. 3 – Damaged roof members; missing metal roof cladding

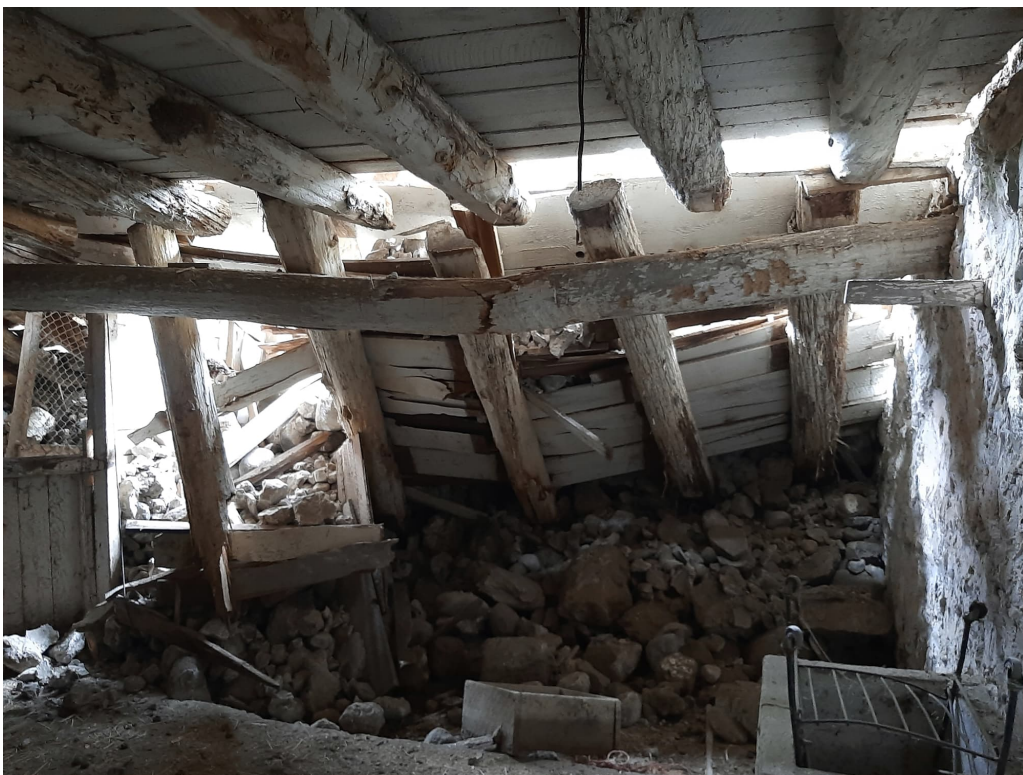
Photograph No. 4 – Collapsed North wall – unsafe to shore

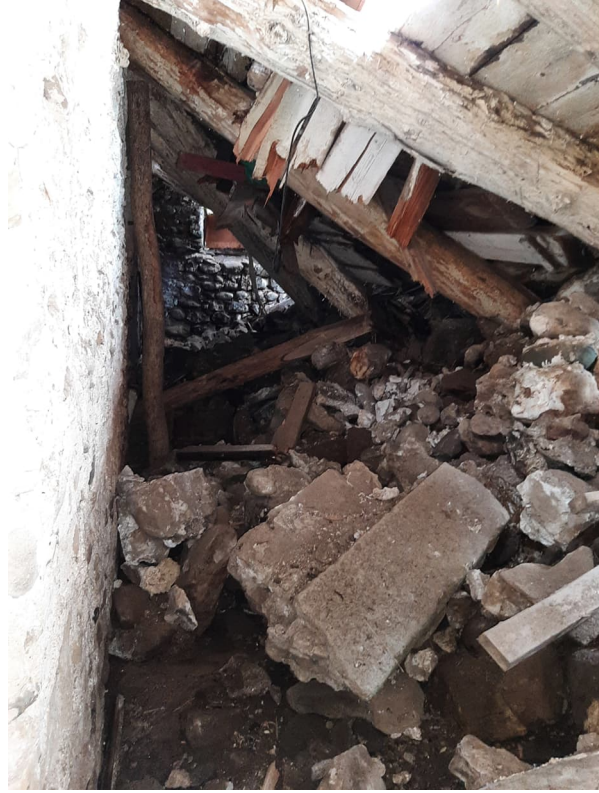
Photograph No. 5 – Collapsed North wall - unsafe to shore

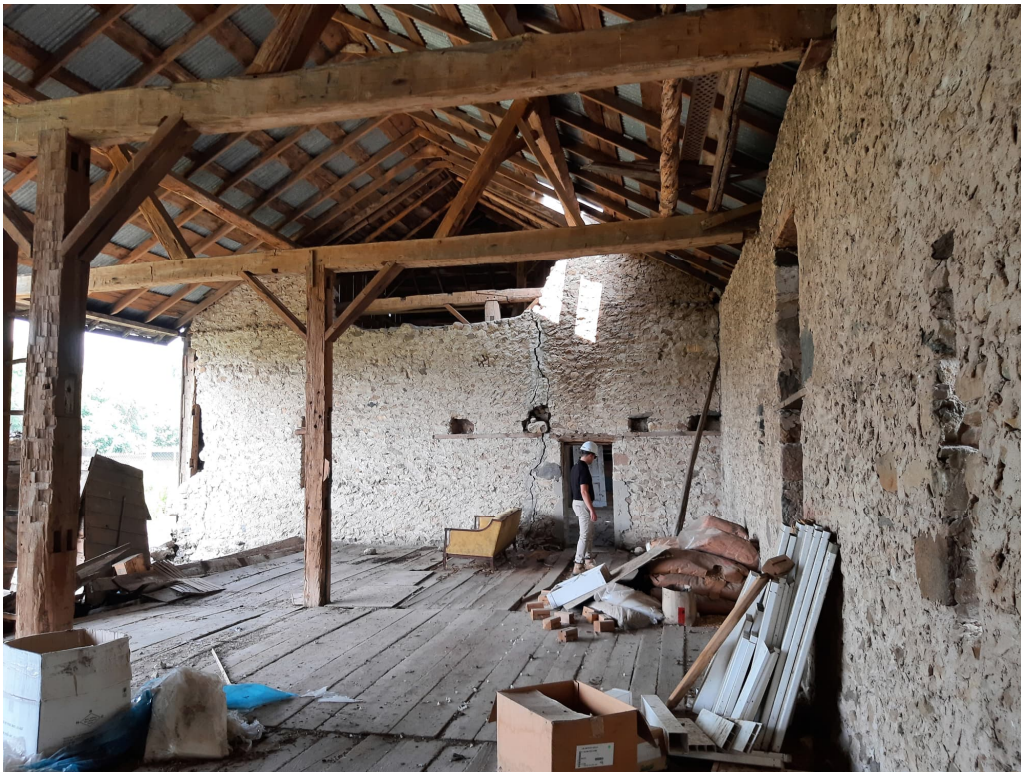
Photograph No. 6 – Stone Wall Cracked, Unsafe to work around
