**2187 Gordon Street, City of
Guelph, Ontario, Cultural
Heritage Resource Impact
Assessment**

Final Report

March 13, 2024

Project Number: 161423769

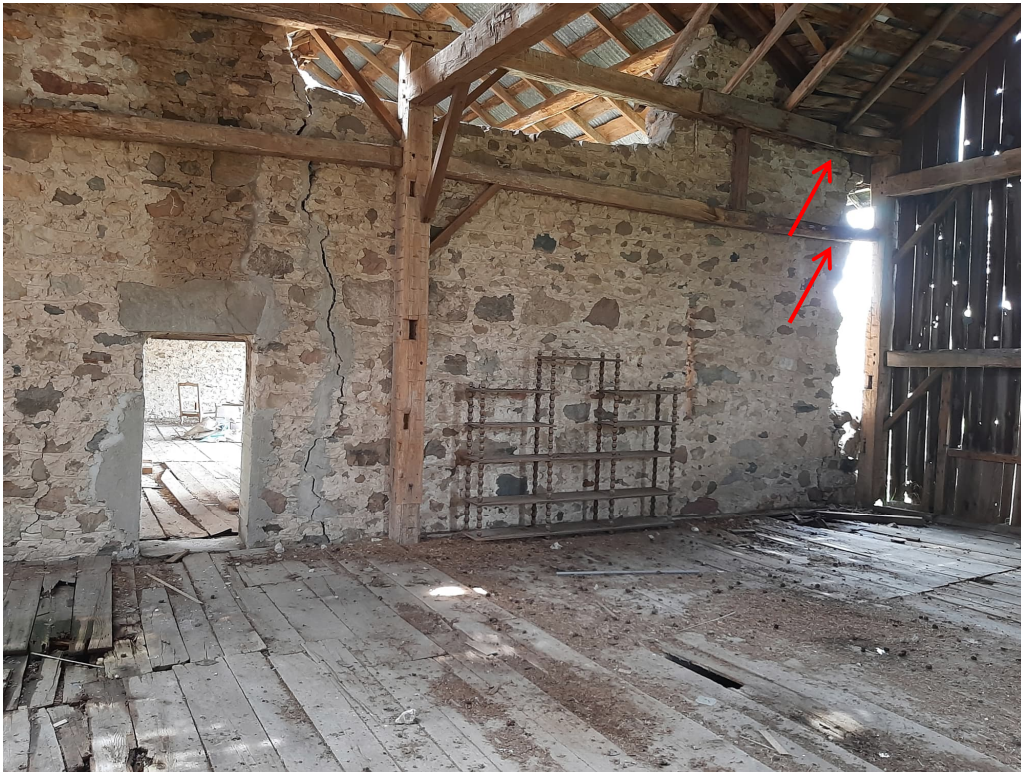
Photograph No. 7 – Stone Wall poorly braced at top – damaged timber (rot)

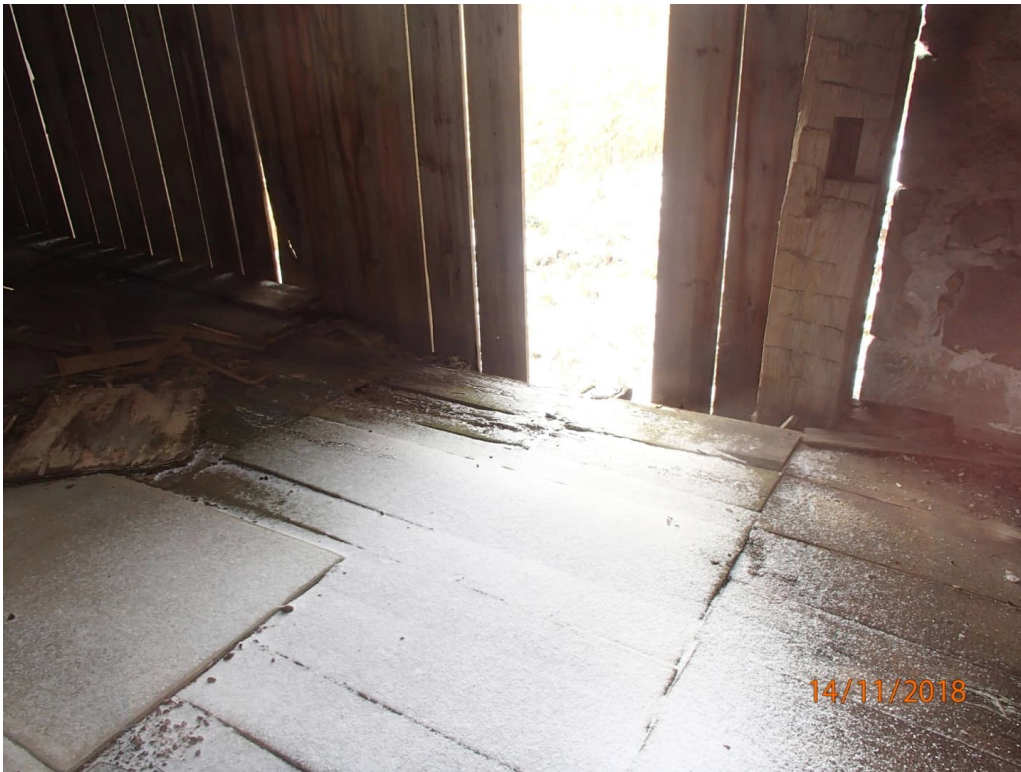
Photograph No. 8 – Taken 2018-11-14 - Condition worse today; floor and wall members compromised, unsafe

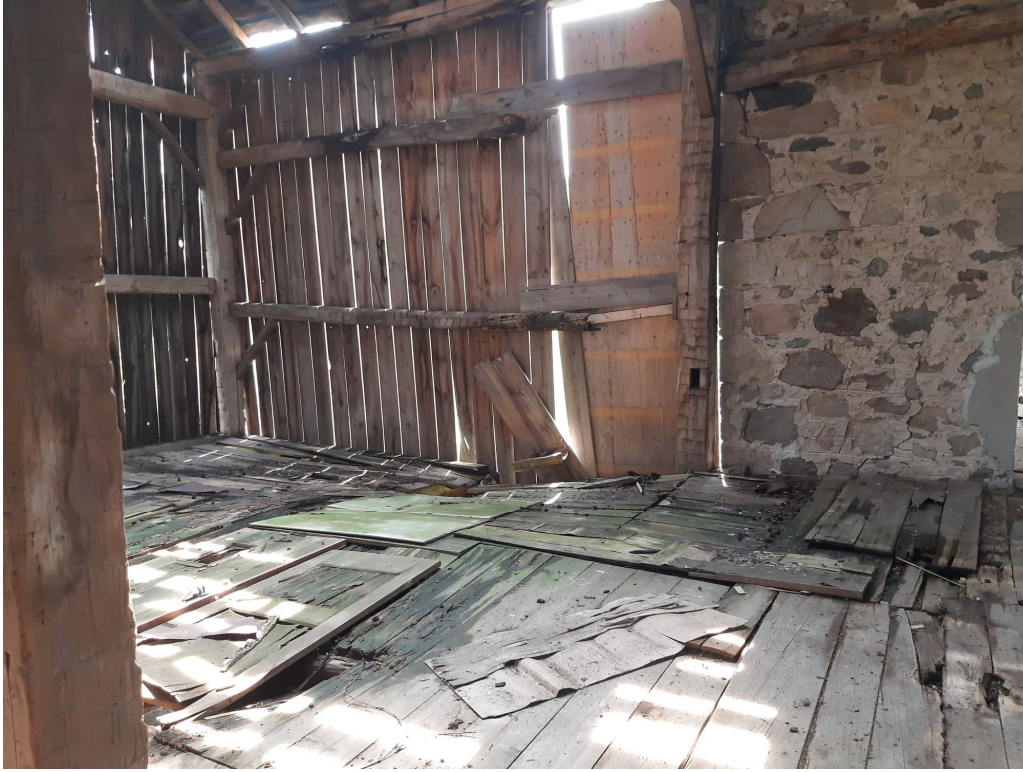
Photograph No. 9 – Southwest framing - floor and wall members compromised, unsafe

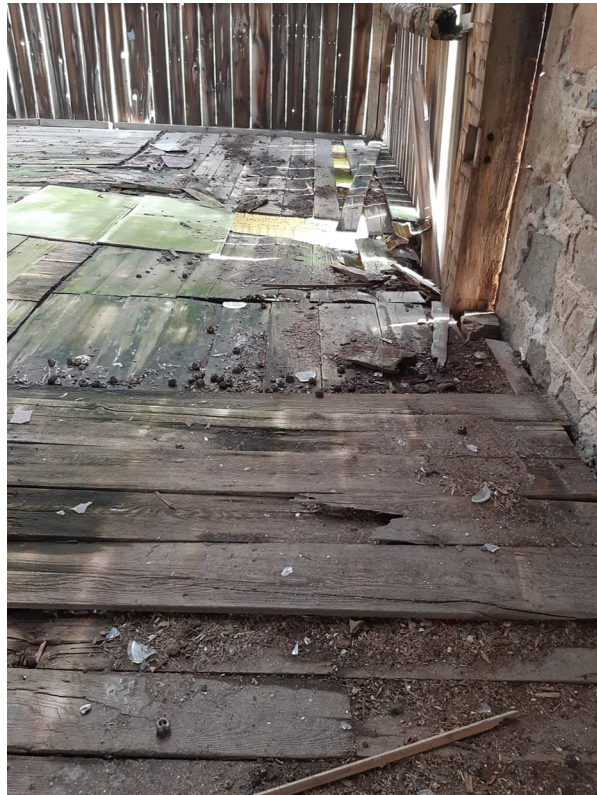
Photograph No. 10 – Floor and wall members compromised, unsafe

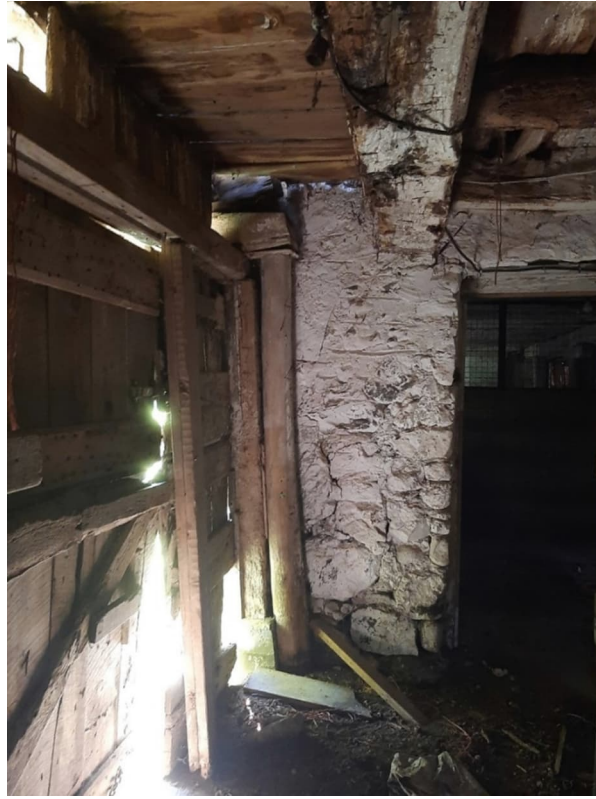
Photograph No. 11 – Structurally Compromised Floor Beam; Lower and Upper Posts vulnerable to collapse

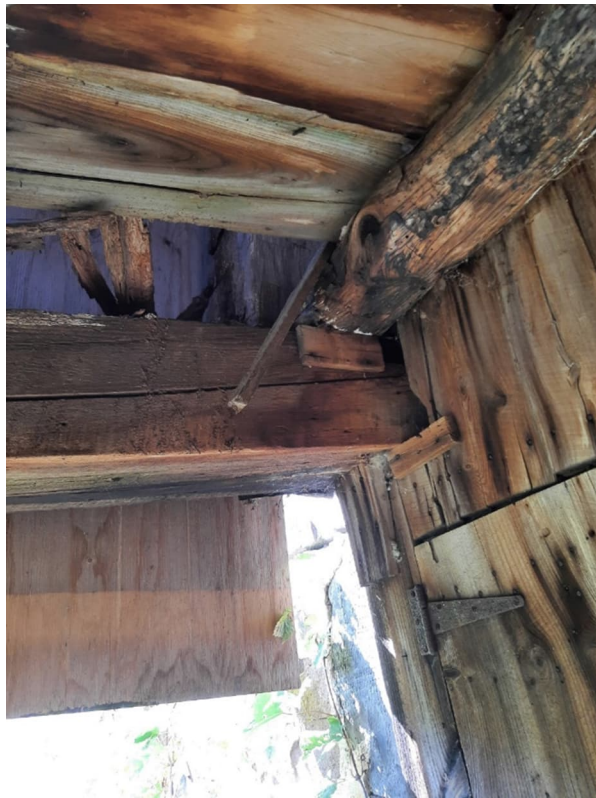
Photograph No. 12 – Floor beam cracked, sagging, unsafely supporting upper column

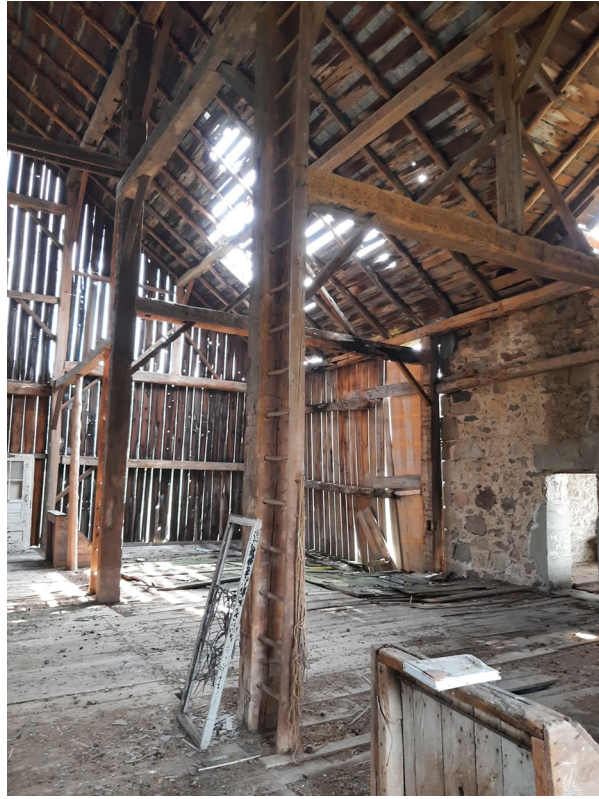
Photograph No. 13 – Unsafe to work on roof cladding

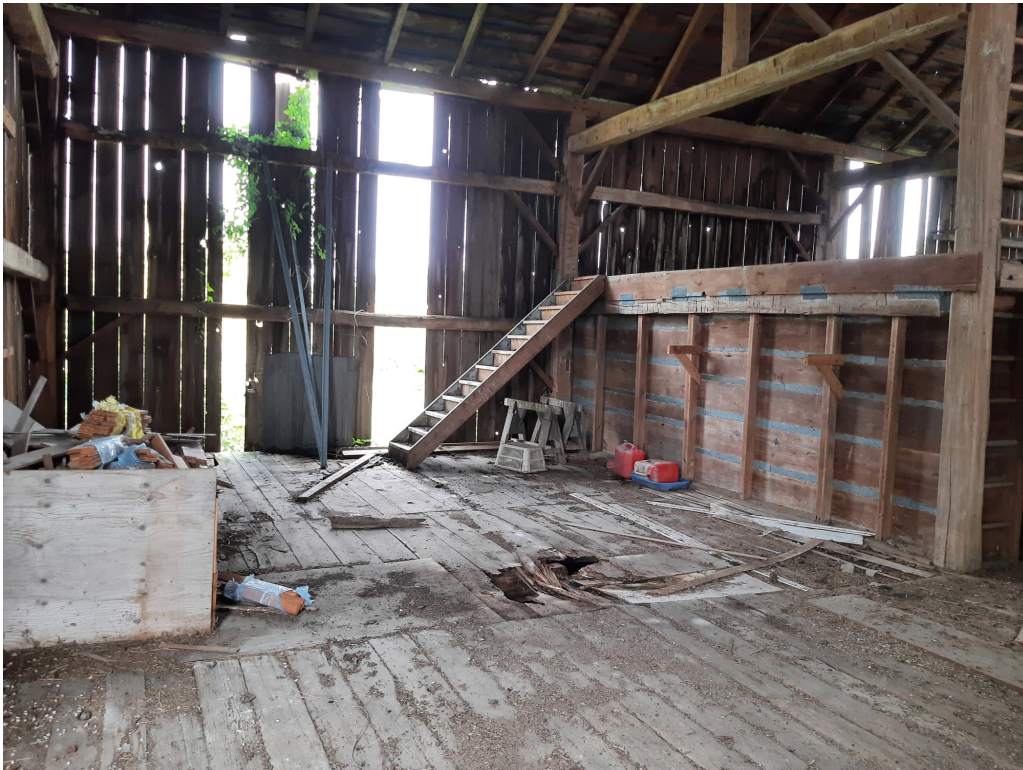
Photograph No. 14 – Floor, wall boards and framing unsafe

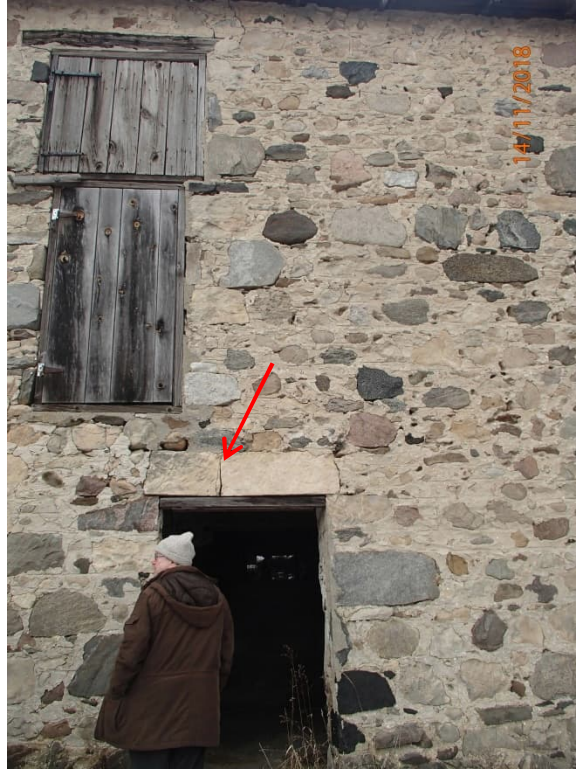
Photograph No. 15 – Cracked lintels (South wall)

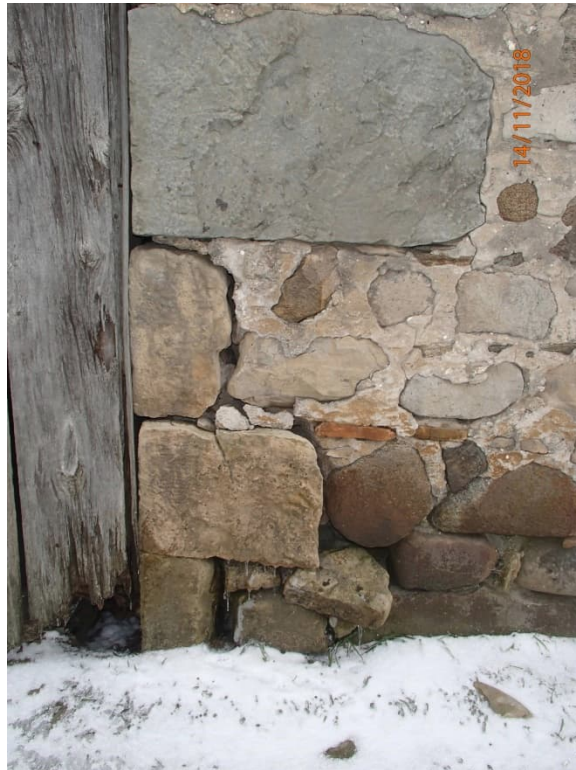
Photograph No. 16 – Stone wall mortar deterioration (North), rotted barn boards

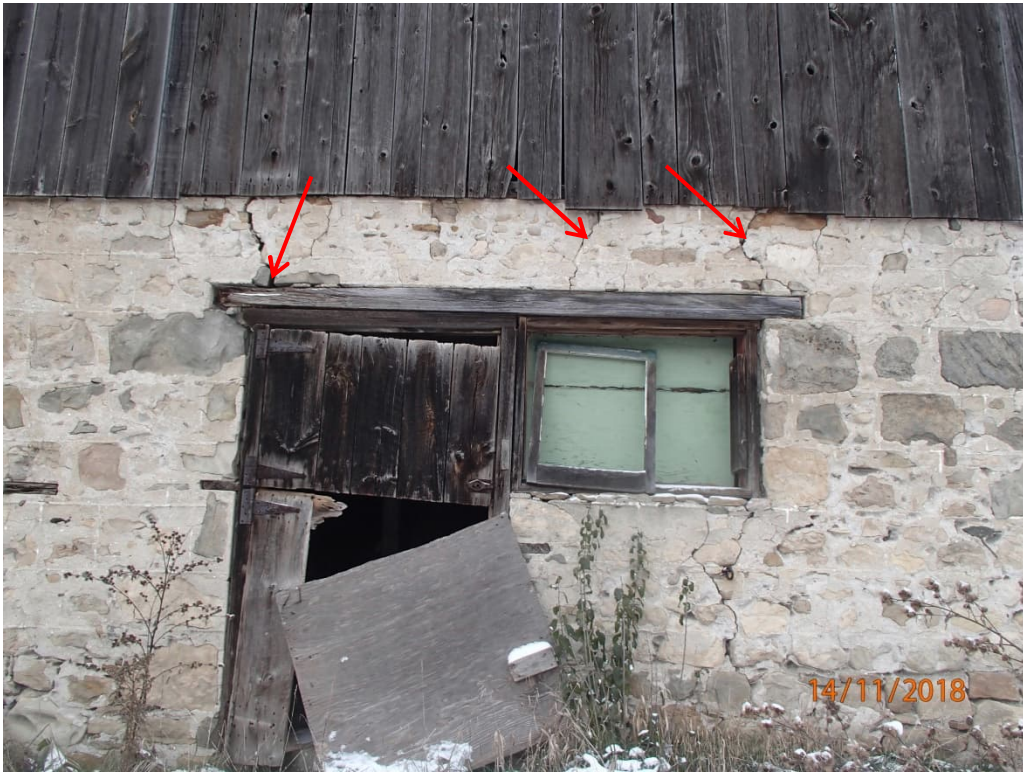
Photograph No. 17 – South wall, cracked stone over wood lintel

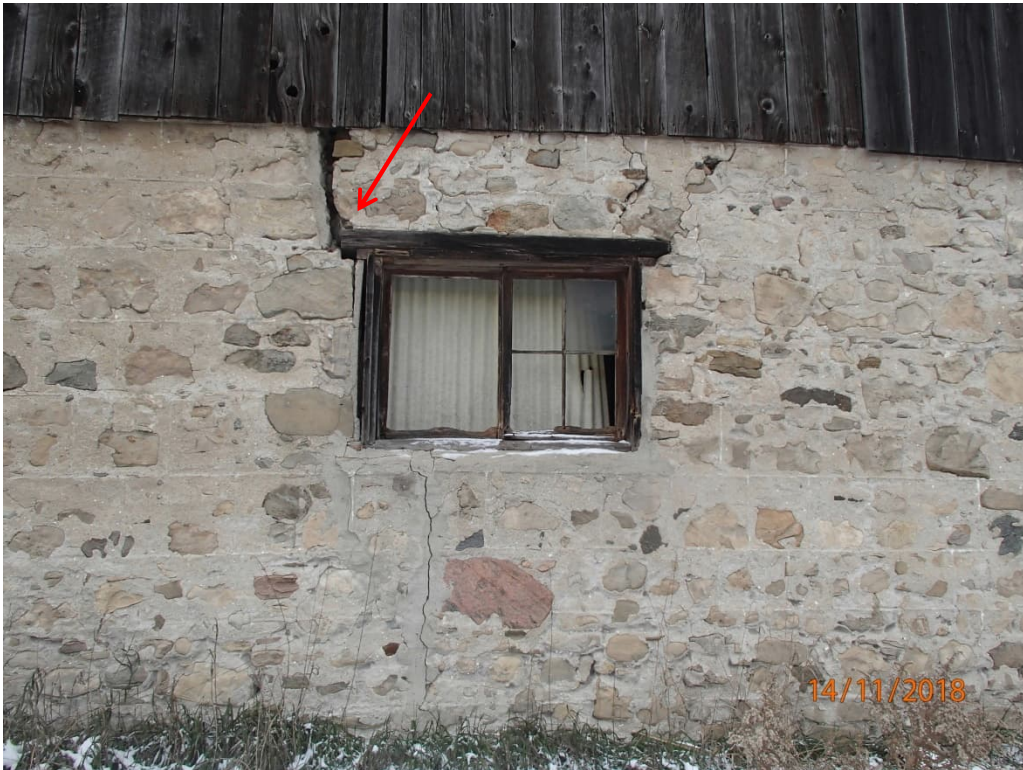
Photograph No. 18 – Crack at lintel, inadequate bearing (south wall)
