Cultural Heritage Conservation & **Relocation** Plan

331 Clair Road East,
Guelph ON

Date:
May 2024

Prepared by:
**MacNaughton Hermsen Britton
Clarkson Planning Limited
(MHBC)**

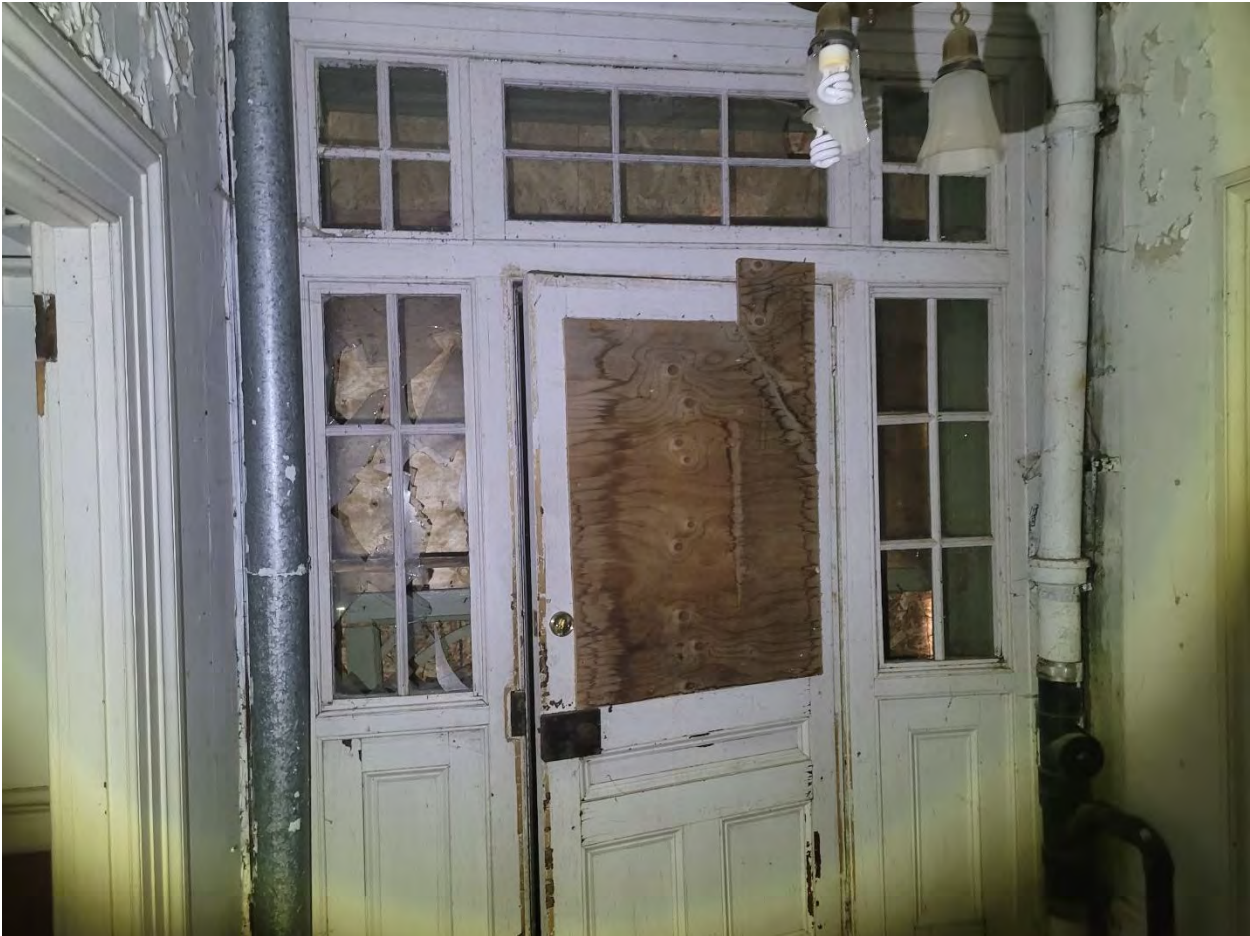
The central door opening includes a wood framed transom and sidelights. The site visit conducted in 2023 determined that the wood and glazing of the front entrance has been damaged due to vandalism and is in poor condition (See Figure 10).

Figure 10: View of the original wood framed door, sidelights and transom (Source: MHBC, 2023)

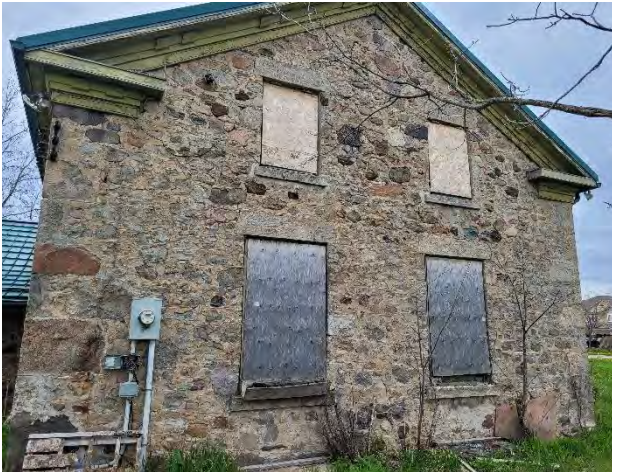
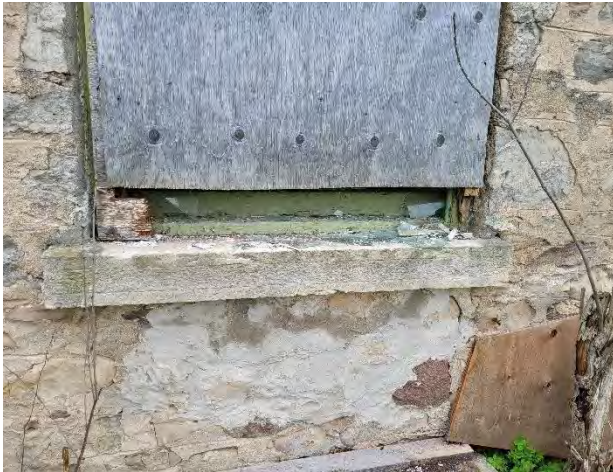
Figures 13 & 14: (left) View of north elevation, looking south (right) Detail view of broken window and sill at north elevation, (Source: MHBC, 2023)

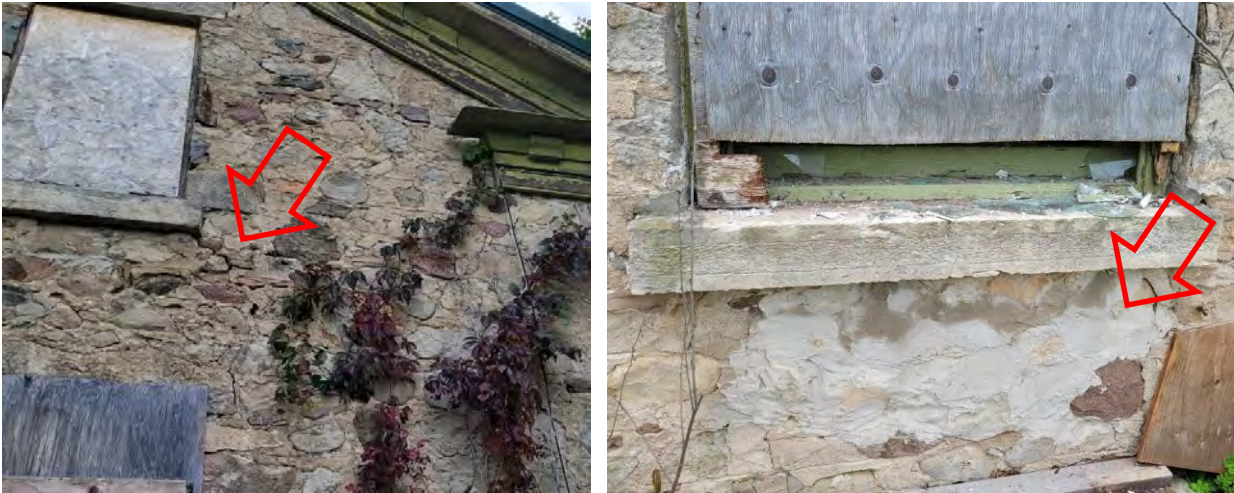
Localized masonry issues were observed, as per the findings of the Stantec structural report. What appear to be settlement cracks and condition issues related to poor repairs were also observed (See Figures 21 & 22).

Figures 21 & 22: (left) Detail view of south elevation and crack in masonry under window, (right) Detail view of broken window and sill at north elevation, (Source: MHBC, 2023)

- Repair any localized masonry issues as noted in the structural condition report or determined by a qualified mason with demonstrated experience in heritage buildings and materials;
 - Masonry repairs should refer to the Parks Canada Standards & Guidelines for masonry & use of lime rich mortar materials (see Appendix B).

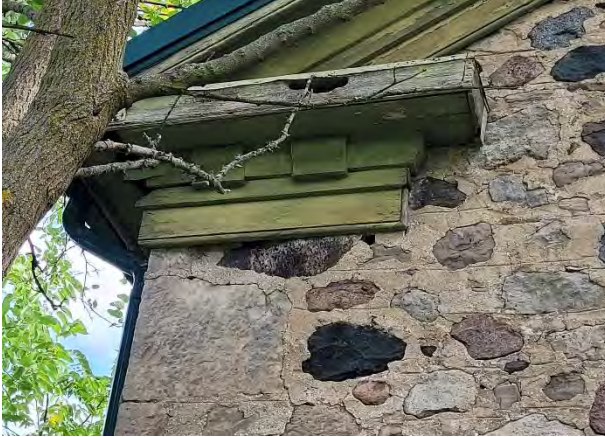
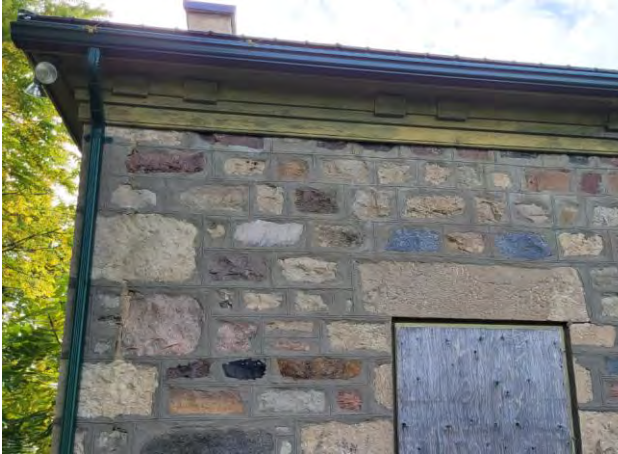
The building includes deep wood eaves/frieze with dentils at all elevations of the building under the roofline. These eaves are in poor condition and in some places are rotted.

Figures 23 & 24: (left) Detail view of section of wood return eaves where wood is rotted, (right) Detail of wood eaves at the front elevation below the roofline (Source: MHBC, 2023)

- Inspect the roof and roof timbers/elements to ensure that they will not be adversely affected prior to re-location;
- Inspect the existing wood eaves/frieze and make repairs to ensure that the condition of these elements will not be adversely impacted during re-location;

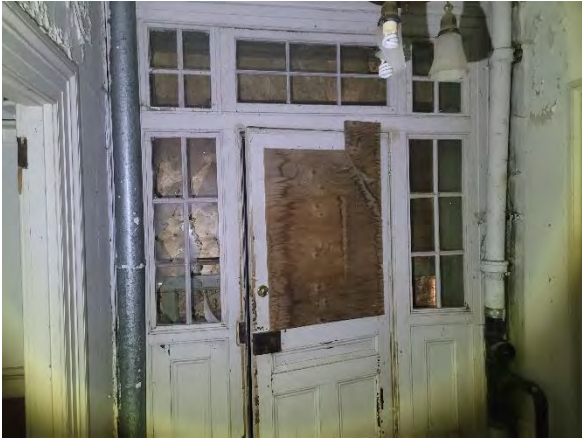
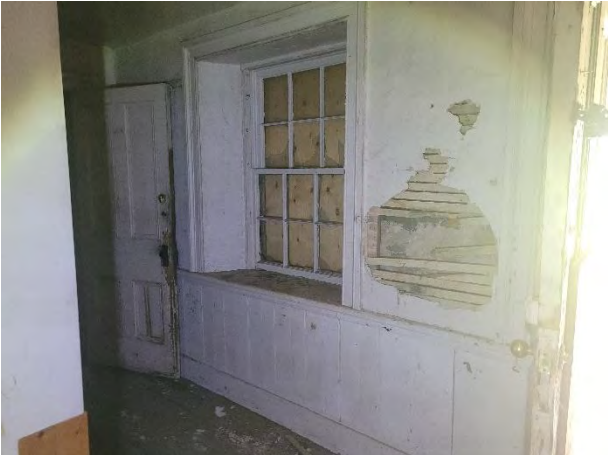
The building includes wood window frames and sashes. All panes of glass within the sashes have been broken and destroyed. The vast majority of windows at the interior of the building are broken and are in very poor condition (See Figures 25 – 26).

Figures 25 & 26: (left) View of interior of the building and central door opening at front elevation noting condition of wood frames and glazing, (right) View of typical first storey window noting broken glazing and condition of wood framing, (Source: MHBC, 2023)

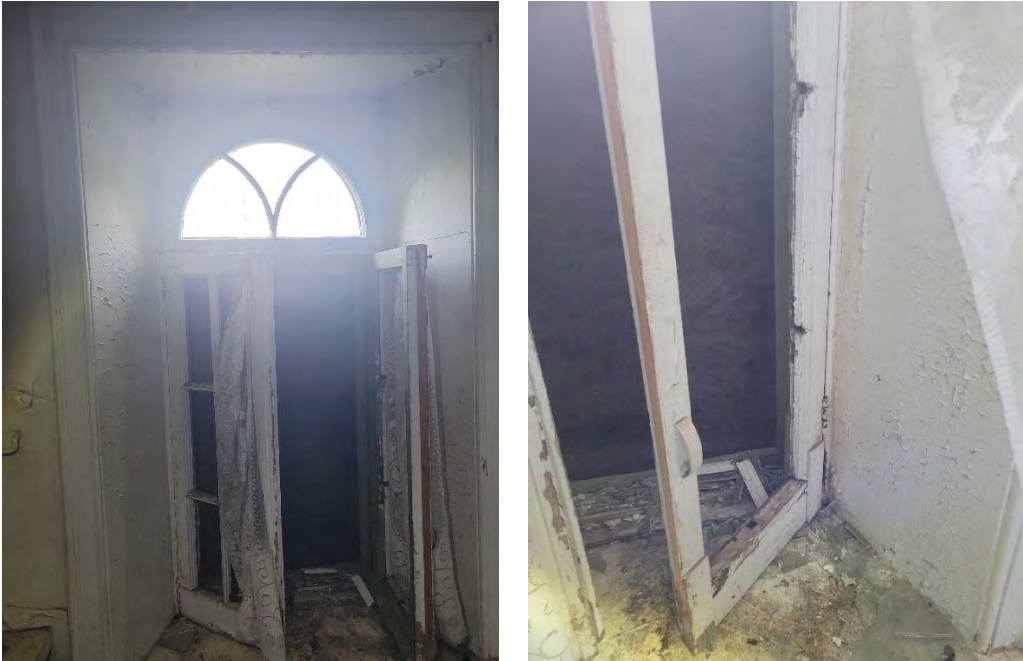
Figures 27 & 28: (left) Detail view of second storey central arched window noting broken glazing and wood frames (right) Detail of condition of wood window sash (Source: MHBC, 2023)

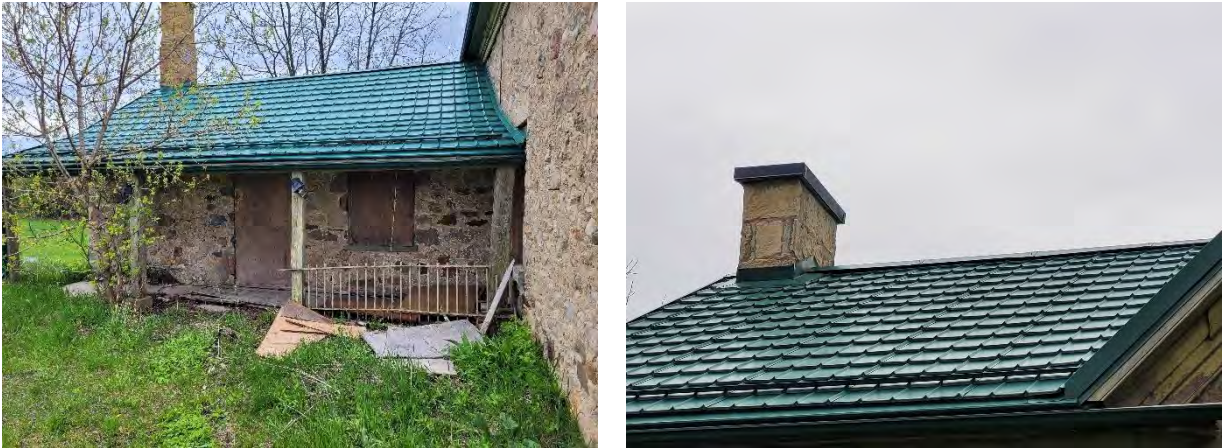
The structural assessment was not able to assess the roof. However, based on exterior and interior visual analysis, the roof includes a relatively new green coloured metal roof. Evidence of leaks were not visible at the interior of the building.

Figures 29 & 30: (left) View of roof, north elevation of Section "B" (right) Detail of condition of metal roof, Section "A" looking east from west elevation (Source: MHBC, 2023)

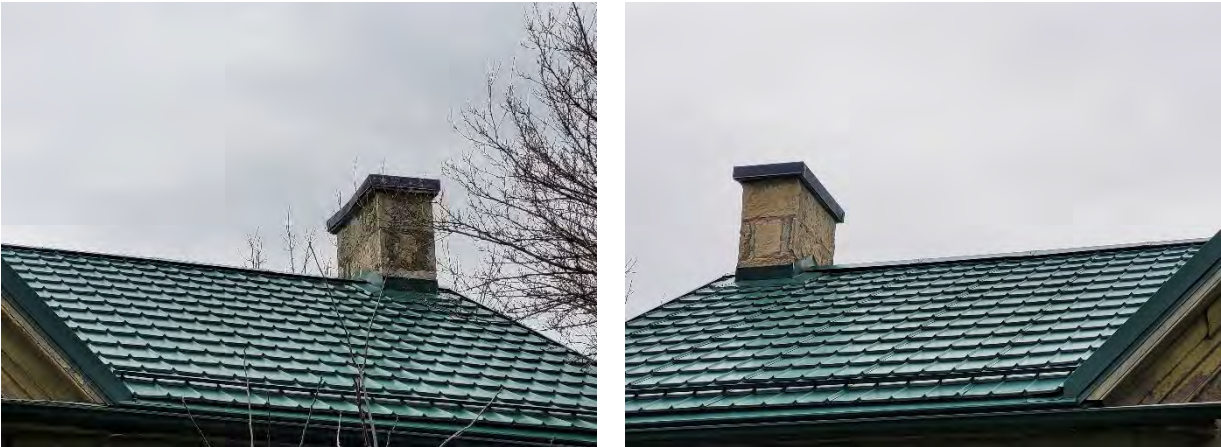
The building currently includes 4 chimneys. Two stone chimneys are located on either side of the roof of Section "A". A brick chimney is located near the east elevation of Section "B" and is in very poor condition. According to the structural report, there are no immediate concerns regarding the stone chimneys.

Figures 31 & 32: (left) View of roof noting chimney at south elevation (right) Detail of stone chimney located at south elevation (Source: MHBC, 2023)

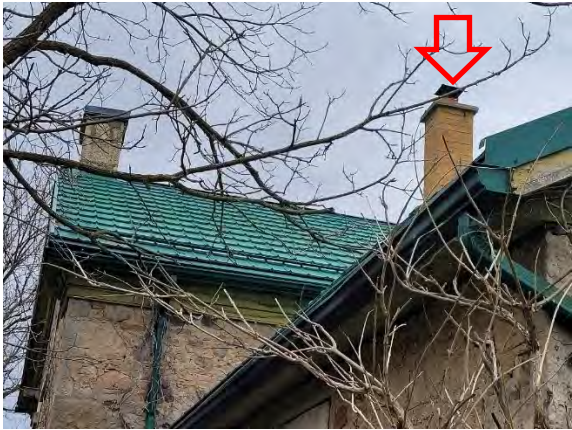
Section "A" includes a yellow brick chimney at the east elevation (See Figure 33). According to the structural report, the chimney shows mortar loss and is in poor condition. The structural report recommends the chimney be dismantled. Given that this chimney is not original and does not add value to the house, it is recommended that it is not reconstructed.

Figure 33: **Detail of east elevation noting location of yellow brick chimney, Section "A"** (Source: MHBC, 2023)

- Enclose any exposed window and door openings;
- **Remove yellow brick chimney at the east (rear) elevation of Section "A". Note that this chimney is not original to the structure and is not recommended to be re-constructed given that it is not of CHVI;**

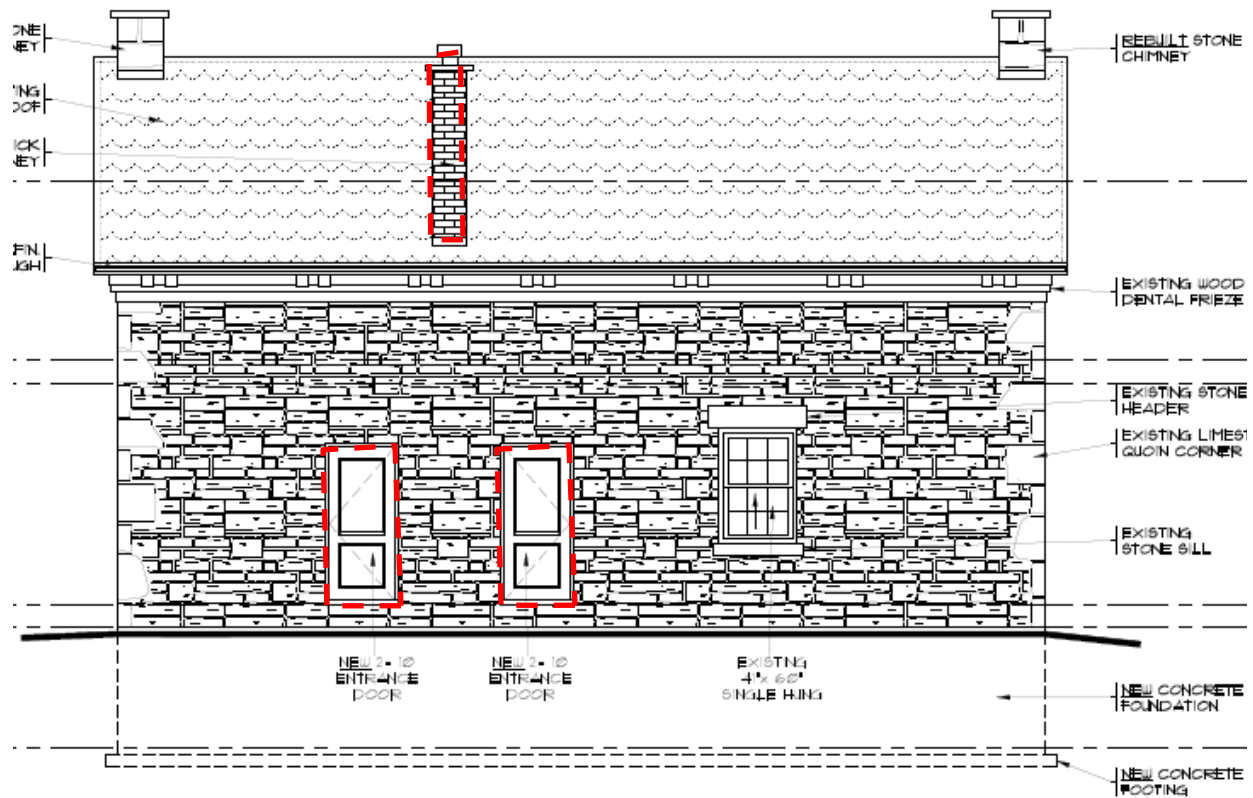
Figure 34: Detail of rear elevation noting two person doors and chimney which should be removed (Source: Reid’s Heritage Homes, 2023)

The chimneys proposed for removal are located at the west elevation of Section "A", and the north elevation of Section "B" (See Figure 34).

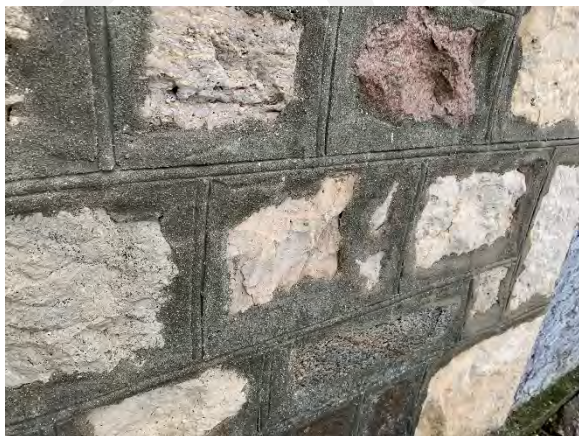
Photo 10: Typical Ashlar with Spalled Face and Tuck-pointing

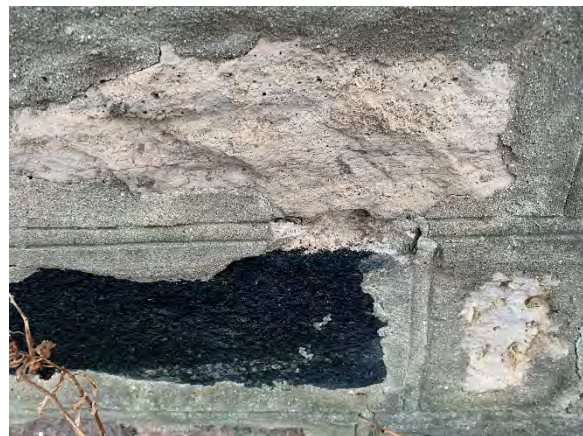
Photo 11: Typical Ashlar with Spalled Face and Tuck-pointing

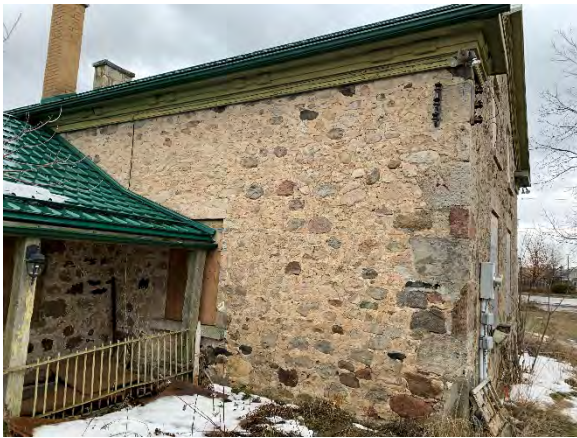
Photo 12: Typical Condition of Rubble Wall

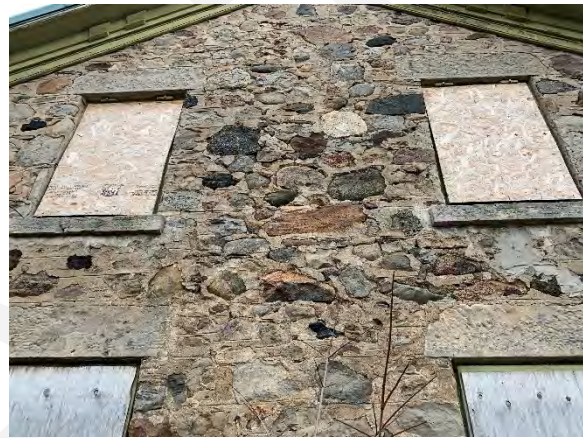
Photo 13: Washed-out mortar and loose stones in Rubble Wall

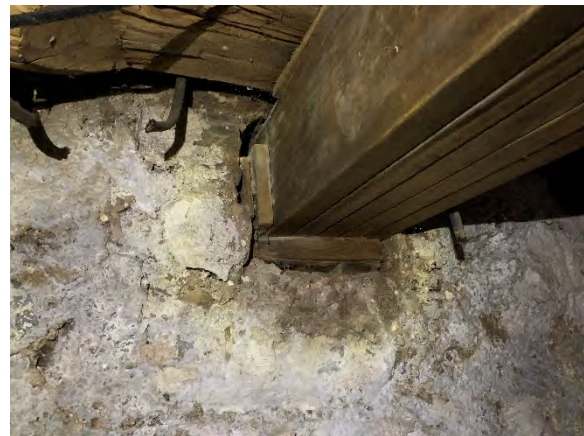
Photo 15: Typical Voids at Joist Ends
