August 31, 2021

Project No. 2114

**RE: 2054 Gordon Street, Guelph – Springfield Golf Course
Technical Review of H6**

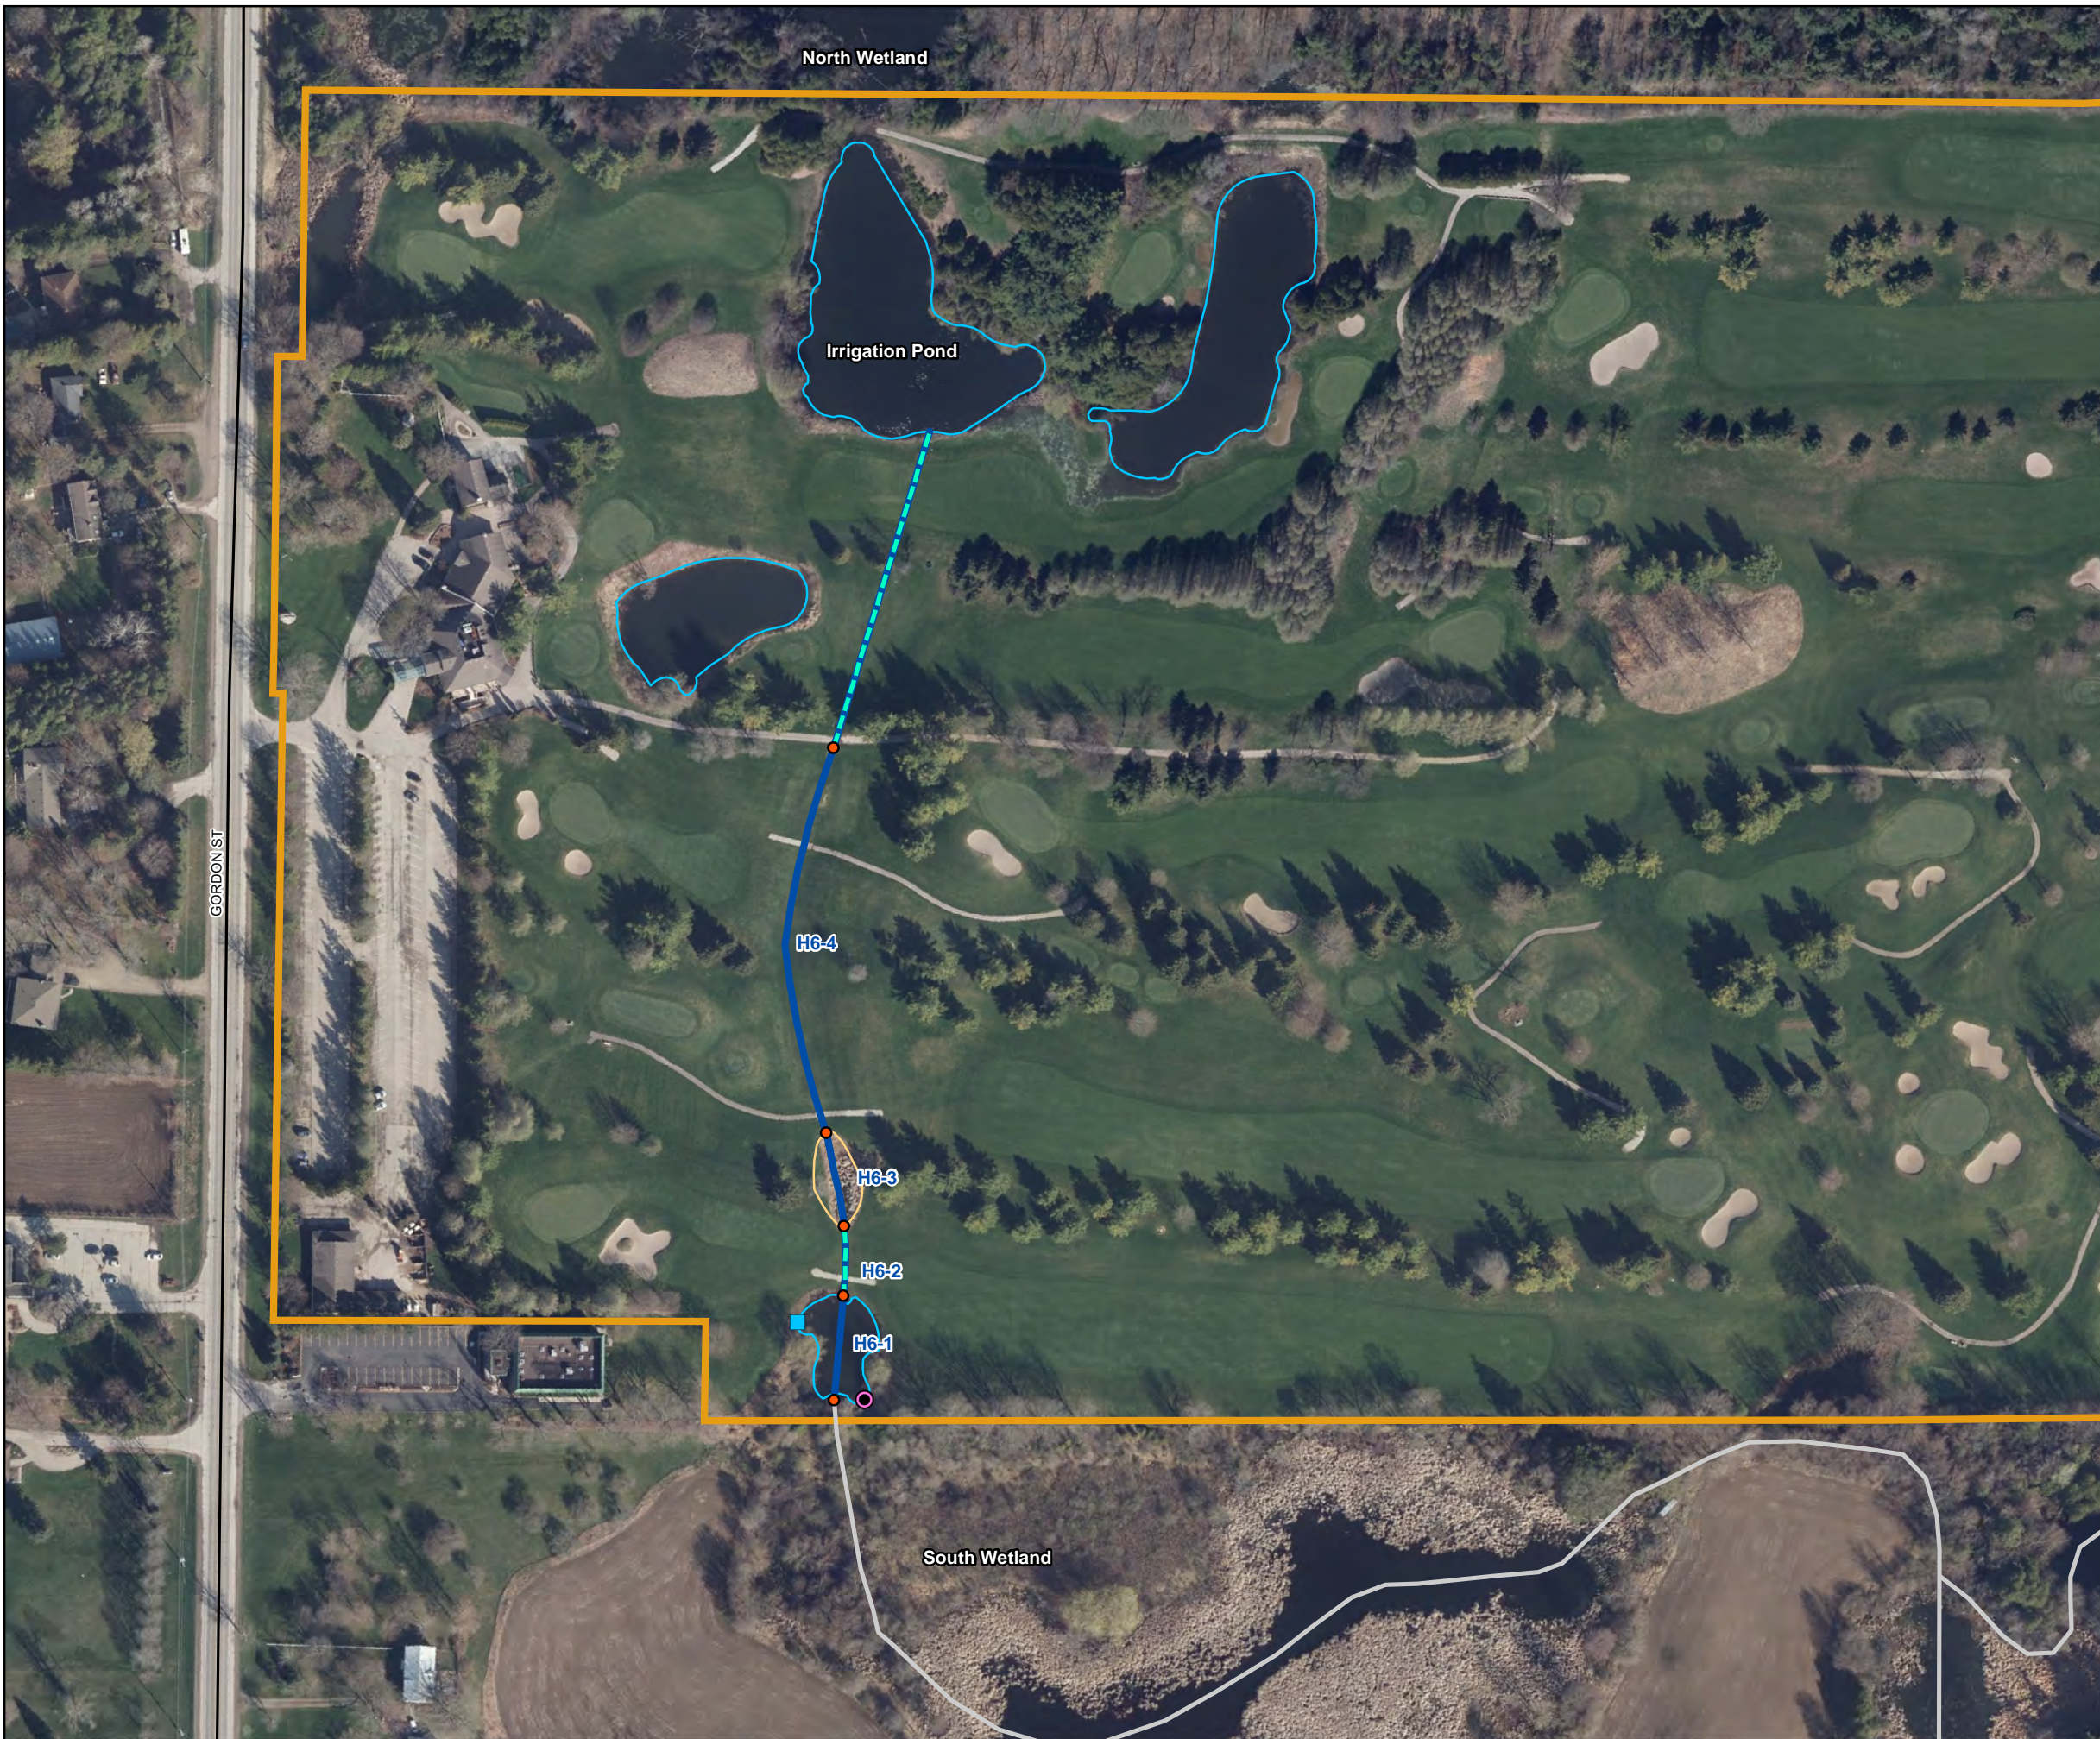
Springfield Golf Course Technical Review of H6

There are 4 segments of H6, labeled 'H6-1' through 'H6-4' as shown on Map 1. Representative photographs of each segment are provided in Appendix I. The following paragraphs describe H6 from north (H6-4) to south (H6-1) and additional site conditions as observed during site visits.

Based on the site conditions observed in 2019 and 2021, and a review of the CEIS and associated mapping (Beacon 2021), NRSI requests that H6 be removed from future iterations of Map NH-4A of the CEIS and Schedule E of the Clair-Maltby Secondary Plan, as well as other mapping related to the Clair-Maltby Secondary Plan and Subwatershed Study. H6 is not an HDF as defined by the Headwater Guideline and OSAP headwater modules. It does, however, provide flows to the wetland south of the subject property for a brief period in the early spring, as it was designed to do. The restrictive 'Protection' management recommendation that has been put forth in the CEIS should not be applied to H6 because it is not an HDF, and has been significantly modified by golf course activities that have altered its form and function.

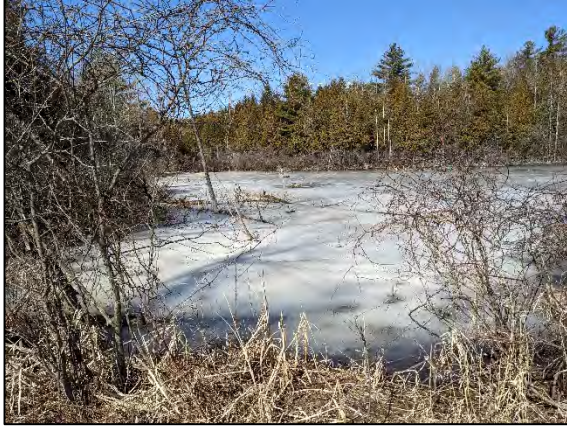
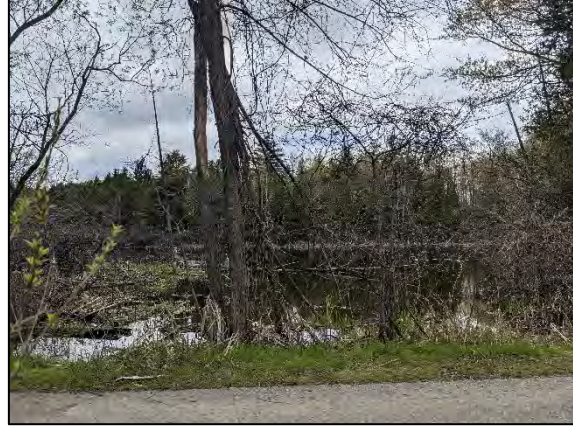
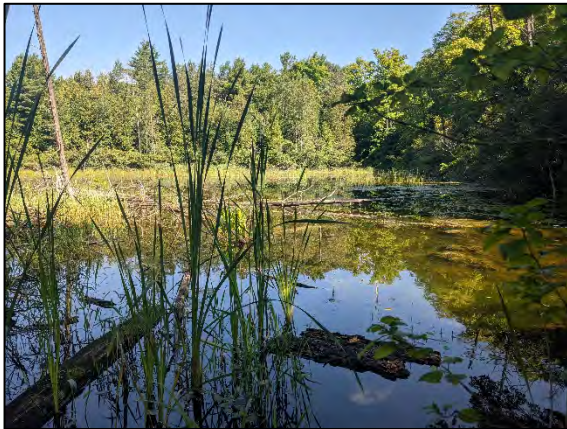
Photo 1
North Wetland: facing northwest.
Visit 1 (March 19, 2021)

Photo 2
North Wetland: facing northwest.
Visit 2 (May 7, 2021)

Photo 3
North Wetland: facing northwest.
Visit 3 (August 4, 2021)

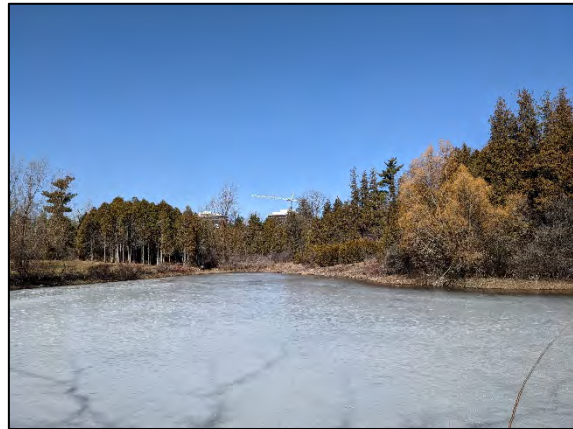
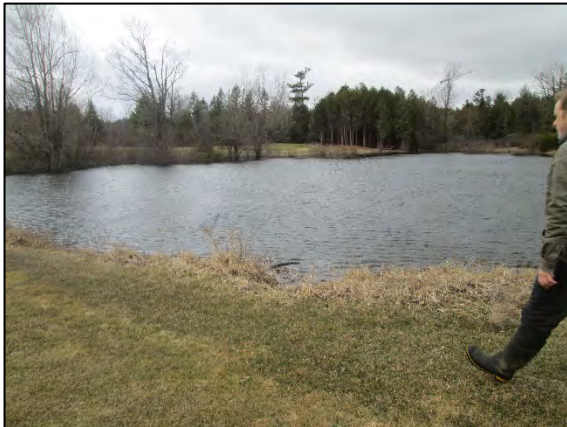
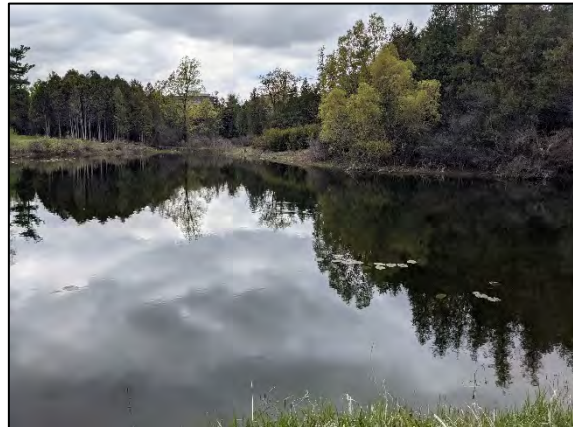
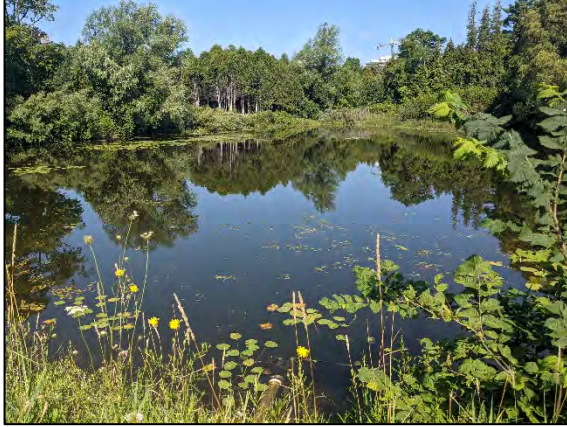
The CEIS identifies the irrigation pond as a continuation of the off-site Open Aquatic feature. However, the pond is not included in the Halls Pond PSW complex, as per Grand River Conservation Authority (GRCA) wetland mapping (shown on Map NH-5A of the CEIS) or Natural Heritage Information Centre (NHIC) mapping (MNR 2021). It is also not mapped as part of H6 (Beacon 2021). The pond measures approximately 80m in length and 45m in width, and is generally encircled by a narrow (5m) band of naturalized riparian vegetation and manicured lawn. Water levels in the pond are controlled by a shut-off valve. When water levels are high and the valve is open, flows are conveyed southwards through a buried tile drain. A pumping system is also installed in the western corner of the pond that presumably provides water to the golf course irrigation system as needed. Photographs of the irrigation pond and buried tile drain area are provided in Appendix I.

Photo 4
Irrigation Pond: facing northwest.
Visit 1 (March 19, 2021)

Photo 5
Irrigation Pond: facing northwest.
Preliminary Visit (April 9, 2019)

Photo 6
Irrigation Pond: facing northwest.
Visit 2 (May 7, 2021)

Photo 7
Irrigation Pond: facing northwest.
Visit 3 (August 4, 2021)

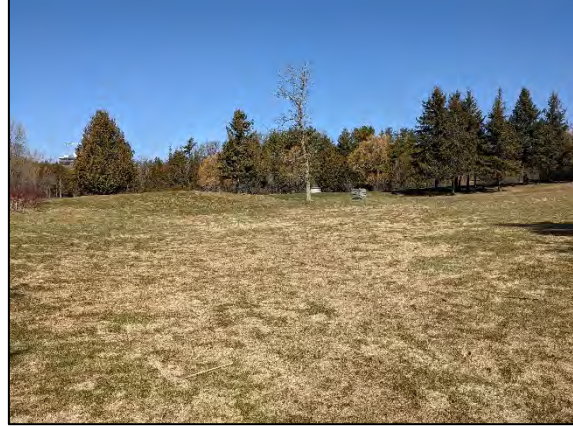
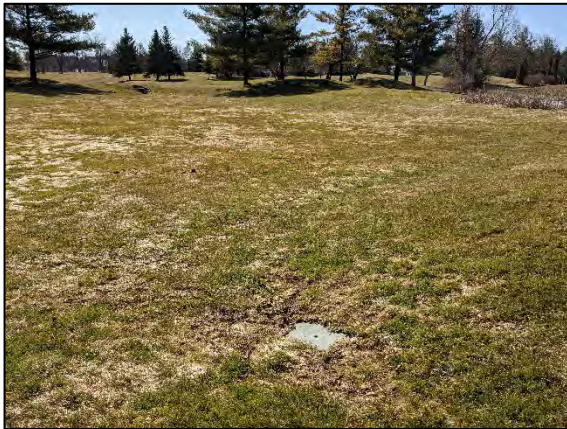
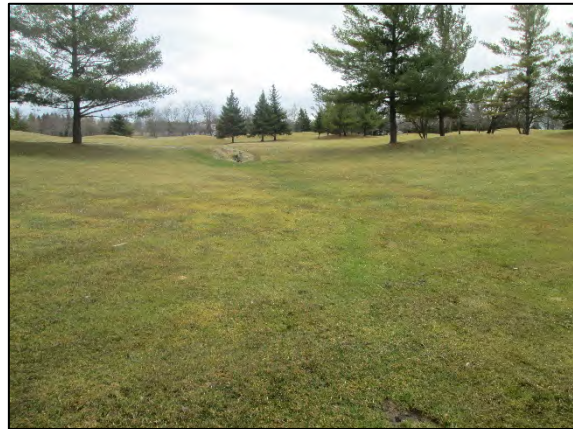
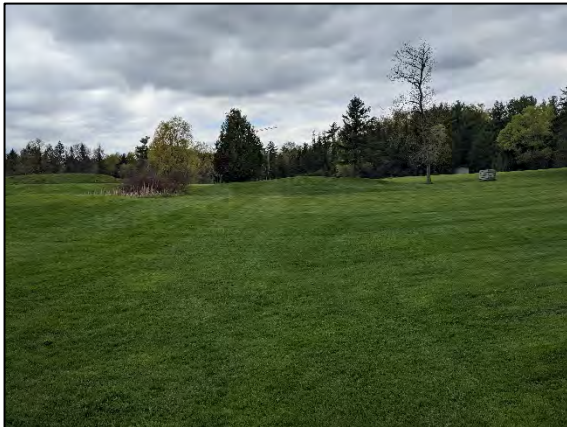
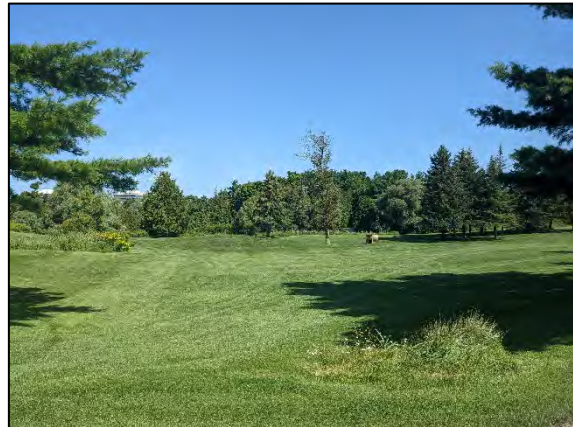
The buried tile drain extends from the irrigation pond for 95m before its outlet to a 0.3m corrugated steel pipe (csp) culvert under a paved golf cart pathway (Map 1). A small, white irrigation system pipe also passes through this culvert (Appendix I). The entire area with the buried tile drain is comprised of manicured lawn. No water was observed discharging from the tile drain outlet during any of the 3 site visits in 2021; it is unclear if this was a result of the shut-off valve being closed, or insufficient water levels in the irrigation pond. During the preliminary visit in 2019, minimal flow (<0.5L/s) was observed exiting the tile drain, and the pond shut-off valve was confirmed to be open on this date.

Photo 8
Buried Tile Drain Area: facing northwest.
Visit 1 (March 19, 2021)

Photo 9
Buried Tile Drain Area: facing southeast.
Visit 1 (March 19, 2021)

Photo 10
Buried Tile Drain Area: facing southeast.
Preliminary Visit (April 9, 2019)

Photo 11
Buried Tile Drain Area: facing northwest.
Visit 2 (May 7, 2021)

Photo 12
Buried Tile Drain Area: facing northwest.
Visit 3 (August 4, 2021)

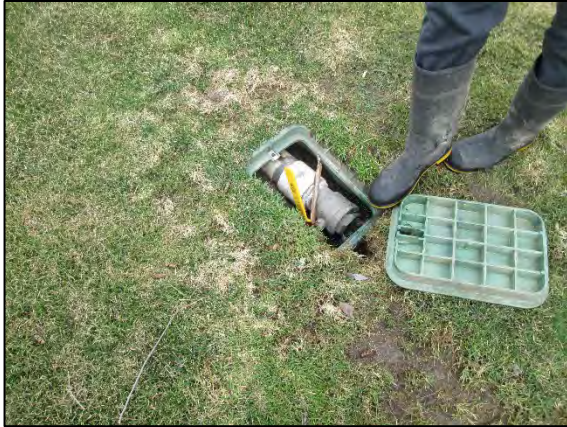
Photo 13

Buried Tile Drain Area: irrigation pond shut-off valve.
Preliminary Site Visit (April 9, 2019)

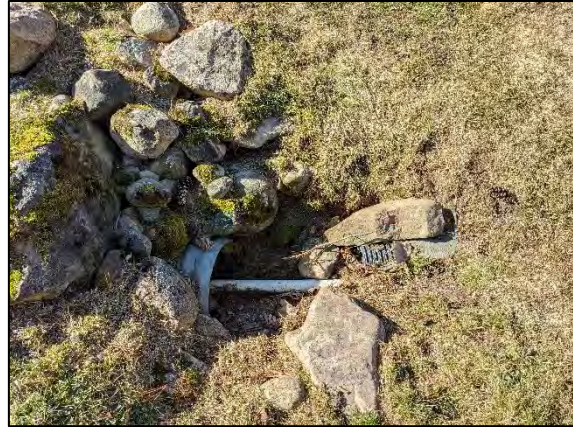
Photo 14

Buried Tile Drain Area: outlet location at culvert under
paved golf cart path.
Visit 1 (March 19, 2021)

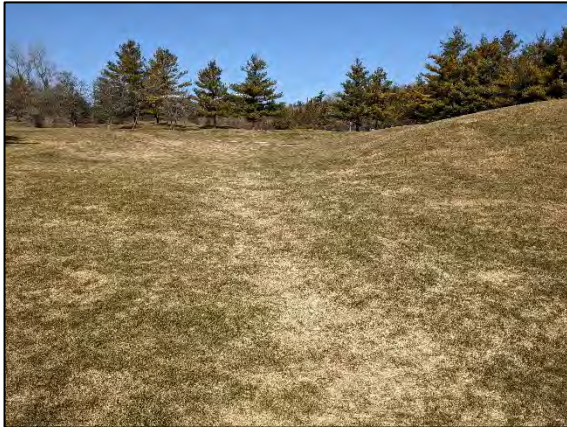
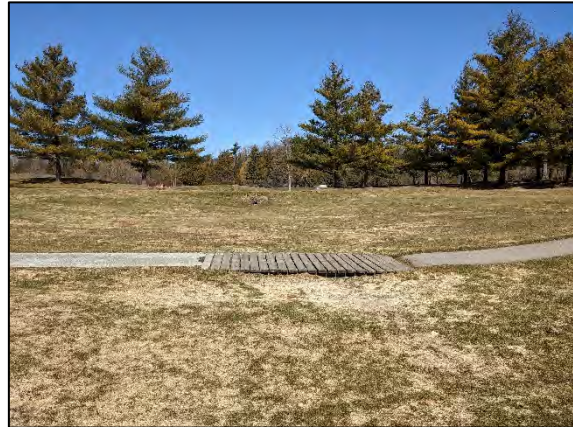
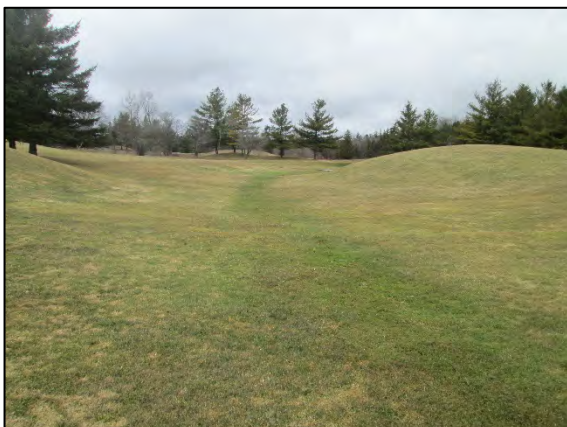
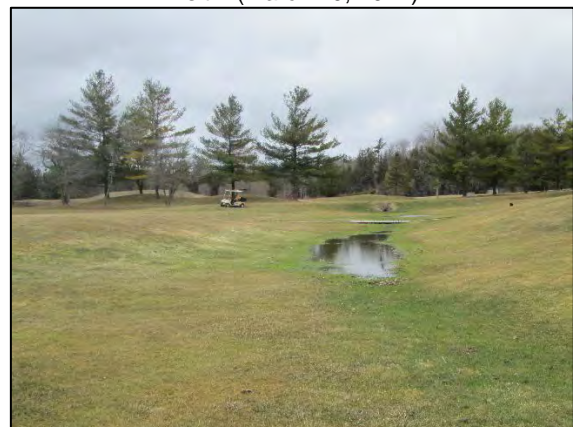
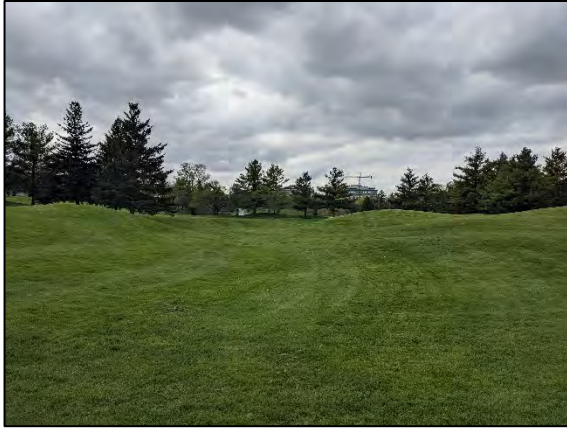
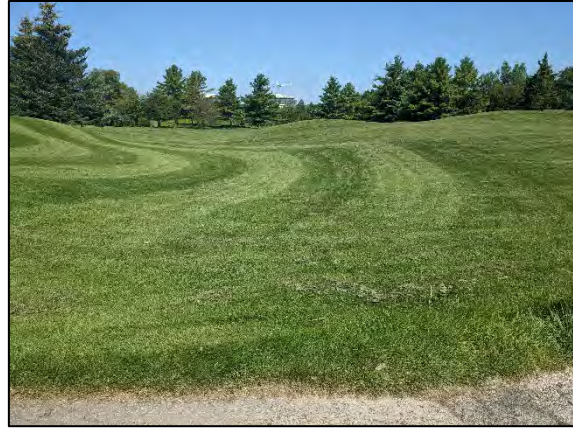
Segment **H6-4** is 120m long and extends from the 0.3m csp at the southern end of the buried tile drain area to a small wetland (H6-3) (Map 1). It passes under a small wooden golf cart span bridge as well as through a 0.15cm PVC pipe below a second paved golf cart path just north of H6-3. Segment H6-4 is categorized as a *no defined feature* using the OSAP Feature Type codes (Feature Type 4). During the preliminary visit in 2019, golf course maintenance staff indicated that no tile drain is present in this area. The segment was dry during all 3 visits in 2021. During the preliminary site visit on April 9, 2019, the minimal flow observed exiting the buried tile drain pooled in the upstream area of H6-4, creating an area of standing water and saturated soils. However, standing water conditions continued for approximately 80m only, and the remainder of the segment was dry. Vegetation within and adjacent to segment H6-4 is manicured lawn.

Segment	Hydrology	Modifiers	Riparian Condition	Terrestrial Habitat	Fish Habitat
<p>H6-4</p> <p><i>Photos 15-20 (Appendix I)</i></p>	<p>Limited Function</p> <p>This segment, classified as ‘no defined feature’, was dry during all 3 visits in 2021. Flow condition during the preliminary visit in 2019 included observations of minimal flow exiting the buried tile drain area to the north and ponding in the northern portion of H6-4 where it presumably infiltrated rather than being conveyed to southern sections of H6.</p>	<p><i>Historic and ongoing golf course activities (e.g., mowing) have modified this segment and continue to do so.</i></p>	<p>Contributing Function</p> <p>Riparian vegetation is comprised entirely of mowed lawn, which results in a ‘Contributing Function’ classification.</p>	<p>Limited Function</p> <p>The mowed lawn in segment H6-4 does not provide opportunities for wildlife movement between natural features, nor are conditions suitable for breeding amphibians.</p>	<p>Contributing Function</p> <p>Overall, H6 transports some allochthonous materials (detritus, insects etc.) to the wetland south of the subject property. The presence of fish in the south wetland is currently unknown; any populations present represent isolated populations since the Halls Pond Wetland Complex is not connected to any watercourses.</p>

H6-4: View of segment, facing northwest.
Visit 1 (March 19, 2021)

H6-4: View of northern-most portion of segment, facing
northwest.
Visit 1 (March 19, 2021)

H6-4: View of segment, facing northwest.
Preliminary Visit (April 9, 2019)

H6-4: View of standing water in northern-most portion
of segment, facing northwest.
Preliminary Visit (April 9, 2019)

H6-4: View of segment, facing northwest.
Visit 2 (May 7, 2021)

H6-4: View of segment, facing northwest.
Visit 3 (August 4, 2021)

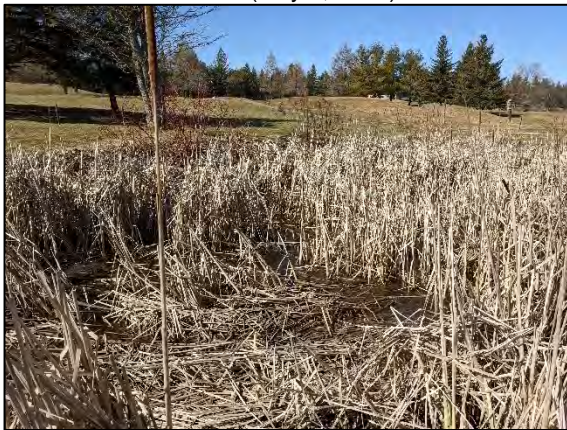
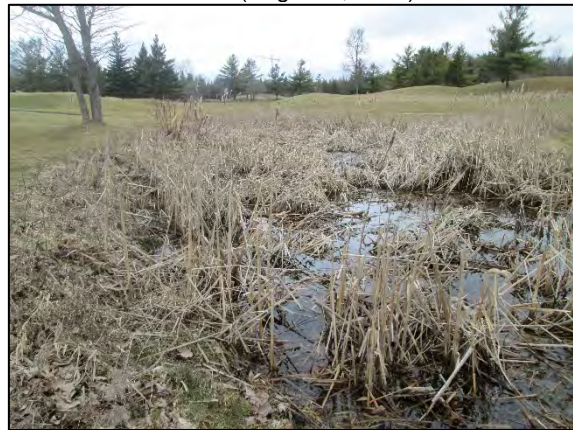
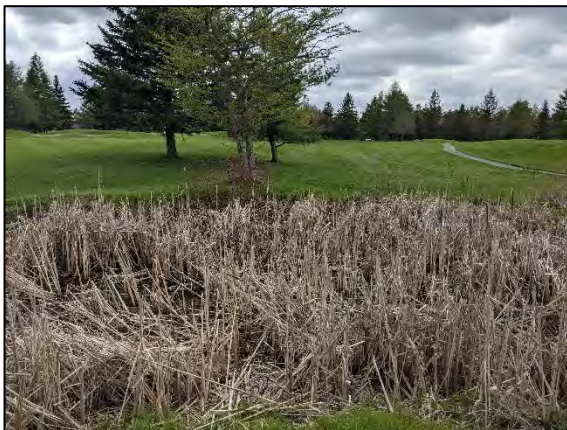
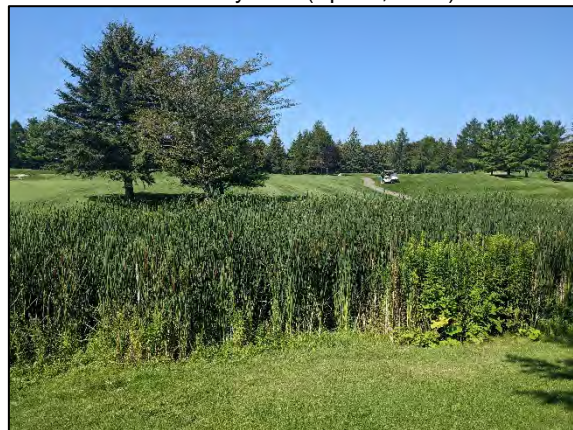
Segment **H6-3** is a small, 0.02ha marsh feature comprised almost entirely of cattails (*Typha* sp.) (OSAP Feature Type 6). Standing water was present during visits 1 and 2. By visit 3, the segment was dry (although damp soils were observed). Riparian vegetation consists of manicured lawn. During site visits in 2021, wildlife observed using this small patch of cattails was limited to a few Red-winged Blackbirds (*Agelaius phoeniceus*) during visit 2 (May 7, 2021) and an adult Gray Treefrog (*Hyla versicolor*) during visit 3 (August 4, 2021). Segment H6-3 is currently mapped as a wetland by the GRCA; however, new information collected as part of the CEIS has resulted in the recommendation that the small marsh be excluded from GRCA wetland mapping as shown on Map NH-5A (Beacon 2021).

<p>H6-3</p> <p><i>Photos 21-24 (Appendix I)</i></p>	<p>Valued Function</p> <p>This segment, classified as a wetland, contained standing water during visits 1 and 2, but was dry (with saturated soils) by visit 3. These flow conditions combined with the wetland feature type result in a ‘Valued Function’ classification.</p>	<p>N/A</p>	<p>Important Function</p> <p>Feature type is ‘wetland’, which results in the ‘Important Function’ classification.</p>	<p>Valued Function</p> <p>No evidence of breeding amphibians was observed, however targeted anuran call surveys are needed to confirm the absence of this ecological function since a suitable hydroperiod is present. The small wetland may provide stepping-stone habitat for amphibians and other low-mobility</p>	<p>Contributing Function</p> <p>Overall, H6 transports some allochthonous materials (detritus, insects etc.) to the wetland south of the subject property. The presence of fish in the south wetland is currently unknown; any populations present represent isolated populations since the Halls Pond Wetland Complex is</p>

H6-3: View of segment, facing west.
Visit 1 (March 19, 2021)

H6-3: View of northern portion of segment, facing northwest.
Preliminary Visit (April 9, 2019)

H6-3: View of segment, facing west.
Visit 2 (May 7, 2021)

H6-3: View of segment, facing west.
Visit 3 (August 4, 2021)

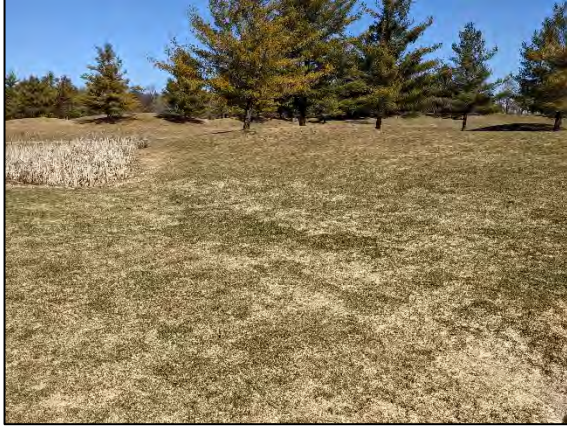
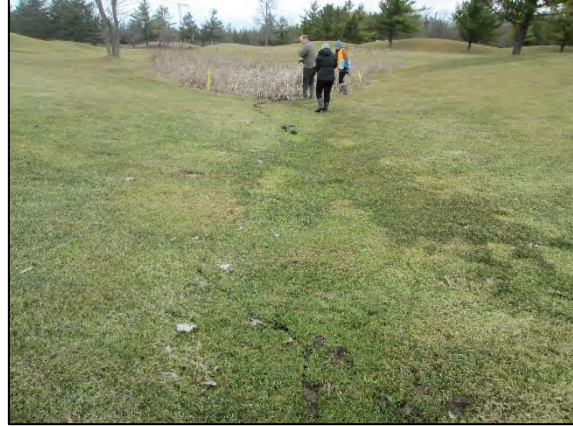
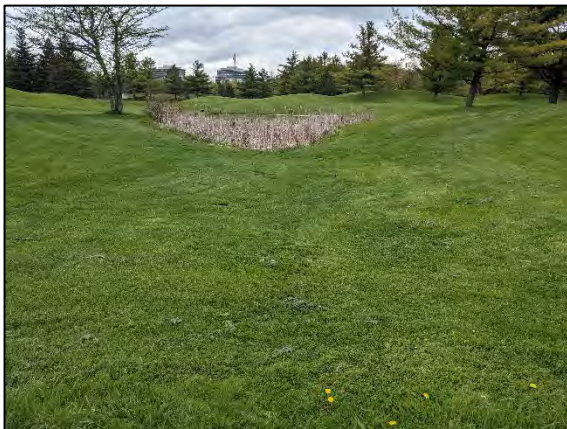
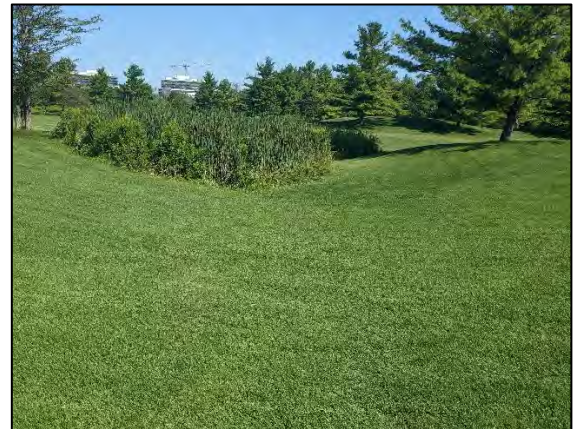
Water from segment H6-3 discharges to a buried tile drain that characterizes segment **H6-2** (Map 1). The tile drain extends for approximately 27m from the marsh feature to a small wooden golf cart span bridge. The tile drain discharges underneath a wooden golf cart span bridge (Appendix I) before entering the pond to the south (segment H6-1). No flow was observed exiting the tile drain during any of the site visits in 2021. During the preliminary visit on April 9, 2019, minimal flow was observed draining to segment H6-1.

Segment	Hydrology	Modifiers	Riparian Condition	Terrestrial Habitat	Fish Habitat
				wildlife based on its location within 400m of the wetland south of the subject property and its proximity to the man-made pond in H6-1.	not connected to any watercourses.
H6-2 <i>Photos 25-30 (Appendix I)</i>	Contributing Function This segment, classified as a tile drain, was dry during all 3 visits in 2021. Flow condition during the preliminary visit in 2019 included observations of minimal flow discharging from the tile drain to the man-made pond in H6-1. In recognition of the drainage connection between the small marsh to the north and the pond to the south, segment H6-2 is assigned a 'Contributing' hydrological function.	<i>The installation of the tile drain comprising this segment has modified its historical form.</i>	Contributing Function Riparian vegetation is comprised entirely of mowed lawn, which results in a 'Contributing Function' classification.	Limited Function The tile drain feature type and presence of mowed lawn result in the 'Limited Function' classification.	Contributing Function Overall, H6 transports some allochthonous materials (detritus, insects etc.) to the wetland south of the subject property. The presence of fish in the south wetland is currently unknown; any populations present represent isolated populations since the Halls Pond Wetland Complex is not connected to any watercourses.

H6-2: View of segment, facing north.
Visit 1 (March 19, 2021)

H6-2: View of segment, facing northwest.
Preliminary Visit (April 9, 2019)

H6-2: View of segment, facing northwest.
Visit 2 (May 7, 2021)

H6-2: View of segment, facing northwest.
Visit 3 (August 4, 2021)

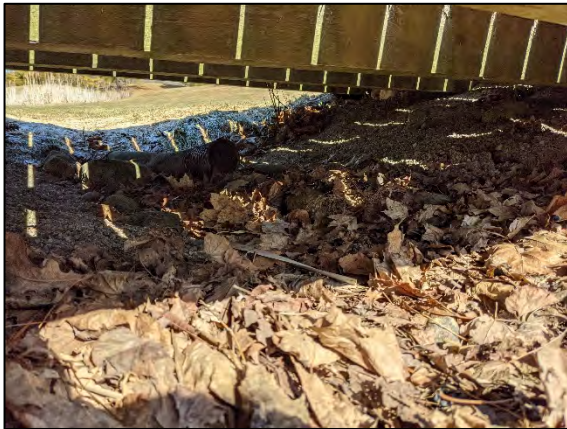
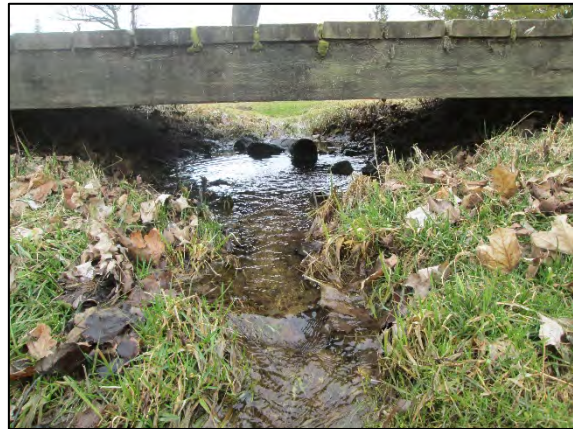
H6-2: tile drain outlet under cart path bridge.
Visit 1 (March 19, 2021)

H6-2: tile drain outlet under cart path bridge.
Preliminary Visit (April 9, 2019)

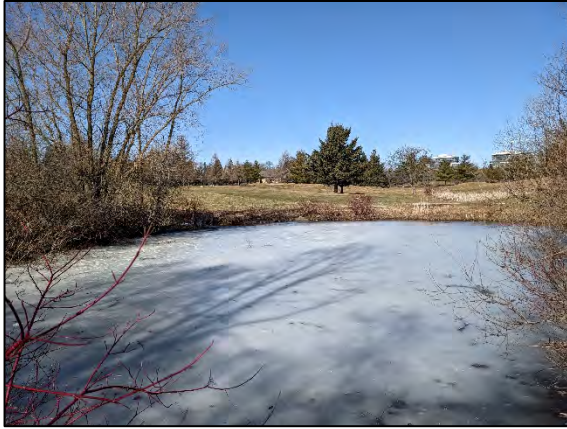
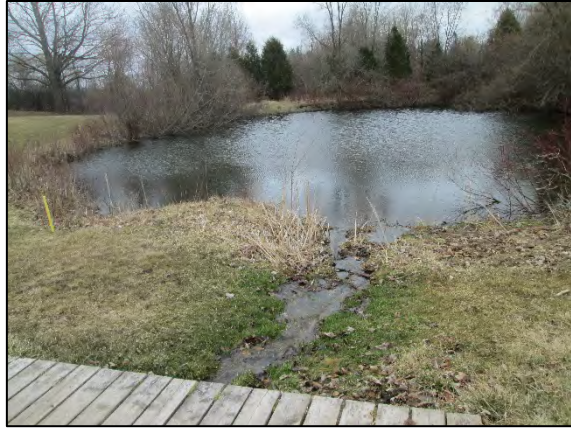
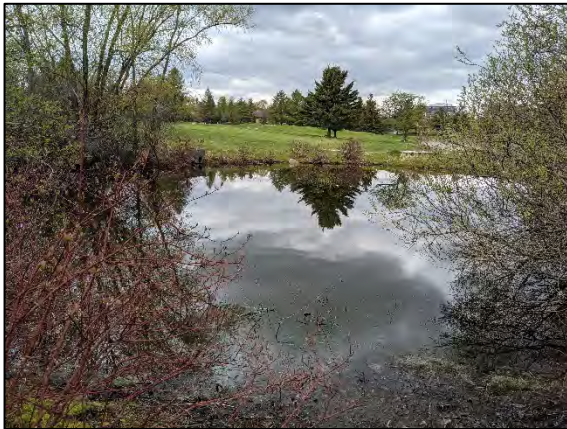
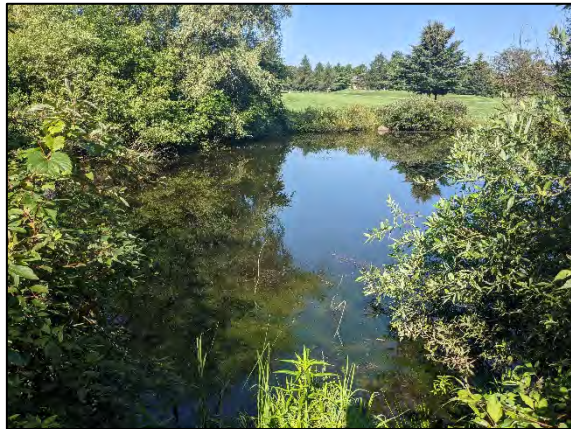
Segment **H6-1** is a man-made stormwater management (SWM) pond measuring 30m in length and 20m in width, and is generally encircled by a narrow (3-8m) band of naturalized riparian vegetation and manicured lawn. The pond was constructed specifically to convey flows to the wetland south of the subject property. The segment receives inputs from both H6-2 and a second tile drain that enters the pond at its western corner via a small headwall (Appendix I). While H6-2 was not flowing during any 2021 visit, minimal flow was observed exiting the second western tile drain on visit 1 (March 19 2021) only. A catch basin in the southeastern corner of the pond provides flow conveyance via a pipe to the south wetland. Water overtopped the invert of the catch basin on visit 1 (March 19, 2021) only. Segment H6-1 is currently mapped as a wetland by the GRCA; however, new information collected as part of the CEIS has resulted in the recommendation that the SWM pond (like segment H6-3 above) be excluded from GRCA wetland mapping as shown on Map NH-5A (Beacon 2021).

H6-1 <i>Photos 31-36 (Appendix I)</i>	Anthropogenic Pond H6-1 is a man-made, in-line SWM pond that provides flow retention but disrupts natural geomorphological processes and thermal regimes. Ponds are therefore not assigned a specific Hydrology classification. The Headwater Guideline indicates that the positive contributions and negative impacts of in-line ponds to	<i>Anthropogenic modifications to the pond area have altered the form of the segment.</i>	Contributing Function Riparian areas within 10m of the pond are comprised of a thicket vegetation, which is categorized as 'scrubland' in the Headwater Guideline.	Valued Function No evidence of breeding amphibians was observed, however targeted anuran call surveys are needed to confirm the absence of this ecological function since a	Contributing Function Overall, H6 transports some allochthonous materials (detritus, insects etc.) to the wetland south of the subject property. The presence of fish

H6-1: View of segment, facing north.
Visit 1 (March 19, 2021)

H6-1: View of segment, facing south.
Preliminary Visit (April 9, 2019)

H6-1: View of segment, facing north.
Visit 2 (May 7, 2021)

H6-1: View of segment, facing north.
Visit 3 (August 4, 2021)

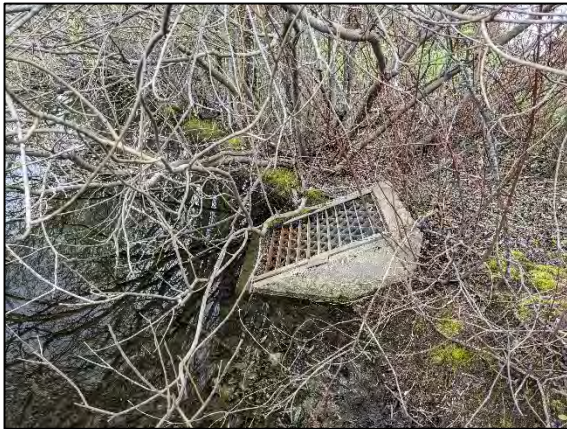
Photo 35

H6-1: Catch basin outlet in eastern corner of pond.
Visit 2 (May 7, 2021)
