Infrastructure Ontario Strategic Conservation Plan

N00249 Guelph Correctional Centre

IO No. D00249
SBA No. 16098

May 2018

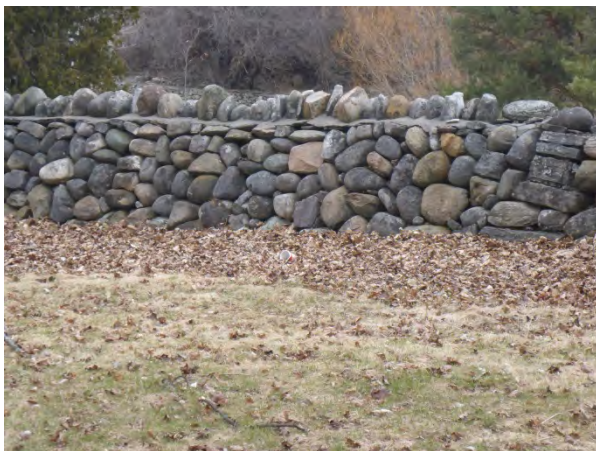
Stone wall detail

Stone Features	Fair	Both dry and wet laid limestone (rubble stone) walls show localized areas of structural deterioration. Stone fences, stairs and gates show weathering and some localized areas of deterioration.
Bridges	Fair	Concrete bridges along York Road entrance no longer have the weight tolerance to support emergency vehicles. As a result the York Road entrance is now closed and new vehicular access from Dunlop Drive was constructed in 2016.
Weirs	Fair	Not assessed in 2017, no specific concerns noted during 2009 Conservation Plan or previous condition assessments.
Ornamental Plantings	Good	Includes terraced gardens around the residences. Perennial plantings are allowed natural growth, overall grounds are well maintained.
Mature Trees	Good	Variety of ornamental and natural species. In general are well maintained with natural growth and minor loss due to weather and age.

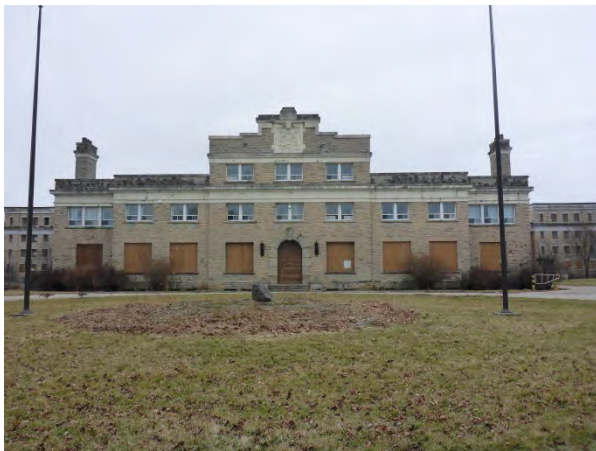
North Elevation of Administration Building (B13430)

B13430: Administration Building		
Includes the aesthetic qualities of the Beau x-Arts tradition, original design executed by John Lyle; the bold scale of the cornice; the regular placement of windows; the exterior articulation of the fireplaces at either end of the building; and the symmetry of the overall design. (Photos: Appendix A, p. 7-8)		
Component	Condition	Description
Foundation Wall and Footings	Good	Consists of concrete elements and 12 foot foundation wall. Localized areas of non-structurally significant deterioration. Overall foundation is functioning as intended with no signs of structural degradation.
Shell/Super-Structure	Good	This system is functioning as intended. No signs of wood rotting, structural soft spots, or visible sagging.
Roof Construction & Coverings	Good	Roof construction is steel reinforced concrete and is functioning as intended. Roof coverings are a modified bitumen system and were replaced in 2016 as part of interim mothballing measures.

Exterior Walls	Fair	There are areas of exterior masonry deterioration in the limestone cladding, including failing mortar joints, cracked masonry units and corroded lintels. This is particularly true of upper parapet areas, but localized points throughout as well.
Openings: Doors & Windows	Fair	The ground floor window and door openings were covered with plywood in 2016 as part of interim mothballing measures. No original windows remain but the openings remain in the same size, configuration and placement as the original design. The main entrance includes an oak wood door (possibly original) with a single pane of glass. The door had been sealed with plywood (fully reversible) to prevent vandalism and maintain integrity.
Cornice and Decorative Elements	Poor: Priority 3	Precast stone cornices retains the original location and bold scale and stone decorative elements (keystones, crest, etc.) remain in situ. However, these components are particularly deteriorated, in need of repair and some replacement, due to freeze-thaw exposure.

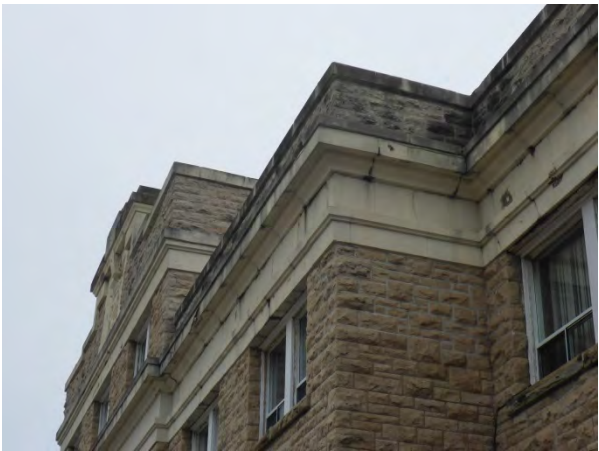
Cornice

Cornice	Poor: Priority 3	Precast stone retains the original location and bold scale. Some areas are particularly deteriorated, in need of repair and some replacement.
Articulation and Arrangement	Good	No changes have been made to the articulation and arrangement of the building as a whole. The symmetry is maintained along with all internal circulation passages, access, and observation points.

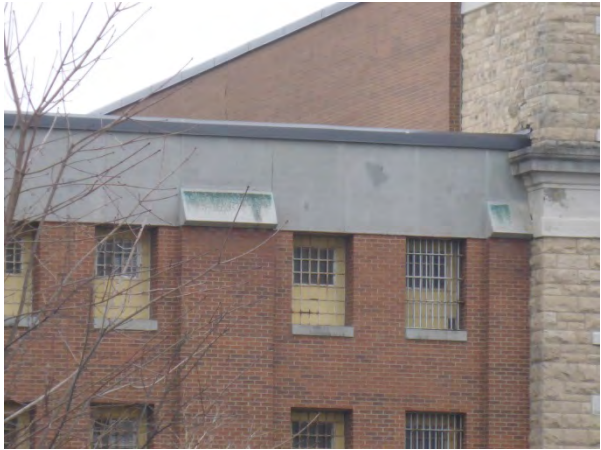
Window Type of B and C Cells(B13432 & B13434)

Openings: Windows	Fair-Poor: Priority 3	The ground floor window and door openings were covered with plywood in 2016 as part of the interim mothballing measures. Window openings remain in the same size, configuration and placement as the original design. Sills show some cracking

but are in generally fair condition. Some windows are showing signs of condensation and leaks, requiring rehabilitation and re-glazing.
Cornice	Fair-Poor: Priority 3	Limestone and precast detailing retains the original location and bold scale. The top cornice of precast concrete at the stone-clad areas has areas of spalling and deterioration
Cell Arrangement	Good	No changes have been made to the articulation and arrangement of the building as a whole. The symmetry is maintained and cells within the block remain in their original configuration.

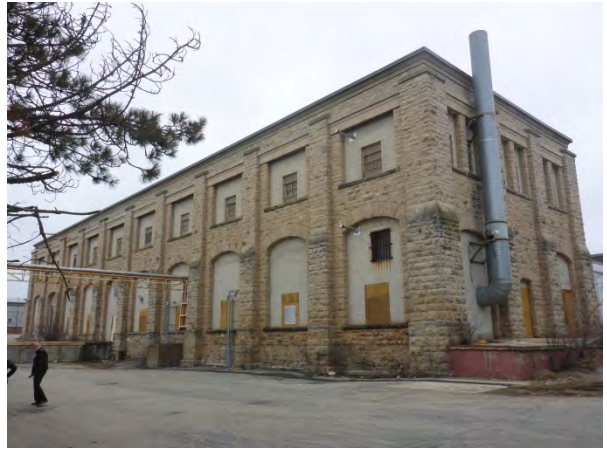
Machine Shop (B13450) – West Elevation

B13450: Machine Shop		
Includes stone exterior; the scale and position of original openings; surviving original windows and doors constructed by prison labour; organization of the property as a whole into a hierarchy of spaces; functional qualities and organization of the complex as associated with its correctional use (Photos: Appendix A, p. 10)		
Component	Condition	Description
Foundation Wall and Footings	Good-Fair	Consists of concrete elements and 5 foot foundation wall. Where the foundation wall is exposed above grade some deterioration of the mortar joints was noted. Overall is functioning as intended.
Roof Construction & Coverings	Good	Roof construction is steel reinforced concrete and is functioning as intended. Roof coverings are a modified bitumen system and were replaced in 2016 as part of interim mothballing and ongoing maintenance.
Exterior Walls	Fair	Limestone walls have areas of exterior masonry deterioration, including: sills, cornices, parapets, and both steel and masonry lintels. A portion of the east wall is now interior the connecting addition of the Woolen Mill building.

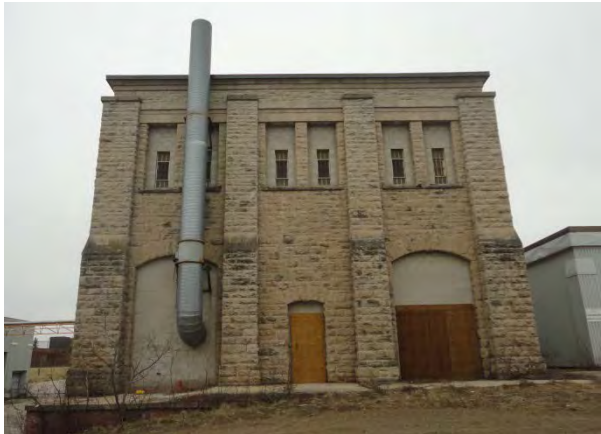
Machine Shop (B13450) – South Elevation

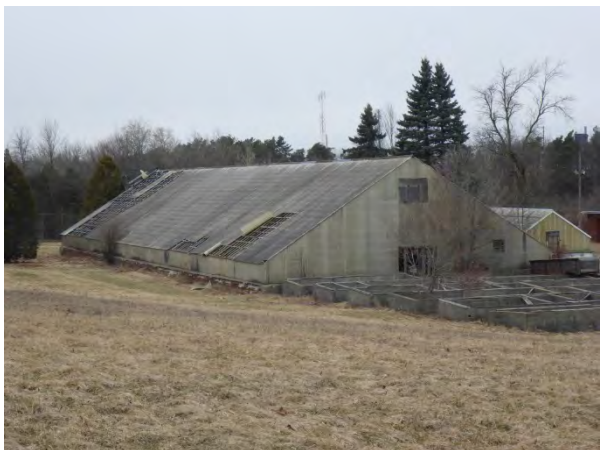
Greenhouse (B13465) – South-West Elevation

- Base Building Assessments are to be completed within the bi-annual schedule and will include a comprehensive lands component.
- Demolition of the Greenhouse (B13465) due to current conditions and health and safety concerns, following completion of a Heritage Impact Assessment and implementation of any immediate mitigation measures (including detailed heritage recording) and upon consent of the Minister of MTCS as required under the S&Gs.

The MTCS approved 2009 Conservation Plan noted that the Greenhouse (B13465) had degraded to such an extent that the cost of repair would be much greater than replacement and it was recommended for demolition (see sections 3.4.2 and 4.2.2). Since that time the structure has degraded further with walls and roof partially collapsed. Due to these conditions this building was not entered within the 2017 site visit.

B13465: Greenhouse		
As part of the greenhouse complex; organization of the property as a whole; functional qualities and organization of the complex as associated with its correctional use (Photos: Appendix A, p. 10)		
Component	Condition	Description
Form/Massing	Poor: Priority 3	Structural elements have begun to collapse. Condition documented in 2009 CP and 2011 Mothball Study as in poor or compromised condition and beyond repair. Condition has worsened since.
Roof Construction	Poor: Priority 3	Partially collapsed, allowing exposure to elements and access to wildlife. Condition is beyond repair.
Exterior Walls	Poor: Priority 3	Partially collapsed, allowing exposure to elements and access to wildlife. Condition is beyond repair.
Openings: Doors & Windows	Poor: Priority 3	Structural elements partially collapsed, allowing exposure to elements and access to wildlife. Condition is beyond repair.
Articulation and Arrangement	Fair	The form design and location of the building remains unchanged, however several structural elements are partially collapsed.

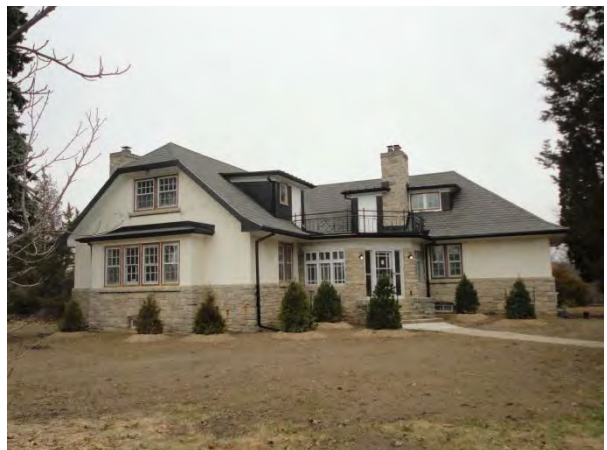
Superintendent's Residence (B13499) - West Elevation

B13499: Superintendent's Residence		
Including domestic appearance; the organization of the property as a whole (Photos: Appendix A, p. 10-11)		
Component	Condition	Description
Foundation Wall and Footings	Fair	Random coursed (rubble stone) limestone and mortar, and masonry piers. Areas of mortar deterioration related to localized water migration on the uphill side of the building were repaired in 2016. Further study is needed to confirm any structural impacts.
Roof Construction & Coverings	Good	Wood truss system. Room membrane and asphalt strip shingles are in good repair and functioning well.
Exterior Walls	Good	Mixture of limestone cladding and stucco. Has localized areas of spalling and mortar deterioration.
Openings: Doors & Windows	Good	The windows are generally the original wood windows, most with modern aluminum storms, and some Georgian wired storms. Temporary exterior wood storm windows were added in 2016. The doors are generally the original wood glazed doors with modern aluminum storms. There are new fire-rated doors at the fire escape. The fenestration including exterior trim is generally in good condition with rehabilitation and reuse possible.

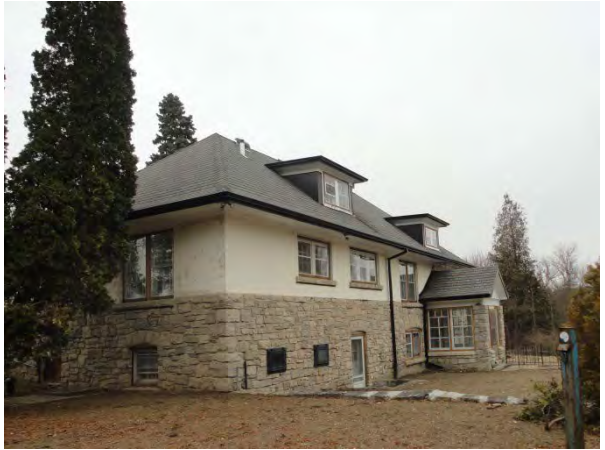
Superintendent's Residence (B13499) - South-East Elevation

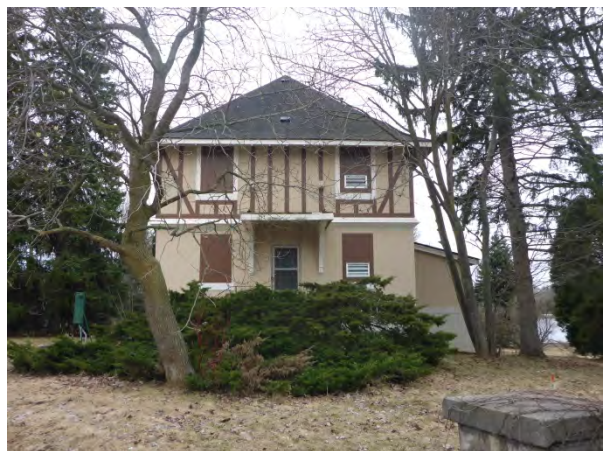
Willowbank Hall (B13498) - South-West Elevation

Willowbank Hall (B13498) has experienced a degree of degradation, however the 2013 Adaptive Reuse study for the GCC confirmed that Willowbank Hall is a viable candidate for rehabilitation. Once vacant, its location away from the main complex and vacant made Willowbank Hall easily accessible to wildlife, which created health and safety concerns. To address these issues all services (heat, electricity and plumbing) were taken off-line; the chimney was dismantled, with stones numbered and stored in the

B13498: Willowbank Hall		
Including domestic appearance; the organization of the property as a whole (Photos: Appendix A, p. 11-12)		
Component	Condition	Description
Foundation Wall and Footings	Good	Random coursed (rubble stone) limestone and mortar below grade, with speed tile and mortar above grade. Areas with small amount of mortar and parging deterioration noted. Overall is functioning as intended.
Roof Construction & Coverings	Good	Wood frame and rafter system. Localized deterioration noticed in some roof boards. Roof membrane, asphalt shingles and associated flashings were replaced within last 10 years and all elements are still functioning well.
Exterior Walls	Fair	Stucco, covered by painted plywood to help conserve the façade. Some cracking evident in the stucco on all faces of the building, however none of the cracks appear to be due to structural failures or movements. For health as safety, chimney was dismantled with stones numbered and stored in basement.

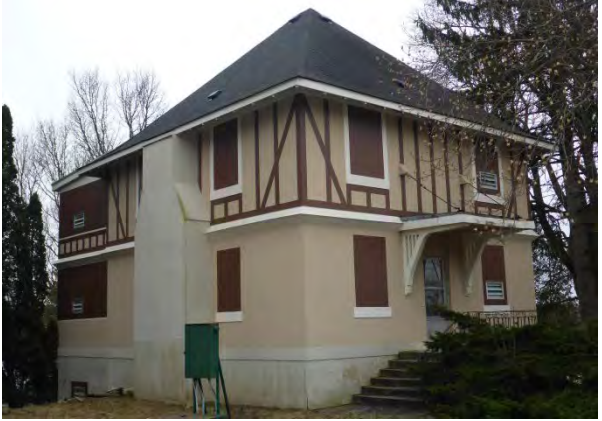
Willowbank Hall (B13498) - North-East Elevation
