Advisory Committee of Council Information Report

Committee	Heritage Guelph
Date	Monday, September 11, 2023
Subject	12 Eramosa Road – Cultural Heritage Evaluation Report

This information report provides a cultural heritage evaluation, a draft statement of significance and determination of cultural heritage value or interest for 12 Eramosa Road. The report is presented for review and comment by Heritage Guelph in preparation for a notice of intention to designate the property under Part IV, Section 29 of the Ontario Heritage Act.

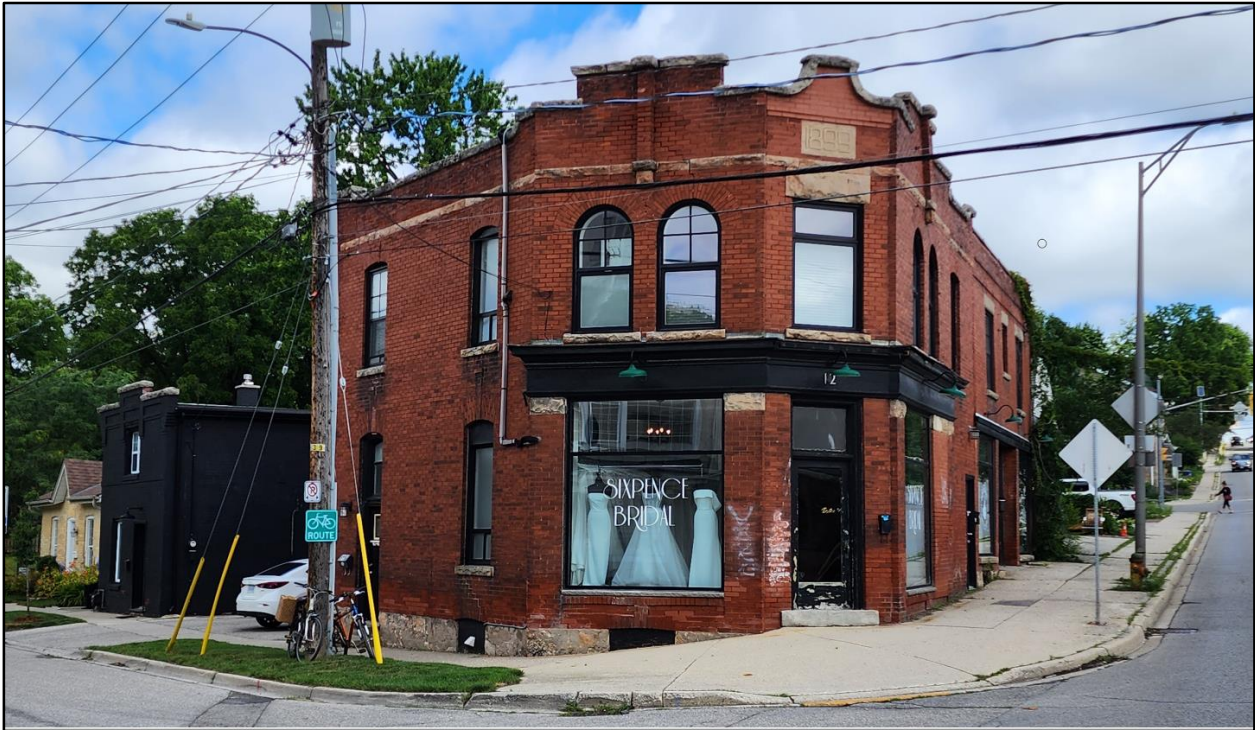
The property includes a 2-storey, red brick, corner store building with residential units above (Figures 3 and 4) and a detached, 2-storey, red brick stable building (now painted black) fronting Arthur Street North (Figure 5).

Figure 3 – 12 Eramosa Road, view from south. (Photo: S. Robinson, 2023)

The corner store built in 1899 is a 2-storey building constructed in pressed red brick laid in a stretcher bond (Figures 3 and 4 and Attachment-1, Figures 1-14). The roof is hidden by a brick parapet with a rock-faced limestone coping that creates an elaborate roofline. The parapet has corbelled brick eave stops at the west and north corners of the building (Attachment-1, Figures 4, 5 and 6). The coping is connected by two protruding red brick pilasters dropping down to a rock-faced stone belt course that extends around the entire street-facing exterior.

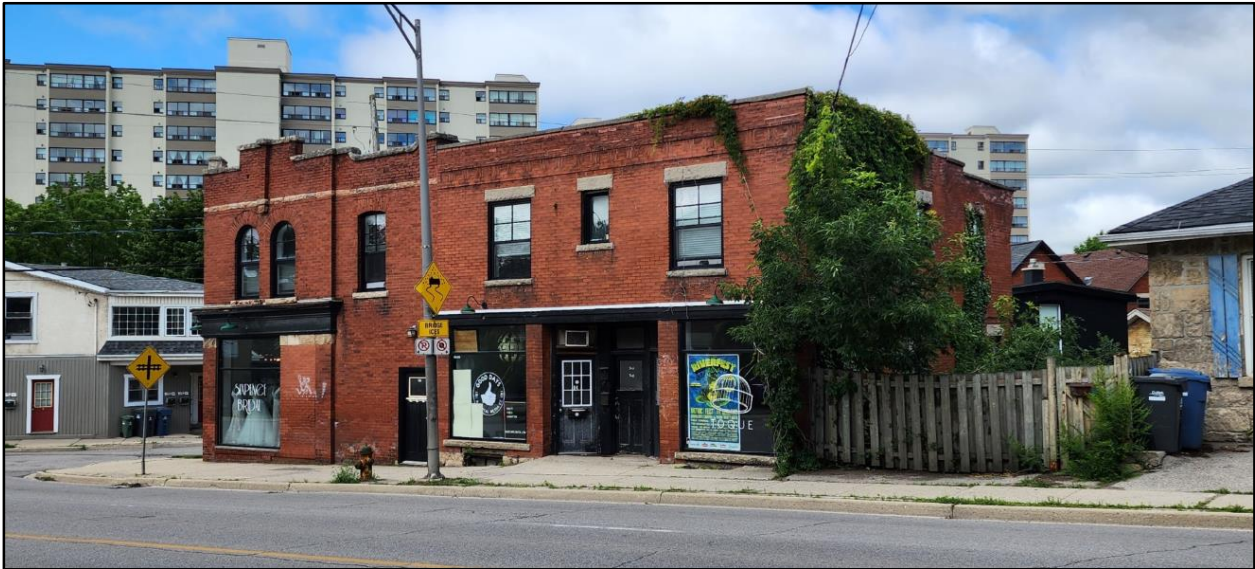
Figure 4 – 12-16 Eramosa Road, view from east. (Photo: S. Robinson, 2023)

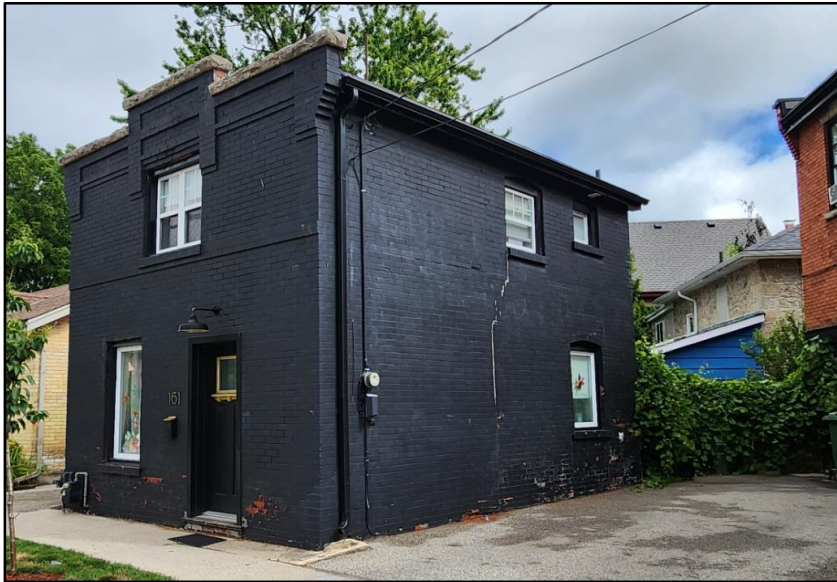
Figure 5: Stable building fronting Arthur St N. (Photo: S. Robinson, 2023)

The detached, 2-storey, red brick stable building (Figure 5) has been painted black in a recent renovation. The building fronts onto Arthur Street North creating a triangular courtyard space between it and the corner building (Attachment-1, Figures 15 and 16). The building form is rectangular in plan with a low-pitch gable roof and a brick parapet over the façade. The parapet has rock-faced limestone coping stones and is articulated with corbelled brick band courses, pilasters and

eave stops. The outline of the large carriage door from the original use of the building as a stable has been bricked in on the elevation facing the triangular courtyard and an original man door bricked in to create the current ground floor window on the ground floor beside it. The upper window within the corbelled brick parapet appears to have a solid sill and was likely the access door to the stable's hayloft. The Arthur Street front door and all other windows (which have rowlock brick sills) were likely created in the conversion of use from stable to dwelling in the mid-1920s.
