Cultural Heritage Impact Assessment

331 Clair Road East
Guelph, ON.

Date:
May 2023

Reference: 331 Clair Rd E, Guelph – Structural Feasibility Review for Relocation of Stone House

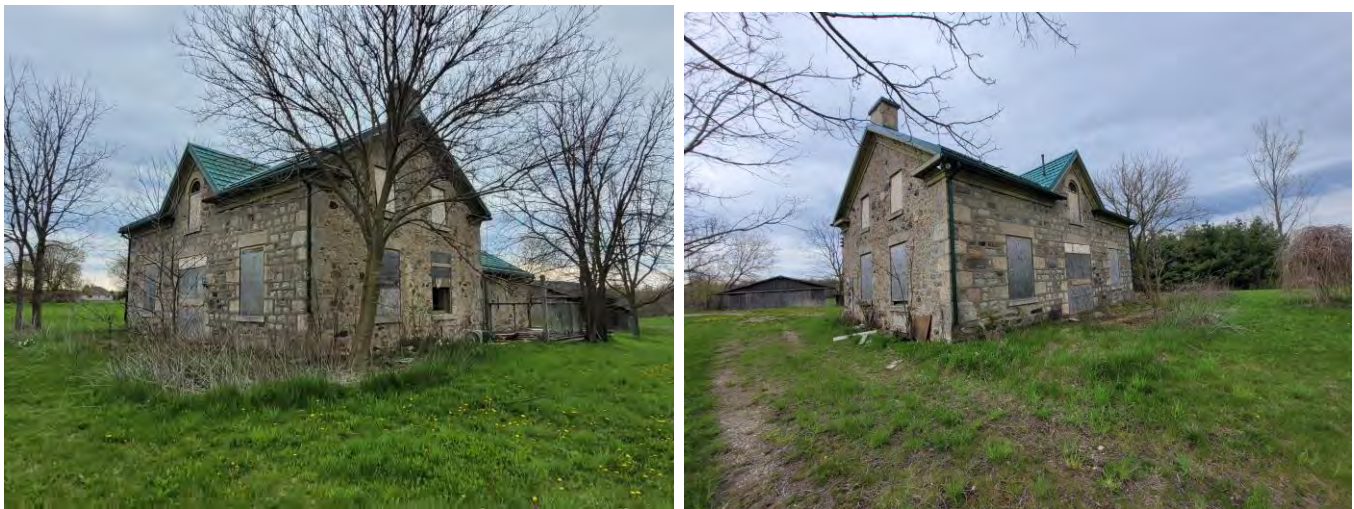
Figures 3 & 4: (left) View of north (front) and west elevations, looking south-east, (right) View of east and north (front) elevation, looking south-west (MHBC, 2023)

The site visit was completed by MHBC in May 2023 in order to undertake a visual analysis of the condition of the building from the exterior. The site visit determined that the majority of original wood windows have been destroyed.

Localized masonry issues were observed, as per the findings of the Stantec structural report. Larger masonry cracks and condition issues were also observed, including a large crack in the masonry in the rear addition (See Figure 6).

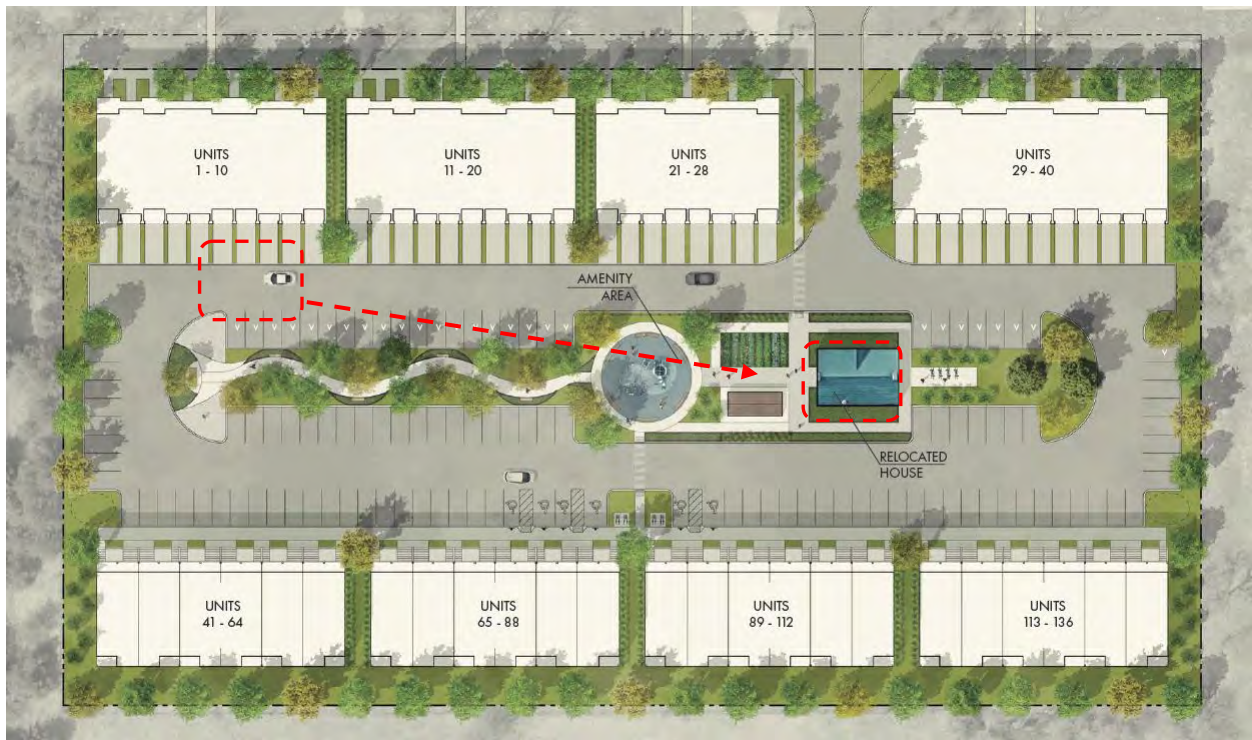
The current development concept includes the development of 8 townhouse blocks with a total of 136 units. The proposal includes parking spaces which are located in the centre of the site around an amenity area. The rear addition is proposed for removal, and the remainder of the dwelling is proposed to be re-located on-site. The house would be re-located to the north-east and placed atop a new foundation within a central amenity area. The building would be restored in its new location and conserved over the long-term.

The building is proposed to be adaptively re-used for amenity use. The specific use of the building will be determined through the site plan approval process. The amenity area includes landscaped open space and inter-connected pathways and seating areas.

Figure 7: Site Plan of the Proposed Development of the Subject Lands noting approximate existing location of heritage dwelling and proposed new location within the central amenity area (MHBC, 2023)

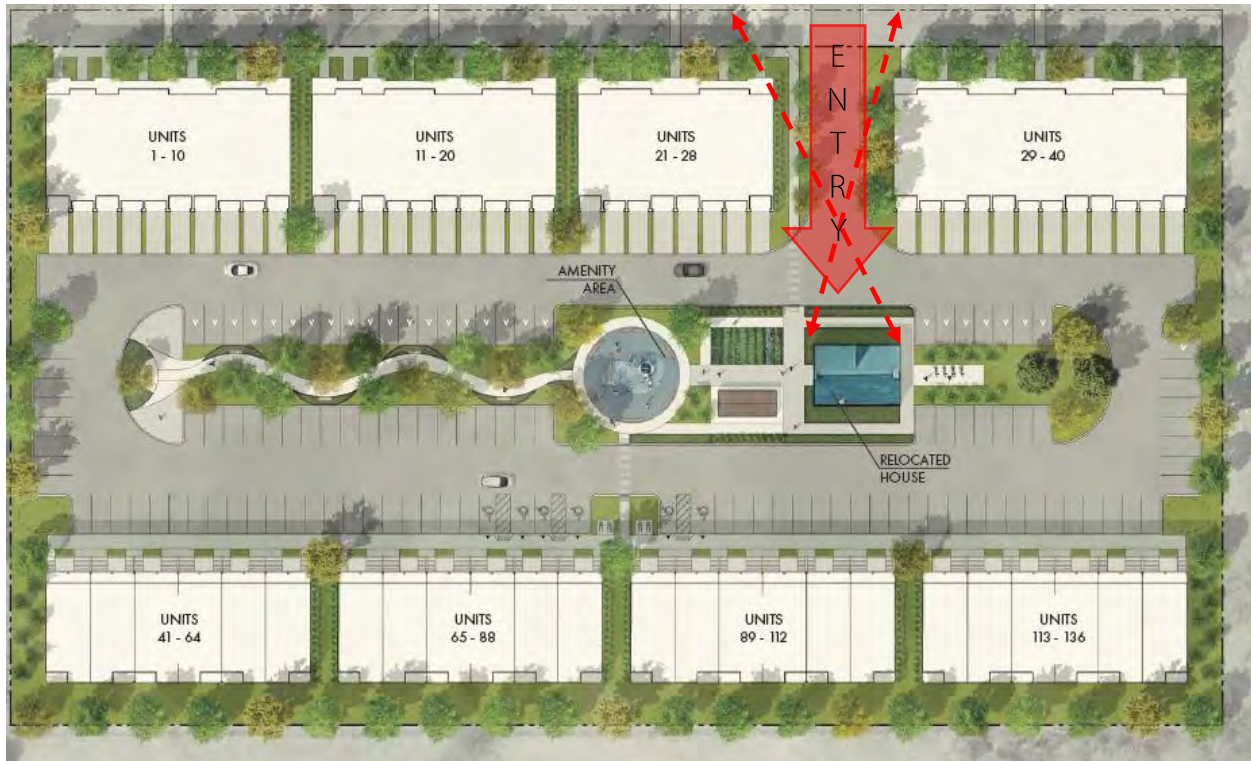
The 2012 Heritage Impact Assessment identified that the visibility of the dwelling along Clair Road was part of its value which would be conserved as part of the previous development concept. The current development concept includes the construction of 4 blocks of townhouse units along Clair Road East. Access to the townhouse development is provided at Clair Road East. Upon entering the proposed development, the re-located heritage house terminates the view from the private driveway resulting in the relocated house being prominently visible within the amenity area (See Figure 8 below) and remaining visible from Clair Road. The loss of open views of the dwelling as one traverses Clair Road East is considered an adverse impact. However, the impact is considered moderate, rather than major given that the primary façade of the building remains visible from the public realm as per the lines of sight noted in the figure below.

Figure 8: Proposed Development Concept noting the lines of sight towards the re-located heritage house from Clair Road East.

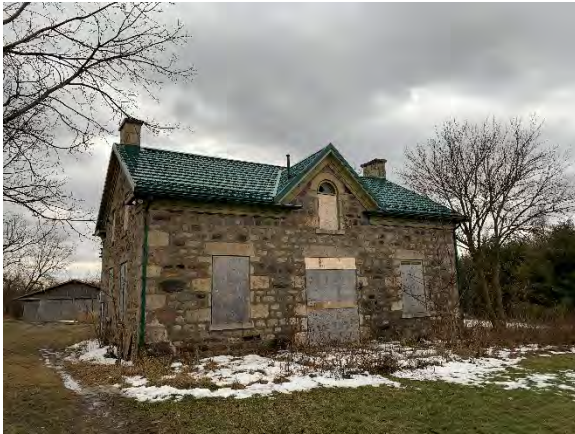
The main house is a 40' x 28' rectangular footprint, with the summer kitchen being 18' x 24', making the entire depth of the house 52'. On the west side of the summer kitchen, there is a 6' deep wooden covered porch. A drawing showing the approximate layout of the building is attached at the end of this memo.

Photo 1: Main House (Principal Elevation -North)

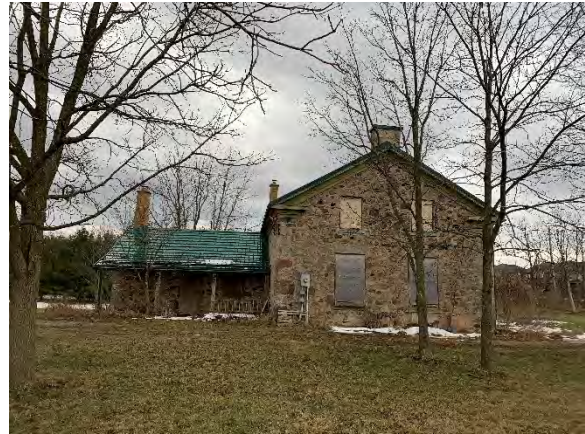
Photo 2: East Elevation

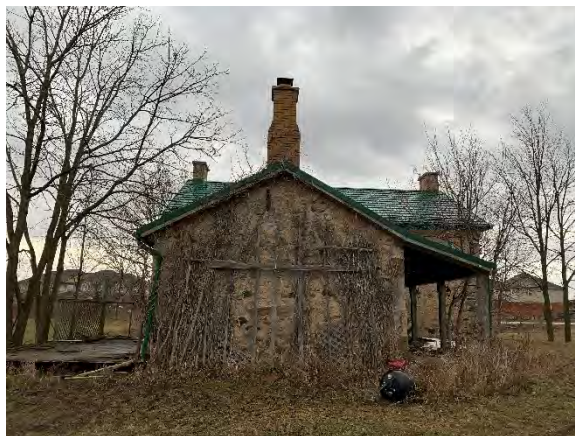
Photo 3: South Elevation (Summer Kitchen)

The summer kitchen was observed to have more advanced deterioration than the main house, with major cracking in the rubble masonry in the south-east and south-west corners. This cracking, while significant, is well within repairable ranges and as noted above would need to be repaired to ensure stability during relocation. Previous structural studys by MTE noted that the floor assembly of the summer kitchen is in poor condition with visible rot which may compromise the integrity of the summer kitchen during a move. Stantec was not able to inspect the wooden floor and therefore cannot further comment on the conclusions drawn by MTE regarding condition. The condition of the floor is an integral part of the relocation and therefore rot in the floor system can certainly affect the feasibility of relocating.

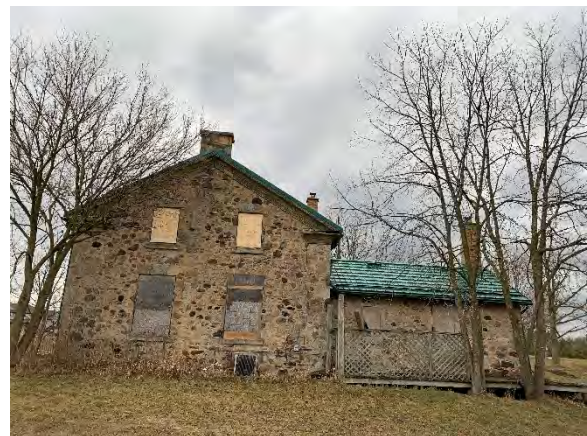
Photo 4: West Elevation

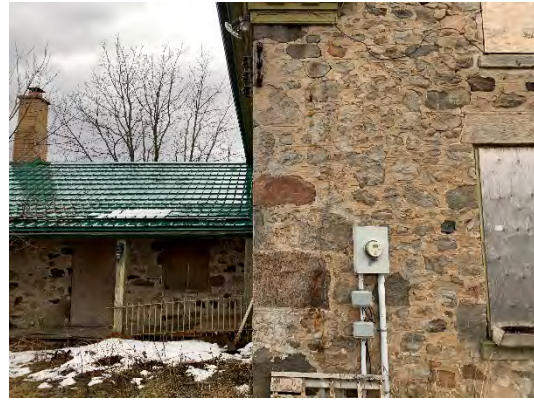
The entire structure is stone masonry with varying stone types used throughout with very high variability in colour. In general, all the stone appears to be variations of granite, likely sourced from the local fields of the area. The principal façade is a coursed ashlar-faced rubble stone wall, with dressed ashlar stones used for jambs, lintels, and quoins. Dressed stones appear to be limestone and are a more consistent quality and finish, it is expected that these stones were sourced from a single quarry and specifically used on the principal façade for their architectural value. It is common for rubble building in this period to source and finish higher quality stone for the principal face of the building. All other walls are uncoursed rubble granite of varying sizes.

Photo 6: Typical Un-coursed Rubble Wall with Ashlar Granite Quoins

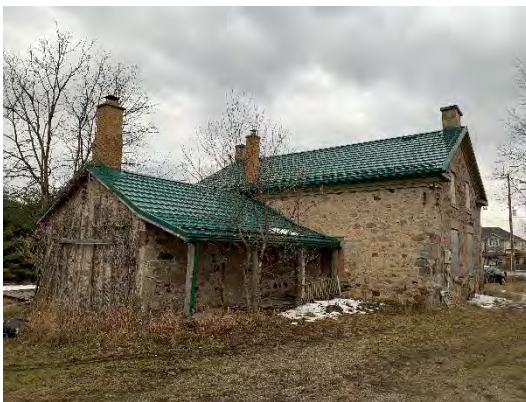
A wooden covered porch is attached on the east side of the summer kitchen and is supported on timber newel posts with concrete foundations. It is not believed that the portico is original to the building given the finish of the timbers used.

Photo 8: Summer Kitchen and Covered Porch

- The wooden porch is in very poor condition with suspect connection to the stone walls. The porch should be removed for relocation and reconstructed in the new location.

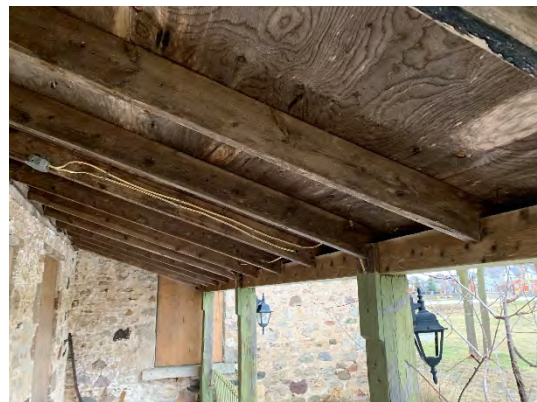
Photo 9: Underside of Covered Porch

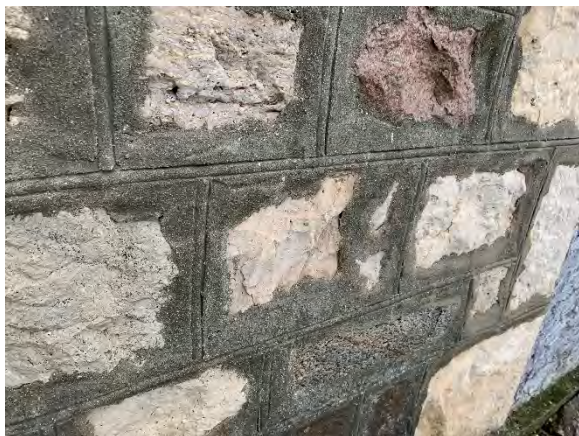
Tuck-pointing was present throughout the entire building, and particularly the principal face. The tuck-pointing has been completed using cement mortar and is not of particular high-quality, with significant smearing over the edges of the ashlar stones.

Photo 10: Typical Ashlar with Spalled Face and Tuck-pointing

Photo 11: Typical Ashlar with Spalled Face and Tuck-pointing

While spalling of the ashlar stone faces was common, it did not appear to have negatively affected the stone integrity. The ashlar all remained well positioned and were not loose when sounded, no broken stones were found spalling beyond the front 1" of the stone. While this condition can lead to major stone deterioration, and subsequent wall deterioration, it appears the stone in the building are of sufficient quality that the backing wall has not been adversely affected in a substantial way. The mortar remains well bonded to the stones, and although the arises have been smeared over, there is little sign of failure in the cementitious mortar.

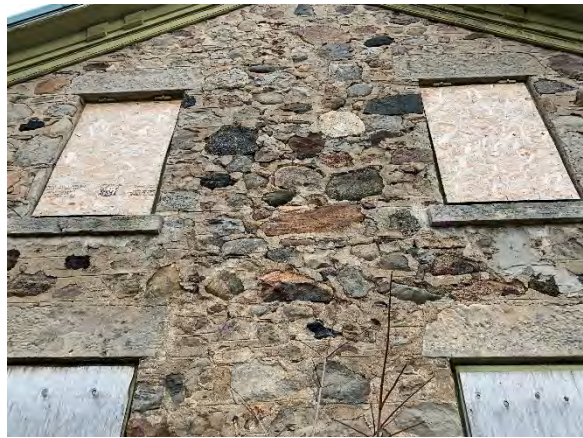
The rubble stone on the rest of the building was found to have moderately deteriorated mortar joints with areas of heavy deterioration. It appears that the deterioration is mostly located on faces which are exposed to driven rain and has resulted in a wash-out of the mortar joints. Rubble stone at both the south-west and south-east corner of the summer kitchen is severely cracked and showing signs of settlement. The core of the walls in these areas is exposed to water through the cracking, with some mortar joints fully washed out.

Photo 13: Washed-out mortar and loose stones in Rubble Wall

In locations with significant mortar wash-out, the lime mortar of the core was visible. It is not clear that the lime mortar observed is original to the building, however it appeared to be mostly lime and sand. The backing lime mortar was in fair condition, still bonded to the stone and with the lime binder not washed away. The extent of voids within the core of the wall was not possible to determine, however in all locations where the core was visible from the outside, there appears to be few voids between the core stones.

- Rubble wall joints throughout had minor cracking in the mortar and moderate washout. All such joints should be raked out and repointed to a depth of sound mortar in order to stabilize the stones. Approximately 25% of the rubble walls should be repaired before relocation.

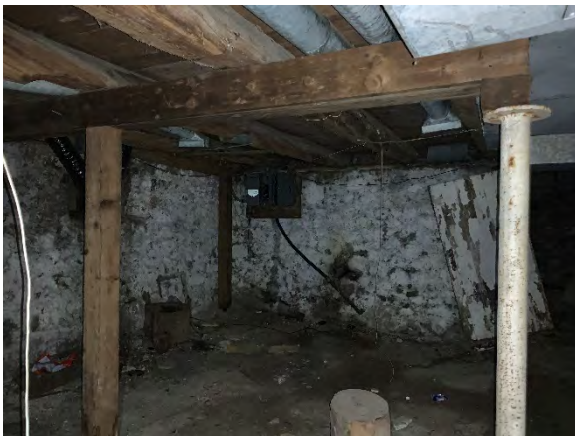
The interior side of the foundation walls were inspected from the basement, and generally appeared to be in good condition. All joints were well mortared, without signs of cracking or de-bonding of the mortar.

Photo 14: Typical Rubble Foundation Wall

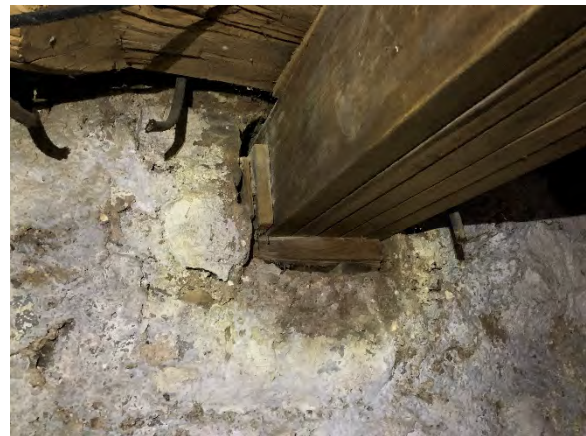
Photo 15: Typical Voids at Joist Ends
