# Advisory Committee of Council Information Report

Committee Heritage Guelph

Subject 15-23 Fountain Street East: Cultural Heritage

**Evaluation Report**

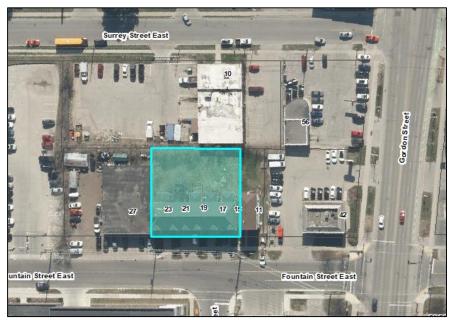
Figure 1: Aerial image of 15-23 Fountain Street East, indicated in light blue (City of Guelph GIS)

Staff analysis: While the neighbourhood surrounding 15-23 Fountain was once populated by factories and other working-class housing, the character of the area has changed dramatically over the last half century. Johnson Terrace is now primarily surrounded by parking lots (see Figure 1).

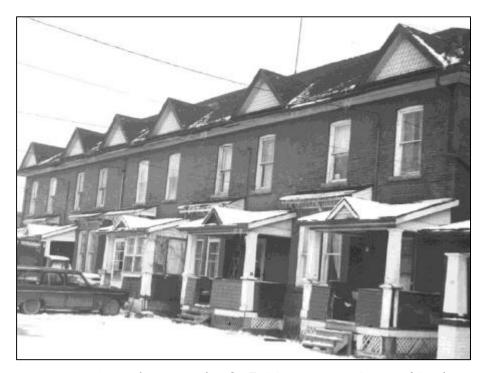
Built with red pressed brick laid in stretcher bond pattern, the structure is a good example of terraced housing or row housing that was popular in the nineteenth and early twentieth century. The terrace is composed of five units, each with an entry door facing Fountain Street. While the original front doors have been replaced, the transom lights remain intact. A 1974 photograph from the Couling Inventory shows that there were once small porches on each unit. Beside each entrance is a protruding bay with coupled double hung sash windows above stone sills. The protruding bays are capped with a shed roof that is supported by corbels and decorated with dentils. The second storey of each unit contains two double hung sash windows with stone sills. The roof of the terrace is hipped, with small decorative gables that protrude above the entrance of each unit.

Figure 1: 1974 photograph of 15-23 Fountain Street (Couling Building Inventory)

Staff analysis: While 15-23 Fountain Street may be well-built, it does not display a high degree of craftmanship or artistic merit. Many of its original features, including the porches and doors, have been significantly altered.
