Attachment-2 Drawings of proposed rehabilitation and alteration

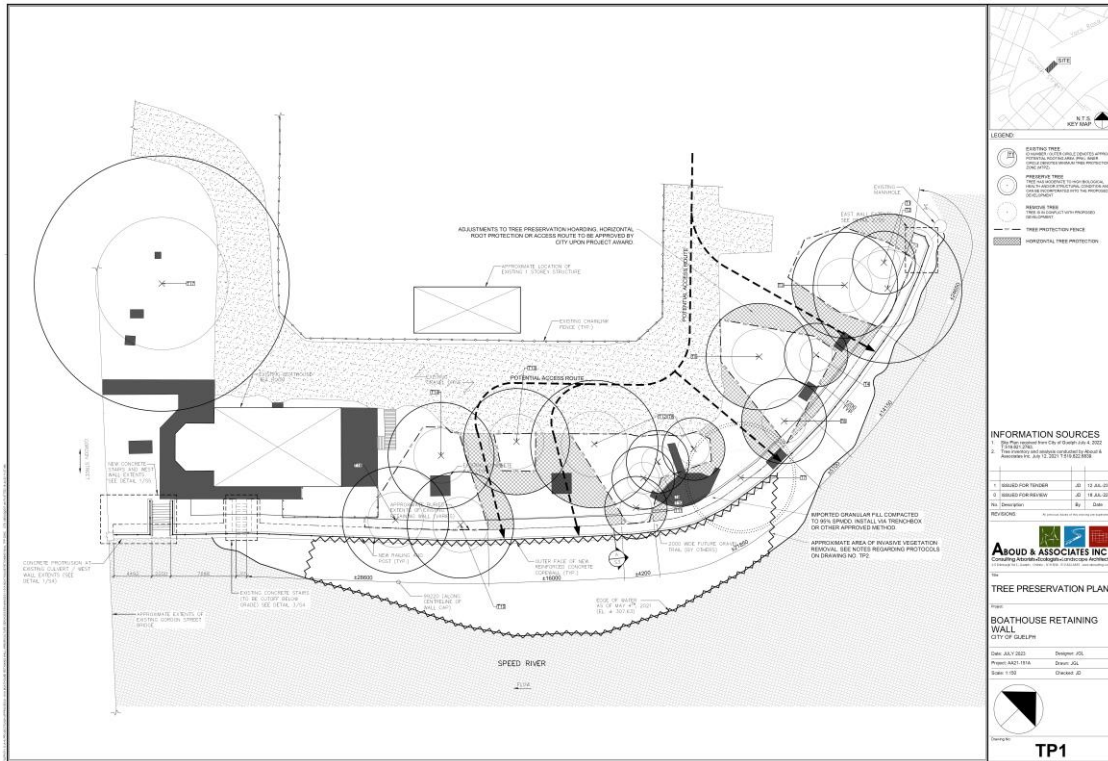
Figure 6 - Tree Preservation Plan (Aboud & Associates Inc., July 2023)

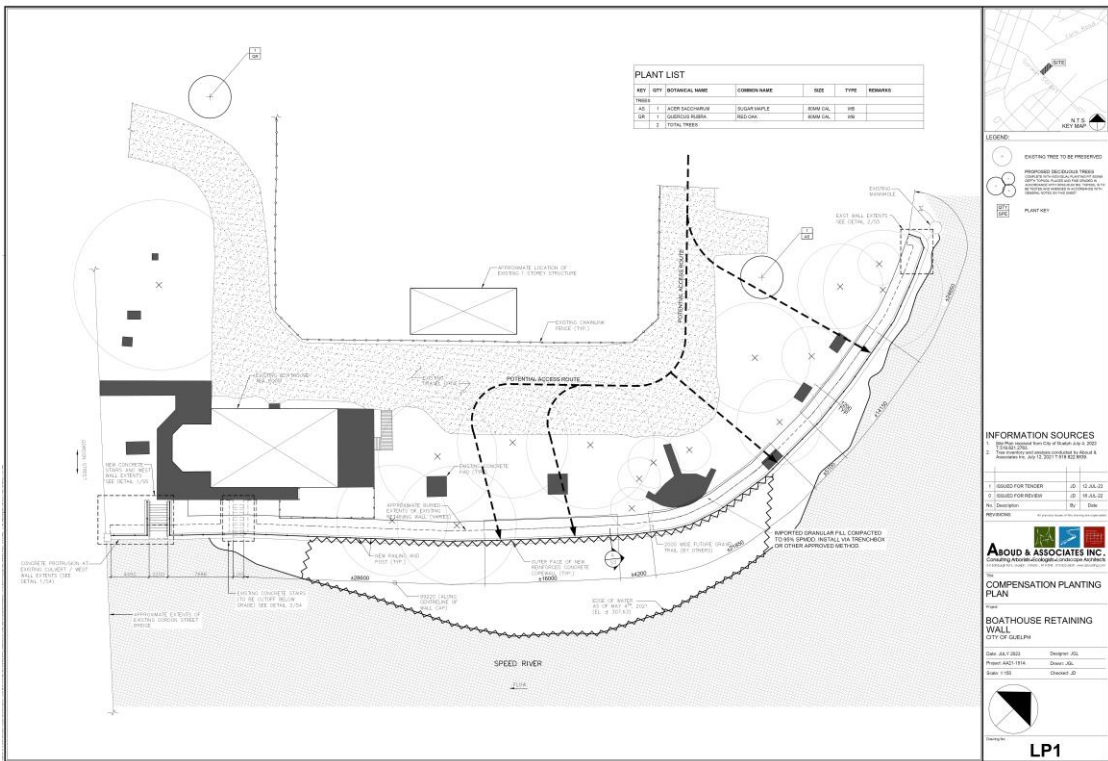
Figure 7 - Compensation Planting Plan (Aboud & Associates Inc., July 2023)
