## **City of Guelph**

## **Schedule B Class Environmental Assessment – Project File Emma Street to Earl Street Pedestrian Bridge**

**November 21<sup>st</sup>, 2019**

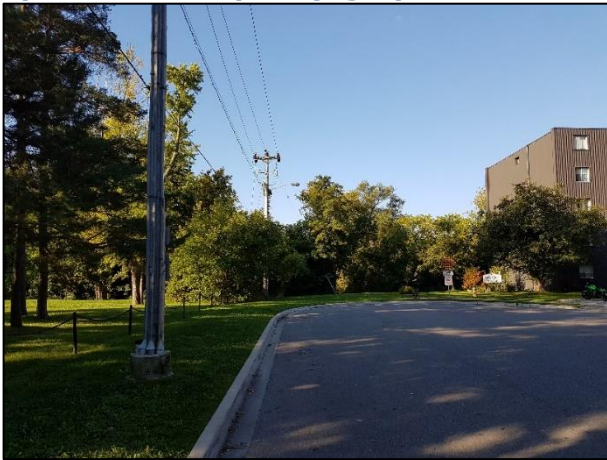
**Photo A. Emma Street Towards Vantage Towards Speed River, with Homewood Health Centre (left), and Emma Street Apartment Complex (right).**

Select photos have been included below to further illustrate the existing conditions at the ends of Emma and Earl Streets, as well as an as-built drawing of the watermain that was open-cut across the channel in 1962.

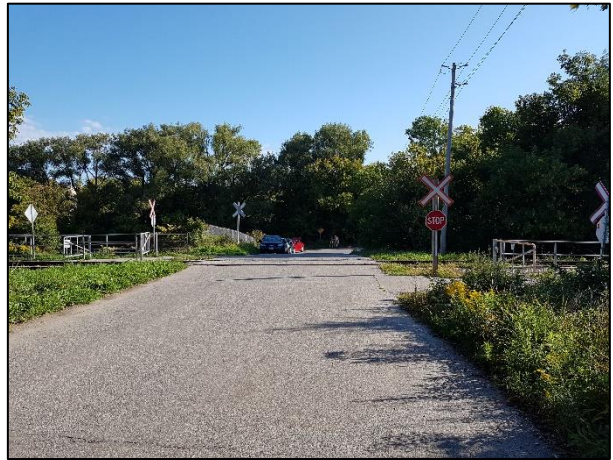
**Photo B. Earl Street Vantage Towards Speed River, crossing the Downtown Trail & Railway, followed by Armtech Entrances.**

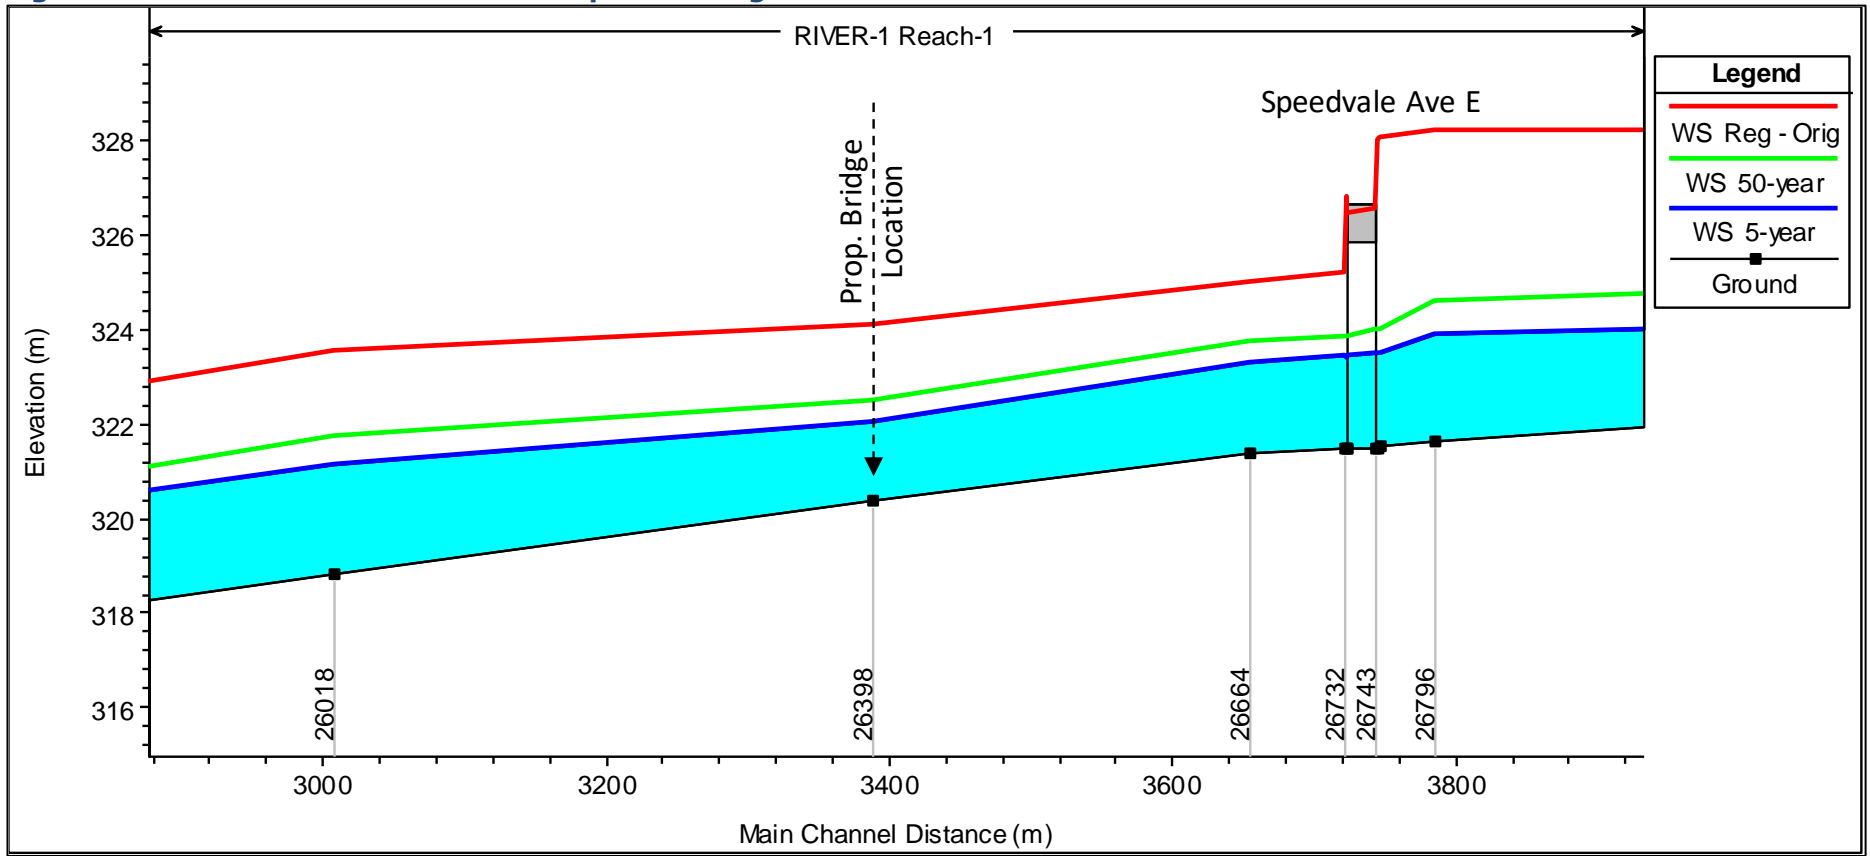
**Figure 3-3 Water Surface Profile at Proposed Bridge Location.**

The hydraulic results of the existing conditions at RS 26398 are presented in Table 3-1 below. A water surface profile plot of the 5-year, 50-year, and Regional flood flows was generated (Figure 3-3). The floodlines and water surface elevations were also plotted on the surveyed planform and cross section (Figure 3-4).

Upon review of the existing conditions model, River Station 26398, which is approximately 40m upstream of the proposed bridge location, was identified as the most relevant cross section for hydraulic analysis. Comparison of RS 26398 to the surveyed cross section in Figure 3-2 showed relatively consistent elevations and of the channel and overbank areas. The major difference was the omission of the island mass within the channel, which was determined to be an acceptable compromise for the purposes of this exercise.

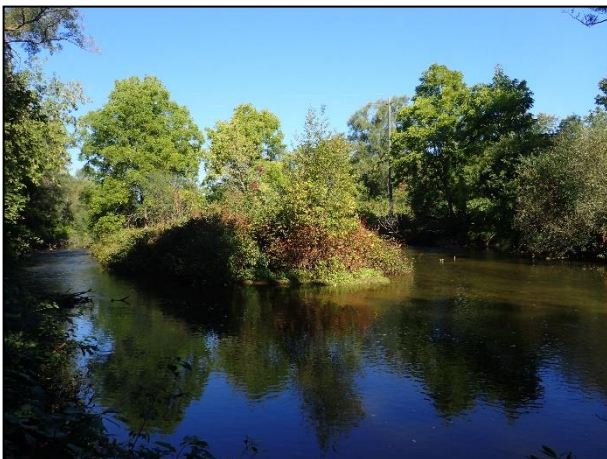
**Figure 3-6 Upstream View of Speed River at Proposed Bridge Location, Showing Island Mass**

There was no excessive scour or erosion within the study area. The mature vegetation along the banks suggests that this section of the Speed River is stable, and not undergoing any significant lateral channel migration. The riffle within the study area is also providing protection against any channel bed scour.

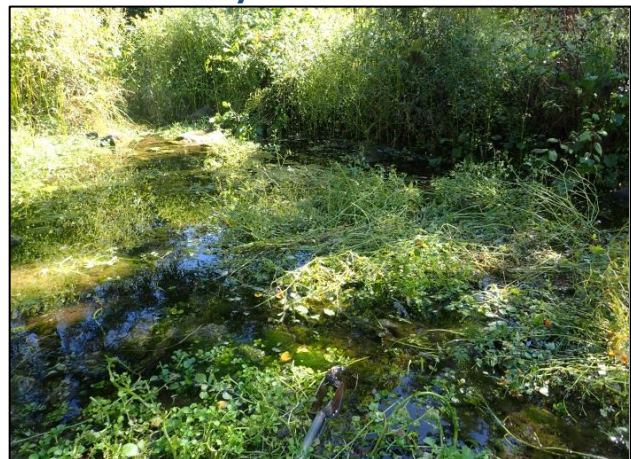
**Figure 3-7 Groundwater Seepage Area Along Northern Bank in the Upstream Section of Study Area**

An area of groundwater upwelling area (Figure 3-7) was noted along the northern bank of the river, described as a Mineral Shallow Marsh (discussed in Section 3.4.1 and Figure 3-9). This area is low lying, making it more susceptible to flooding, and has soft, wet mineral soil which is less desirable for bridge foundations. The proposed bridge alignment should avoid this area if possible.

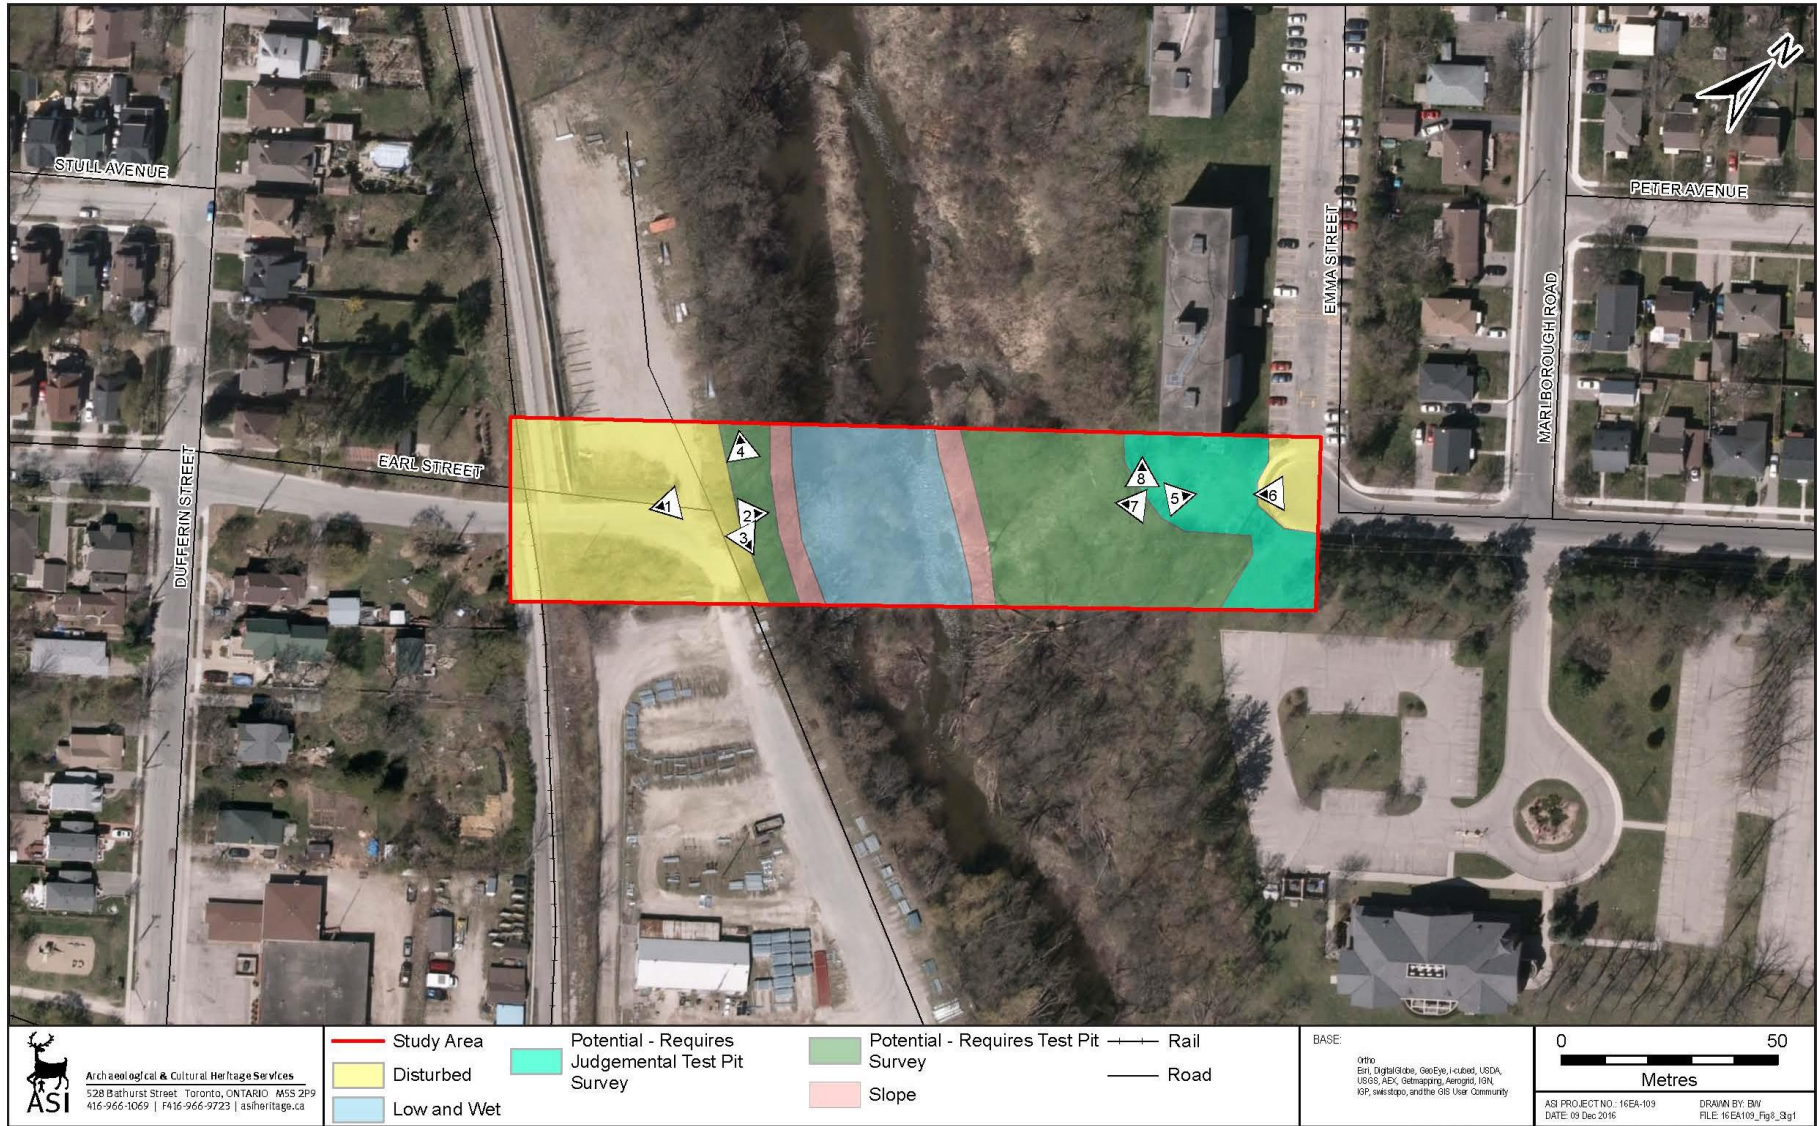
Figure 3-10 Results of Archaeological Property Inspection for Emma St to Earl St Pedestrian Bridge

Figure 8: Emma Street to Earl Street Pedestrian Bridge - Results of the Property Inspection

The property inspection determined that parts of the study area retain archaeological potential (Plates 3, 4 & 7, Figure 3-10) and require Stage 2 archaeological assessment by test pit survey prior to any development.

1. Two previously registered archaeological sites are located within one kilometre of the study area.
2. Parts of the study area possess archaeological potential and require Stage 2 assessment during the detailed design stage, prior to any proposed works.

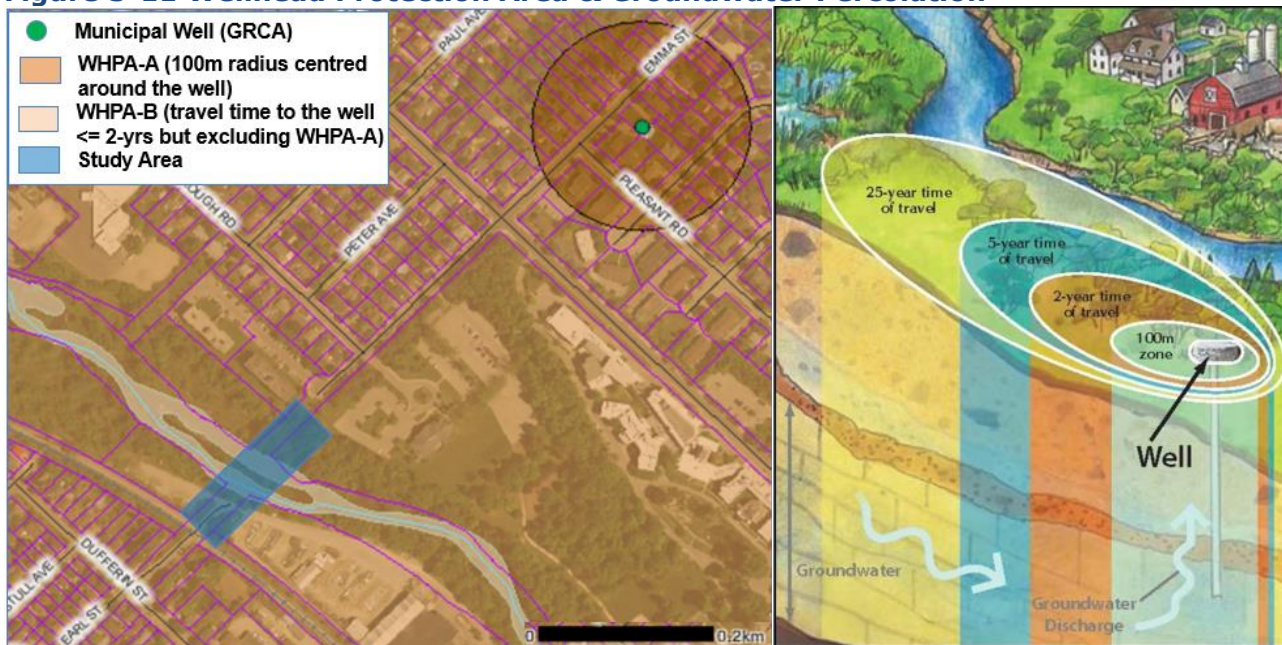
**Figure 3-11 Wellhead Protection Area & Groundwater Percolation**

Information from the plans show that the groundwater in the study area has been classified as vulnerable and there is a municipal well approximately 400m from the study area (Figure 3-11).

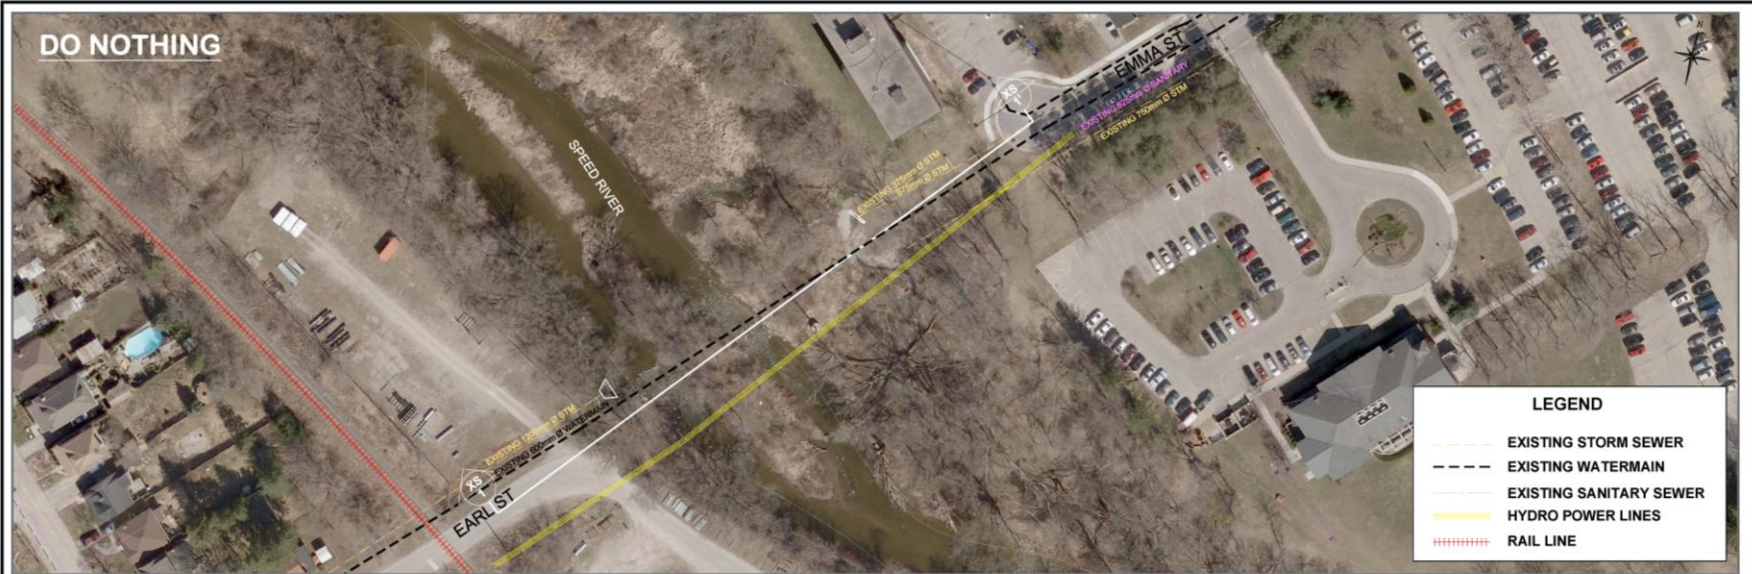
**Figure 4-1 Null Alternative – Existing Conditions Remain with No Bridge Connection.**

- Safety risk for pedestrians and cyclists using Speedvale Ave
- Reduced connectivity for pedestrians and cyclists between downtown and the northeast
- Inconsistent with the Guelph Trail Master Plan (2005), Official Plan Schedule 6, and Speedvale EA Preferred Alternative (2015)
