Heritage Conservation Plan
Isolation Hospital
65 Delhi Street, Guelph
Final Report March 30, 2023

+VG ARCHITECTS
THE VENTIN GROUP LTD.

Heritage Conservation Plan Introduction

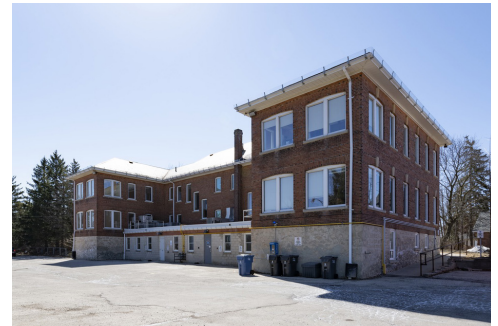
View of the south-east corner of the building showing the symmetrical end wings and hip roof line, and overall massing. The one-storey infill section with a flat roof was a later addition.

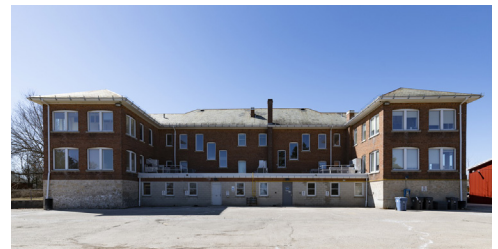
Brick chimneys which appear above the roofline in the 1916 photograph have since been removed or altered.

View of the south elevation of the building showing the symmetrical end wings and hip roof line. Remaining chimney portions are visible. The one-storey portion with a flat roof was a later addition.

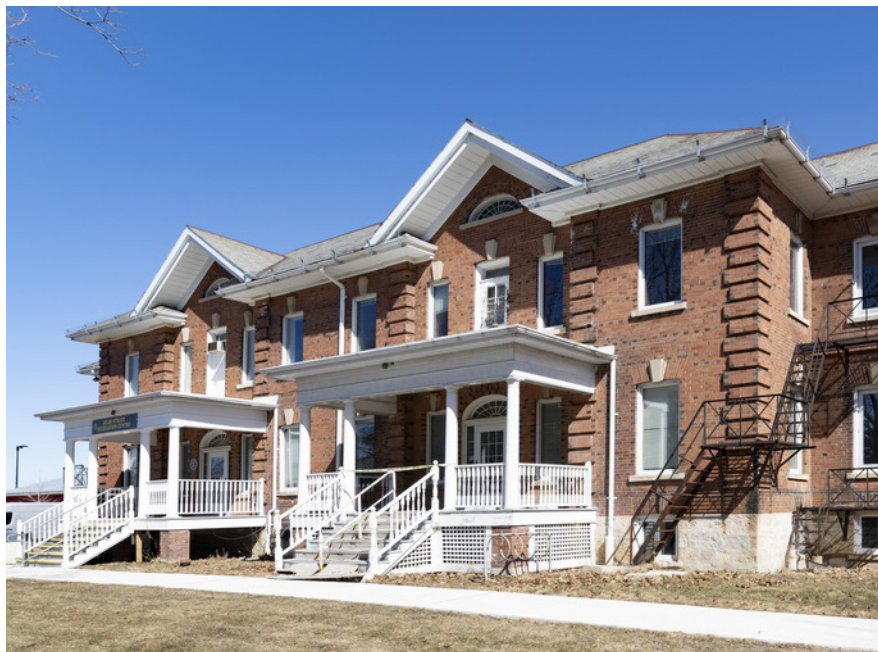
Brickwork appears to be in good condition with areas of efflorescence and mortar deterioration. The original mortar is limebased with a tooled incision which shows some deterioration but is still performing. Mortar deterioration is noticeable where water is present at:

- the base of the brick facades where a projecting band of brick below the lower windows is blackened due to exposure to the elements. The mortar is cracked or missing altogether.
- the area below cracked stone window sills where water follows the cracks, and
- areas of cement mortar repairs where joints are no longer permeable such as below stone stills, cracks and soldier coursing.
- Efflorescence is visible in the flat arch coursing and quoins below the main roof (on the upper right side of the entrance porch in the image below).

View of the original front (southeast) elevation showing the characteristic Edwardian Classicism details: quoining, oversized stone keystones and horizontal brick banding.

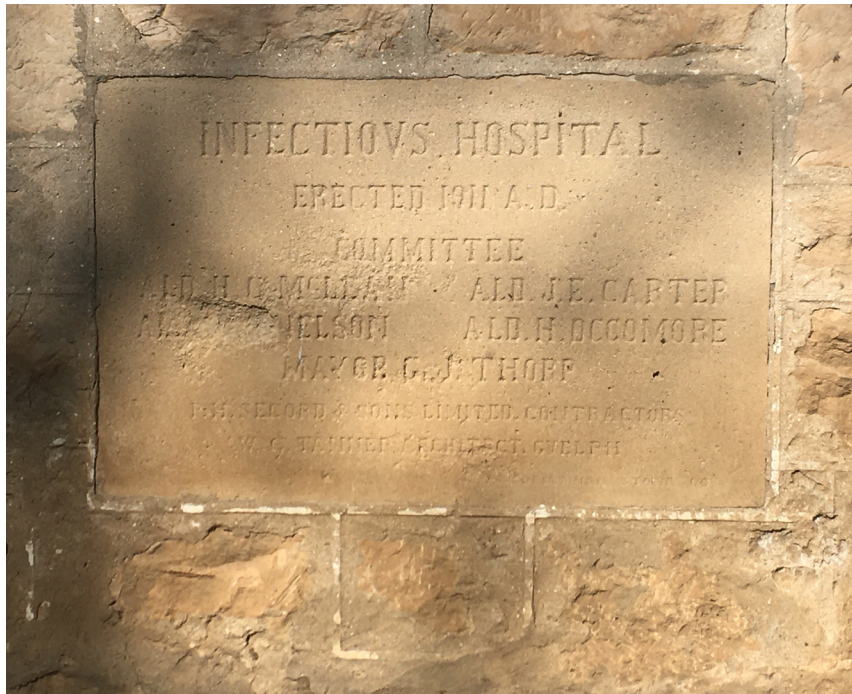
The datestone is set into the stone rubble foundation wall on the south facade. Early ribbon joints framed the datestone and some remain visible on the lower half while others have been patched. A small inscription on the lower right notes 'The Corinthian Stone Company', which began operation in 1907 in Guelph, producing artificial stone as well as natural stone products⁵. The window keystones and lug stone sills both contain linear etching which may indicate fabricated stonework.

Datestone located on the southwest (front) elevation. Faint inscription on lower right not clearly visible.

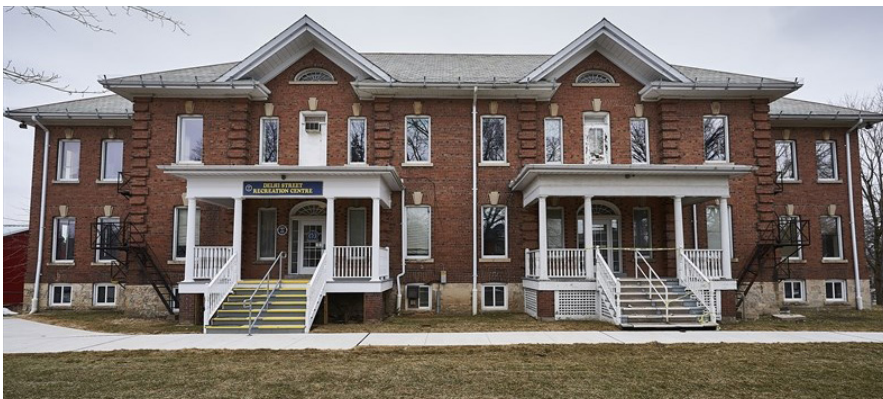
- removal of the balcony railing,
- removal of, or covered dentil work of the porch roof eaves,
- column replacement which are now narrower in profile,
- replacement of simple picket railing at the entrance level,
- addition of new handrail on entrance steps, as well as visible nosings for code compliance and improved visibility.

The only original porch element remaining appears to be the brick corner piers of the porch base, and possibly the substructure of the roof and floor deck.

Two views of the front facade c. 1916 top, and more recent photo below.

- Inspect and repair existing woodwork.
- Replace existing railing with design in keeping with historic details, such as a lower height profile with additional guard rail above to meet OBC requirements.
- Repair/provide wood screening around porch base to protect building materials from intrusion of environmental elements and animals.
- Maintain the characteristic white finish details, which have been similarly done on the adjacent Nurses' Residence.
- The maintenance strategy be included in the Maintenance Manual issued to the Owner at the end of construction.

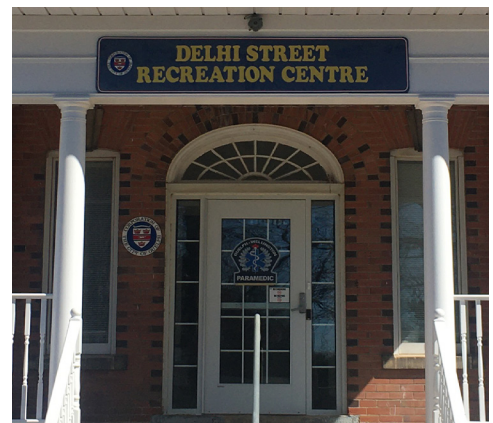
Front Entrance Doors: The symmetrical entrance doors paired on the south-west facade were originally of french style doors with a semi-elliptical arched transom window with fanned muntin bars under a triple rowlock brick head. The original wood arched window remains in both locations, but the doors and frames have been replaced with a single door and side light on each side.

Front view of the left (west) entrance on the front facade shows the updated door style, also featured at the other porch entrance. Original wood transom window above.

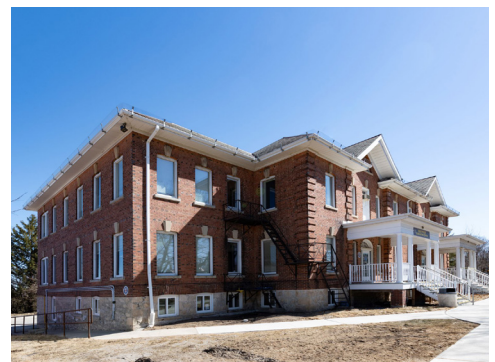
Foundation window openings found on all facades except the rear, are original openings and have been replaced with double-glazed metal sliding units.

View of the south-west corner of the building showing replacement vertical sliding windows at the foundations.

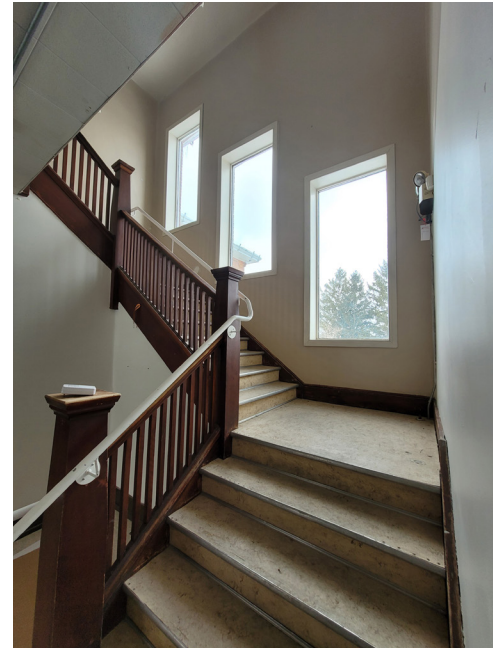
Whether composite sheet or linoleum, the flooring and nosings on the steps and landings are heavily worn and likely not original to the building. The wood baseboard and trim on each side of the stair is also well-worn. The stair is not in compliance with current building code but would likely be subject to Part II exemptions as it is no longer an exit stair in the proposed design. Staircase floor treatment should be replaced.

Top Image: View of the west staircase with stepped window openings.

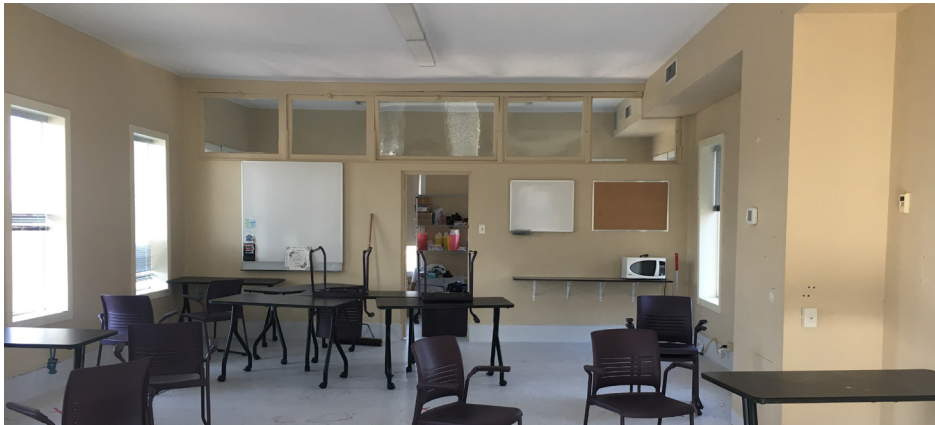
View of the infirmary space in the east wing top floor, with plaster walls and ceiling. Mechanical systems have been added and covered with gypsum board on the right vertical shaft and bulkhead vents at the ceiling.

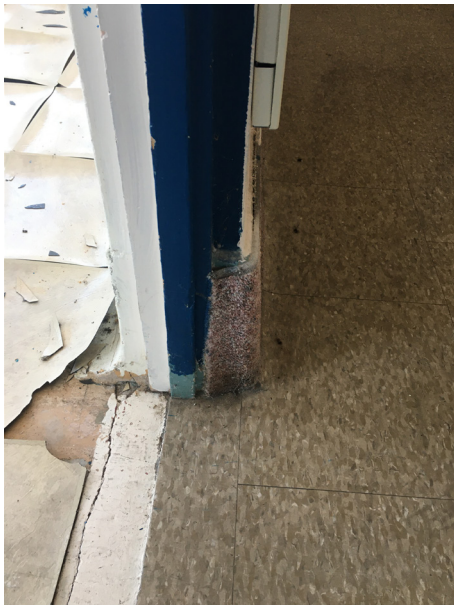
The interior main and second level floors contain plaster walls and some plaster ceilings. Wall corners are rounded with generally minor damage. Baseboards covered with plaster can be found throughout these two levels. Finishes have changed over the years including covering the cove baseboards with carpet or sheet flooring. Conduit has been surface-mounted to provide electrical needed for emergency exit signage and additional lighting.

View of plaster cove baseboards with painted finish (left) and carpet application (right).

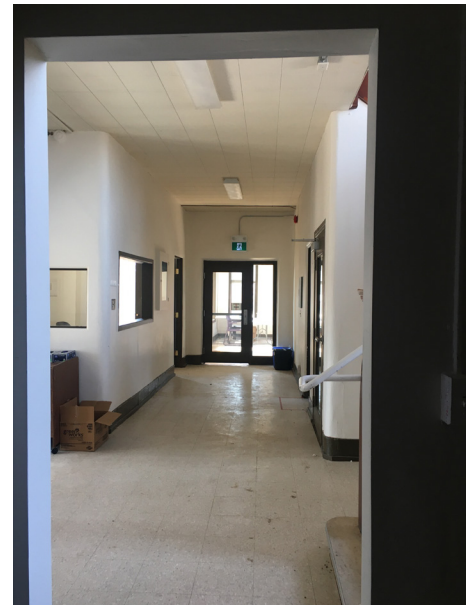
Image showing plaster walls and rounded corners. A tiled ceiling was a later addition, dropped below the plaster ceiling.

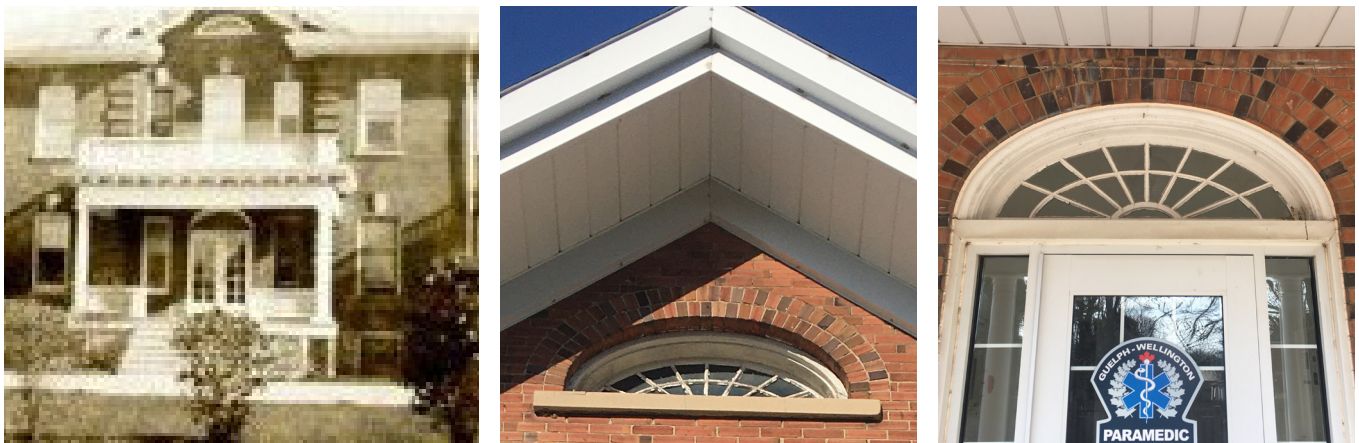
Images showing remaining original wood windows as seen in the c. 1941 photo left, and current views today: the semi-elliptical gable window and the arched window transom above the door. Both will be maintained as part of the annual maintenance program.

- Clean and scrape woodwork. Prime and repaint woodwork with linseed oil-based paint on the exterior.
- Remove cracked and peeling caulking at glass panes. Clean and scrape woodwork. Apply new caulking to maintain seals.
- The maintenance strategy be included in the Maintenance Manual issued to the Owner at the end of construction.
