Attachment-1 Property location and photos taken by Heritage Planning staff

2023 July 27 – Photos taken by S. Robinson of Heritage Planning during site visit with Property Standards staff.

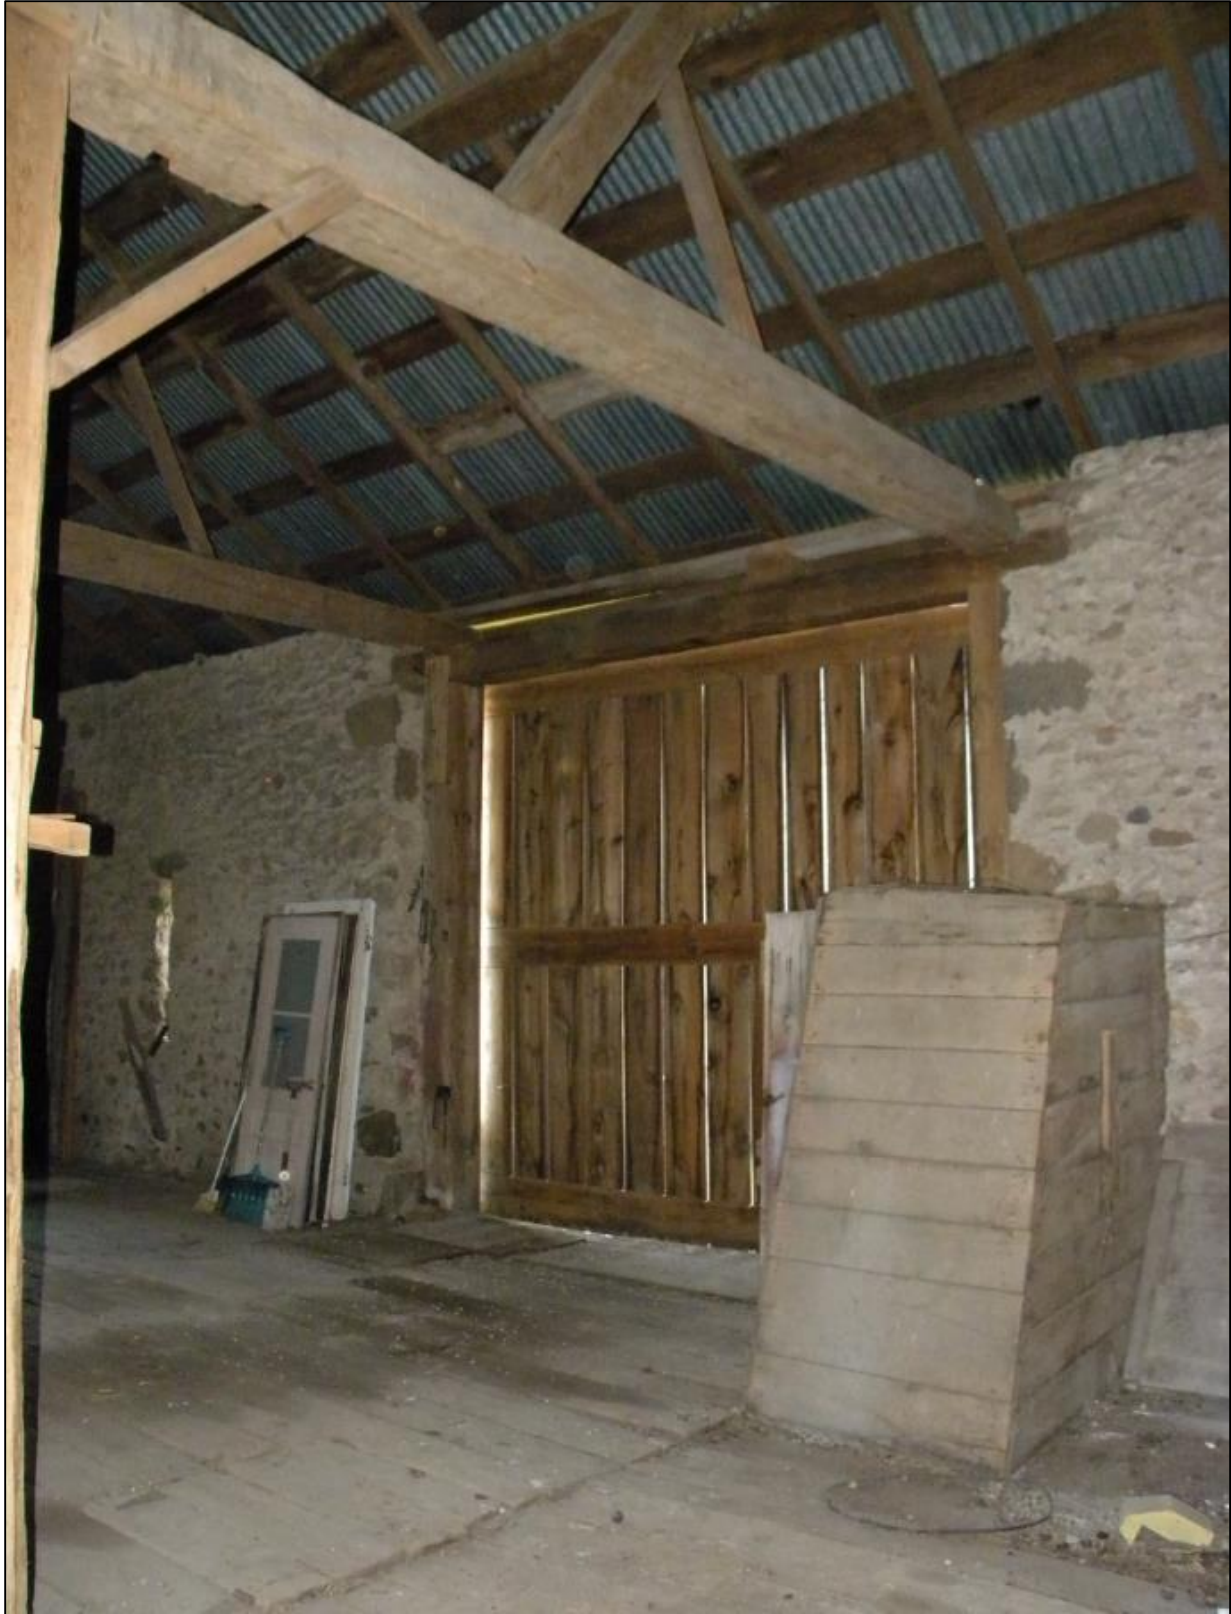
Figure 63: Photo of the stone barn interior facing the main door. Taken August 15, 2011, by S. Robinson.

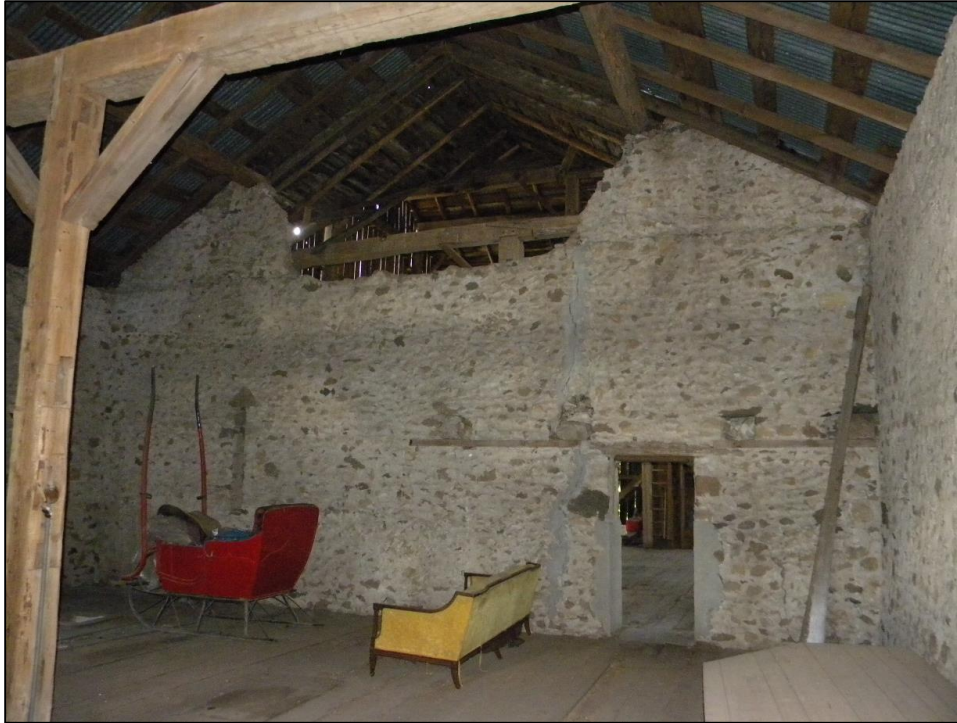
Figure 65: Photo of the stone barn interior facing internal doorway. Taken August 15, 2011, by S. Robinson.

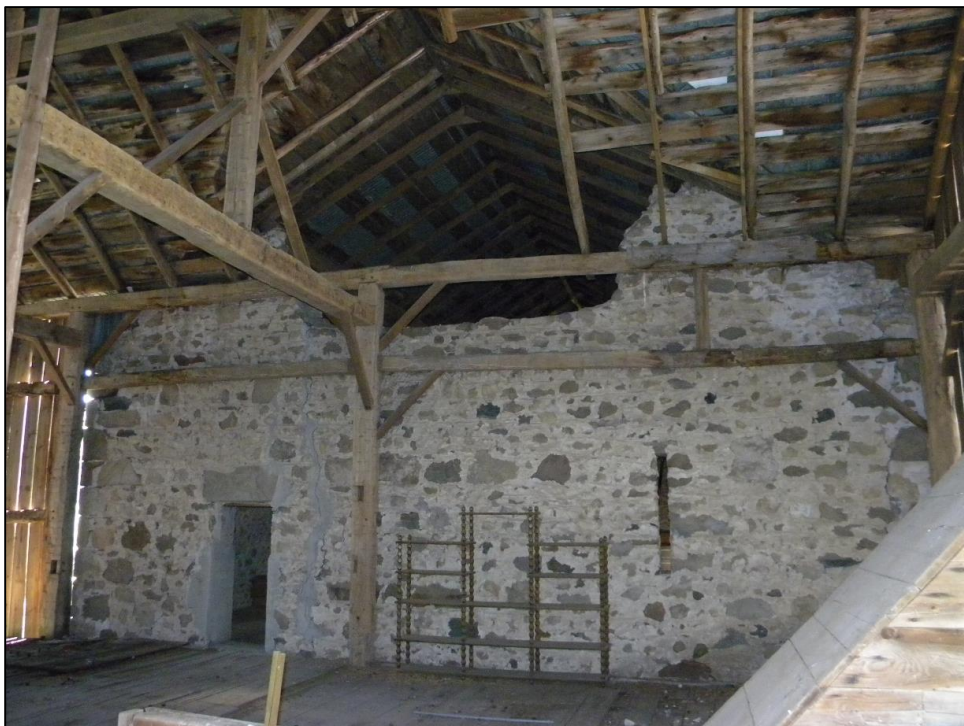
Figure 66: Photo of the wooden barn addition the interior door. Taken August 15, 2011, by S. Robinson.

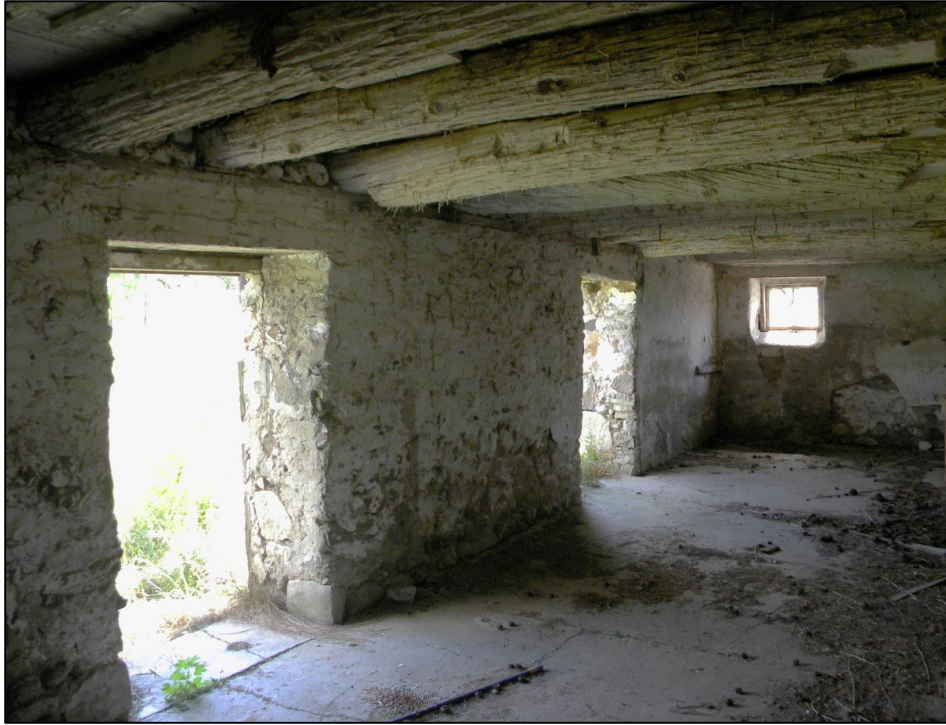
Figure 67: Photo of the stone basement interior facing out exterior doors. Taken August 15, 2011, by S. Robinson.

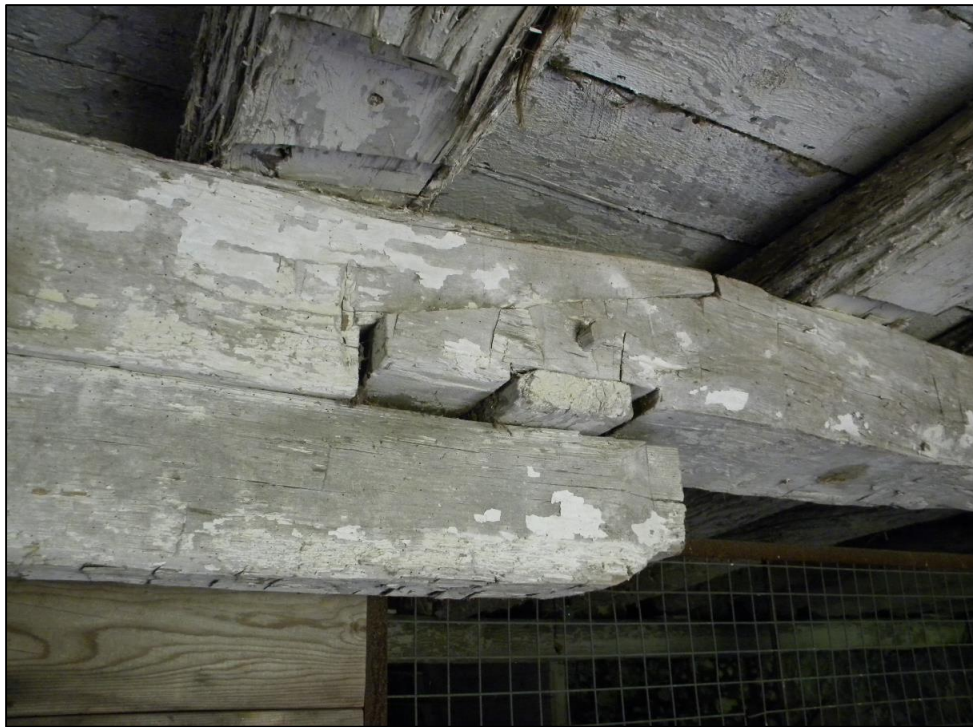
Figure 68: Photo of scarf joint in stone barn basement framing. Taken August 15, 2011, by S. Robinson.

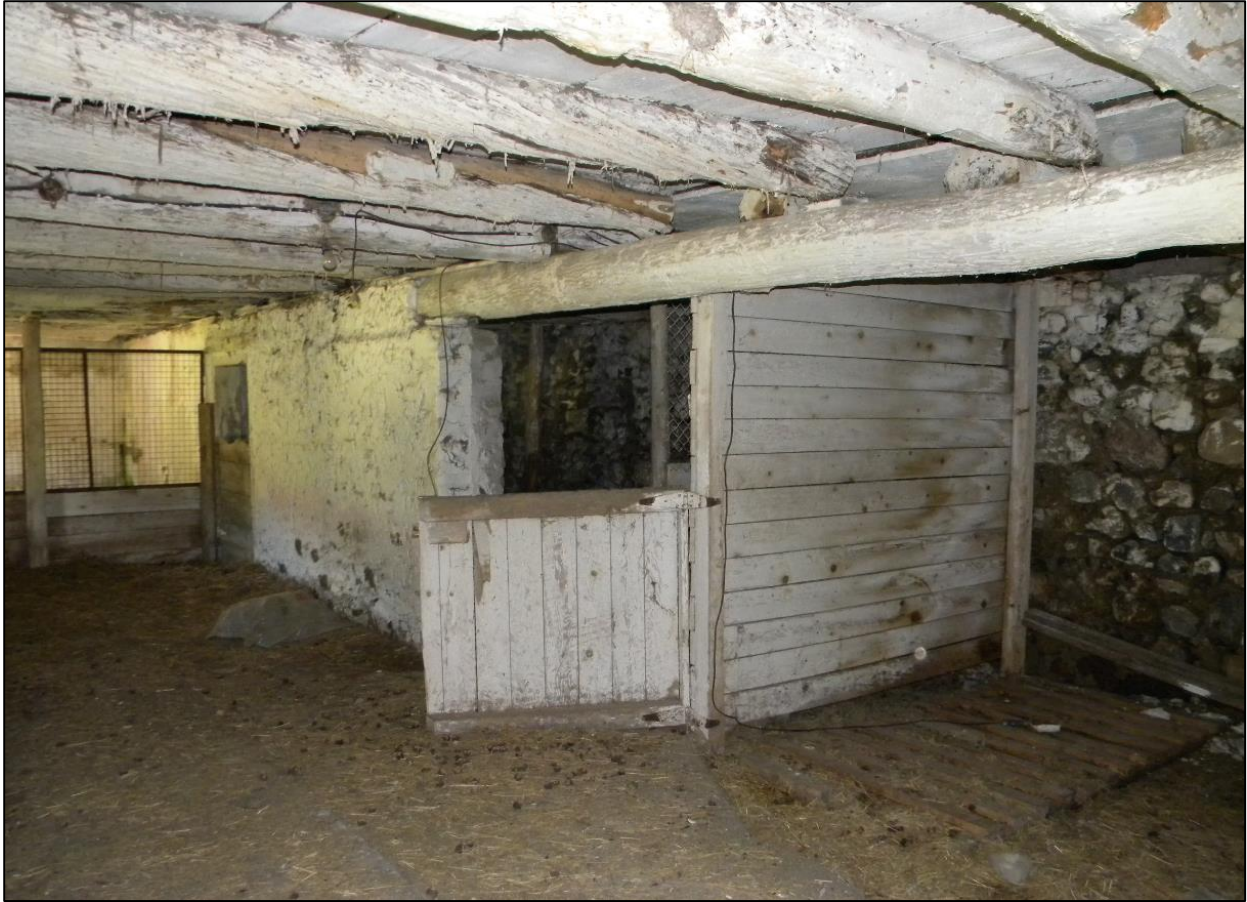
Figure 69: Photo of the stone barn root cellar entrance. Taken August 15, 2011, by S. Robinson.

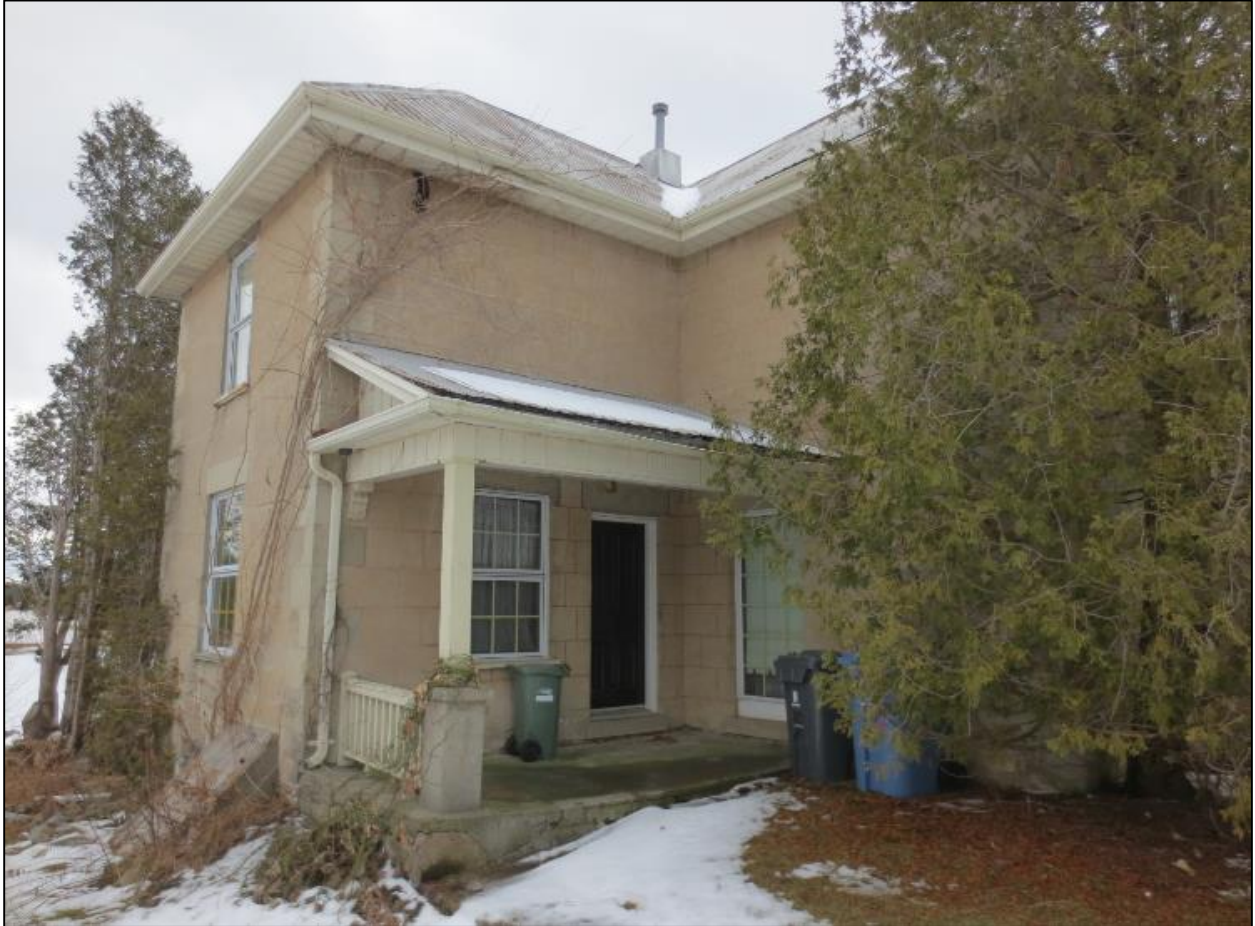
Figure 73: Image of front exterior of the poured-concrete farmhouse. Taken January 24, 2019, by S. Robinson.

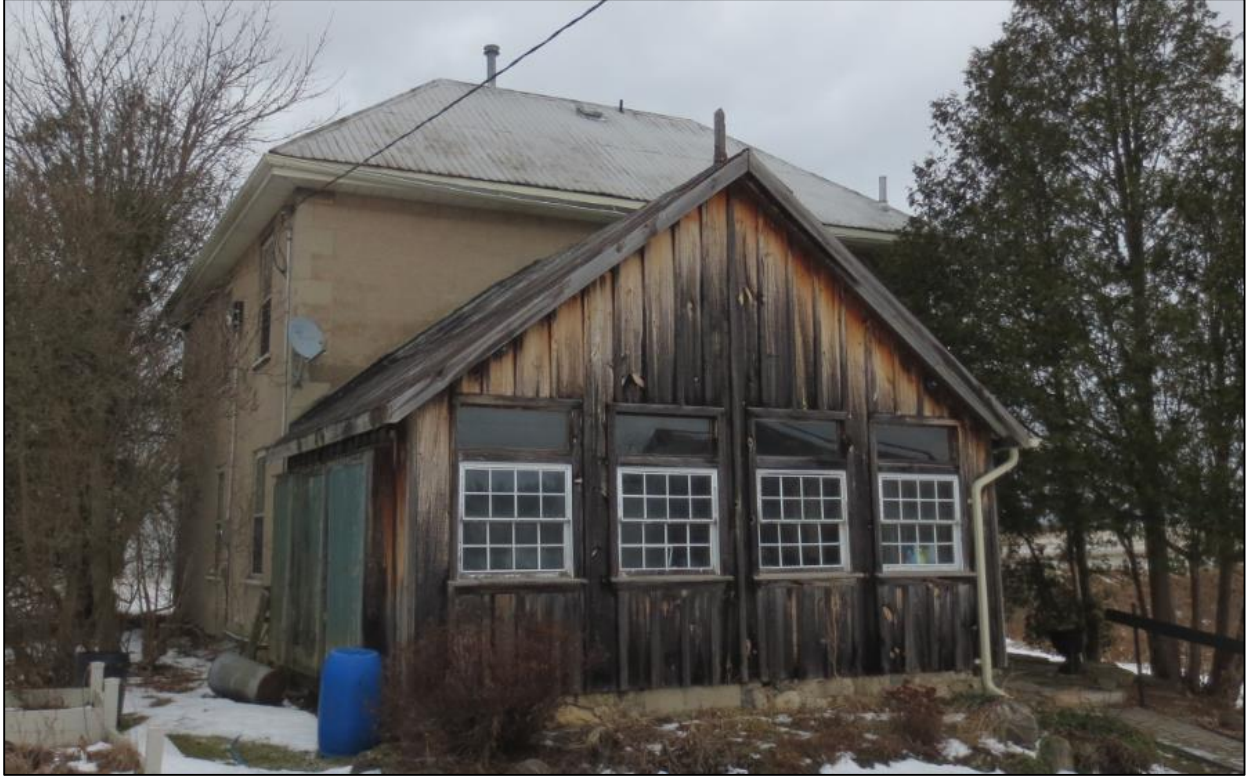
Figure 74: Image of rear exterior extension of the poured-concrete farmhouse. Taken January 24, 2019, by S. Robinson.

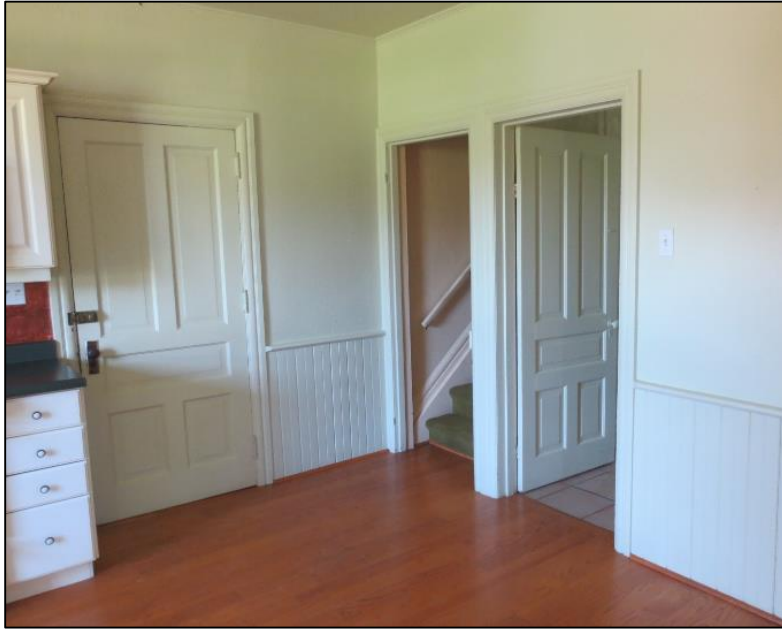
Figure 75: Photo of interior of poured-concrete farmhouse. Taken June 17, 2019, by S. Robinson.

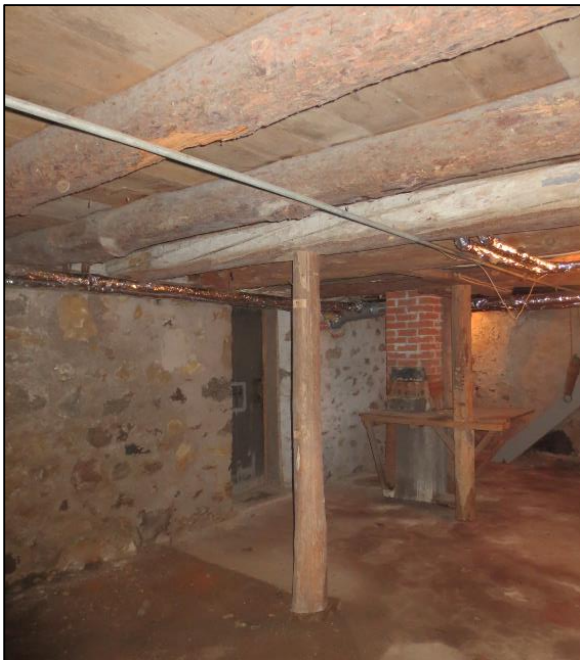
Figure 76: Photo of interior of poured-concrete farmhouse. Taken June 17, 2019, by S. Robinson.

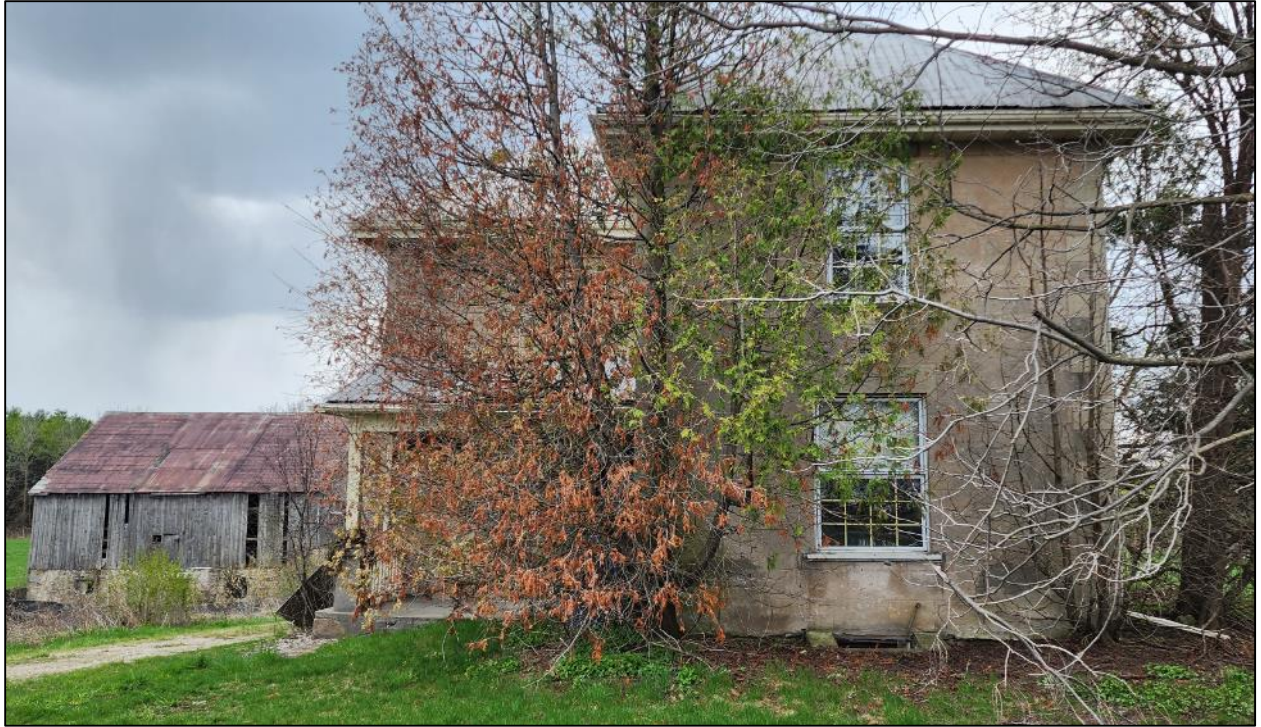
Figure 77: Photo of exterior of the front of the farmhouse. Taken April 25, 2023, by S. Robinson.

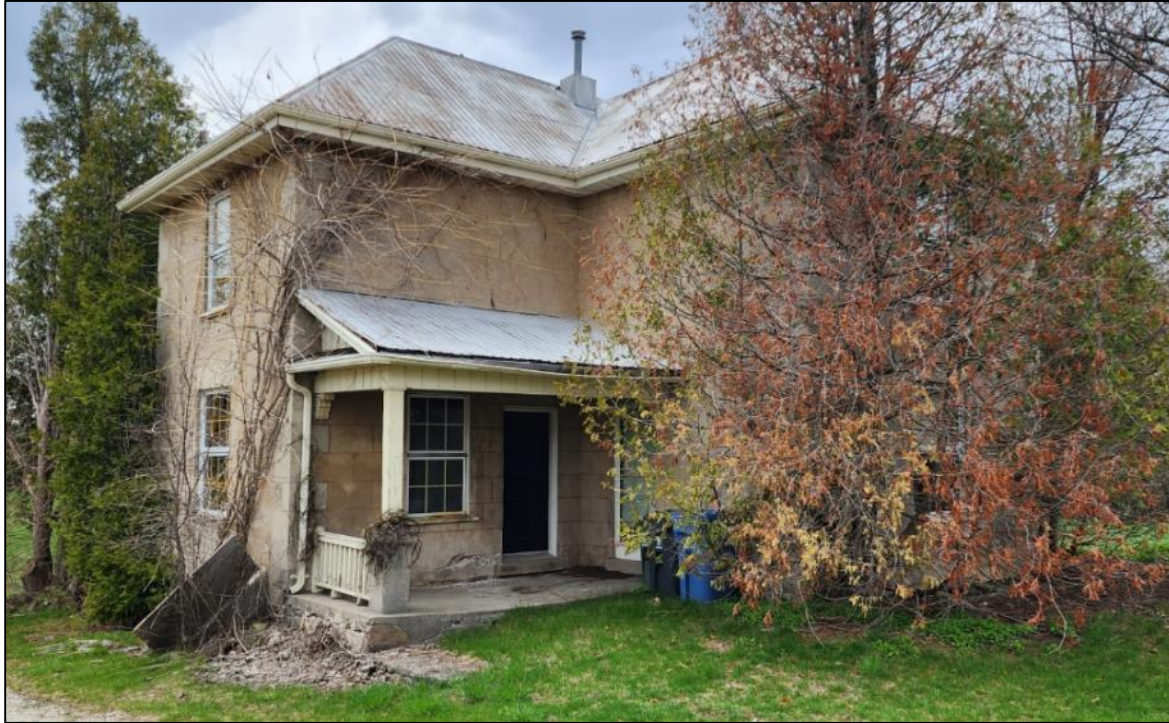
Figure 78: Photo of exterior of the front of the farmhouse. Taken April 25, 2023, by S. Robinson

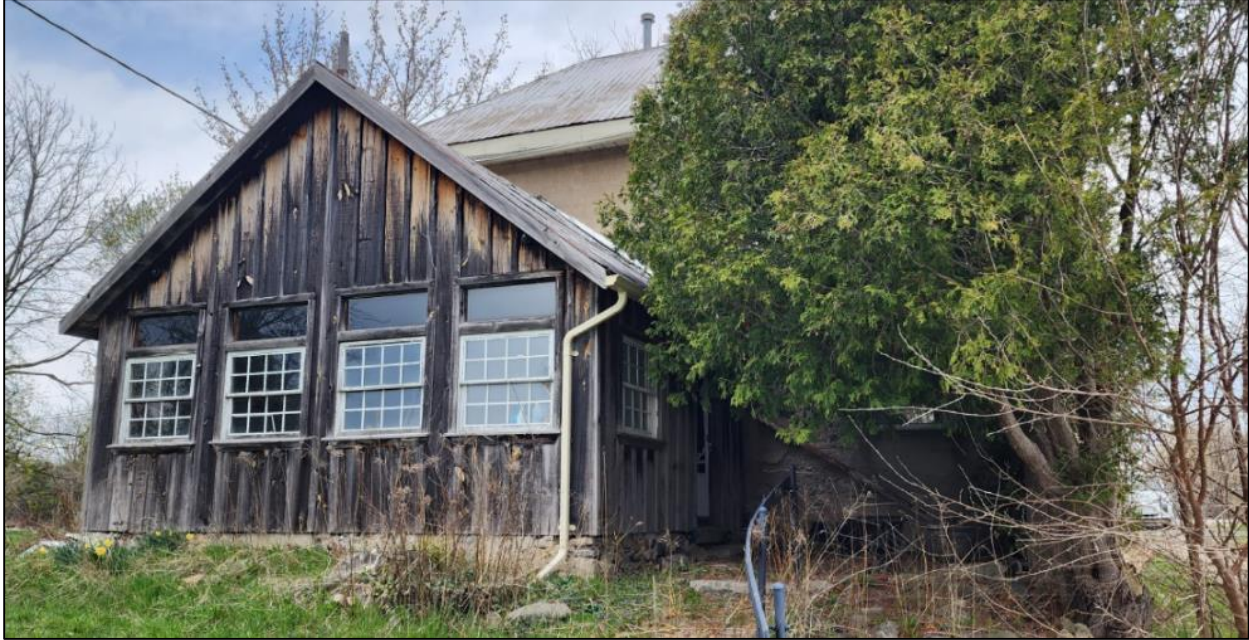
Figure 79: Photo of exterior of the rear extension of the farmhouse. Taken April 25, 2023, by S. Robinson.

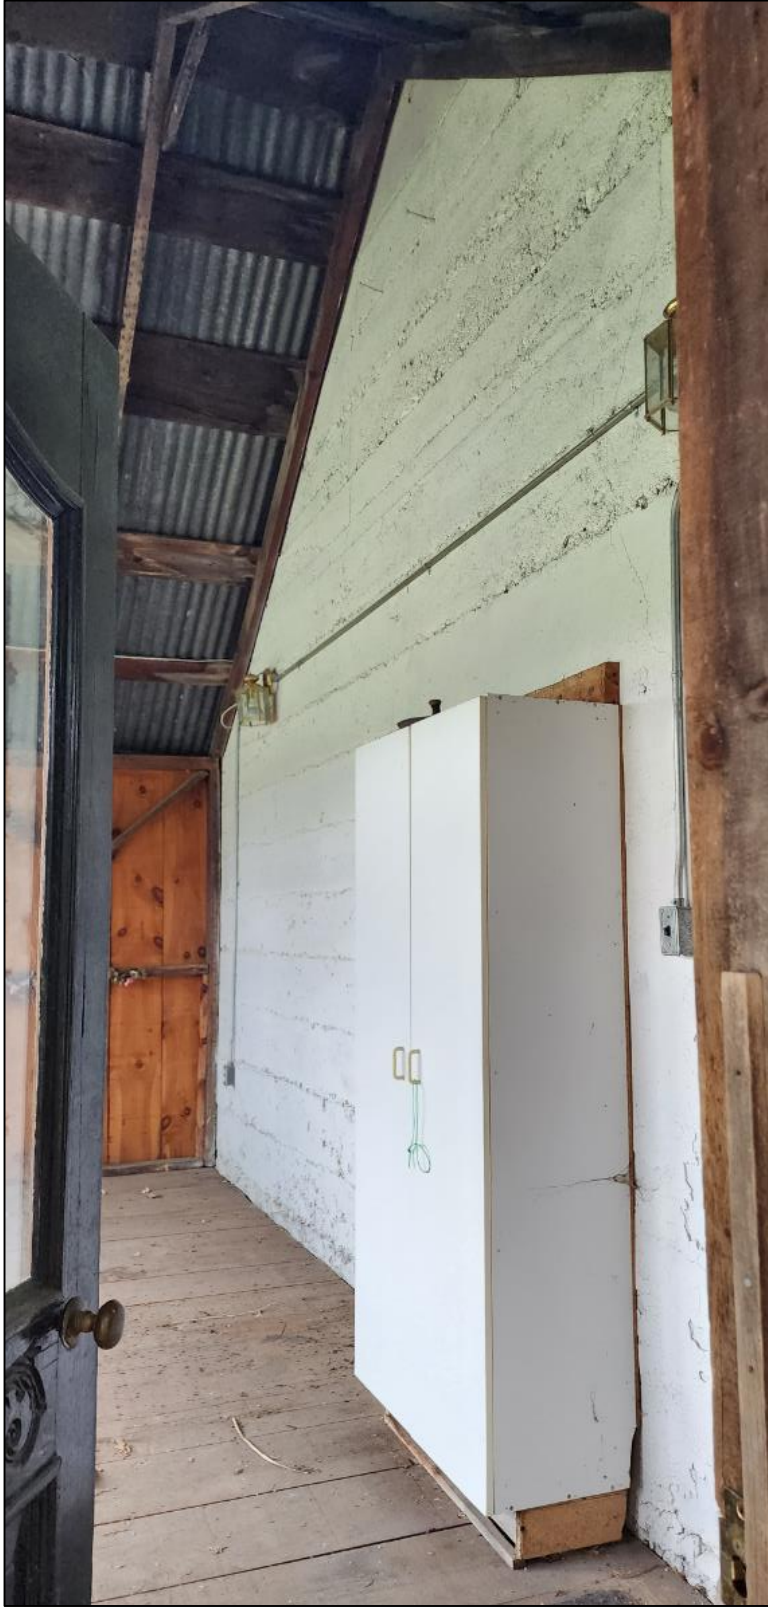
Figure 81: Photo of interior of wooden extension on rear of farmhouse. Taken April 25, 2023, by S. Robinson.

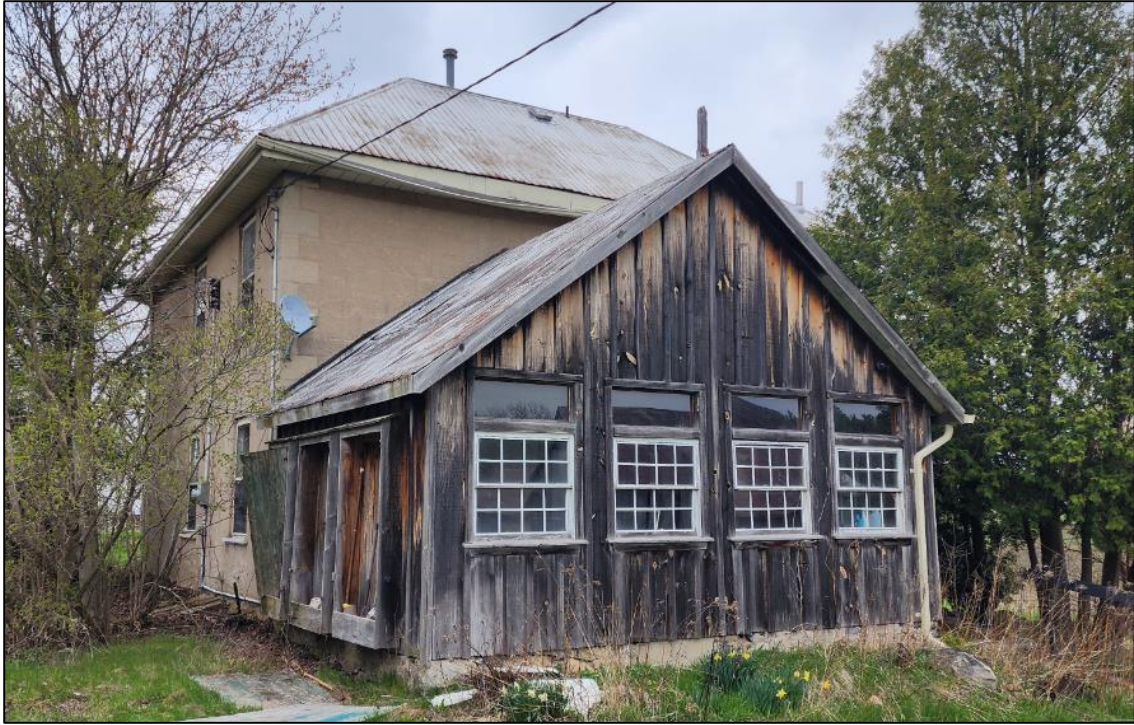
Figure 82: Photo of exterior of the farmhouse and extension. Taken April 25, 2023, by S. Robinson.

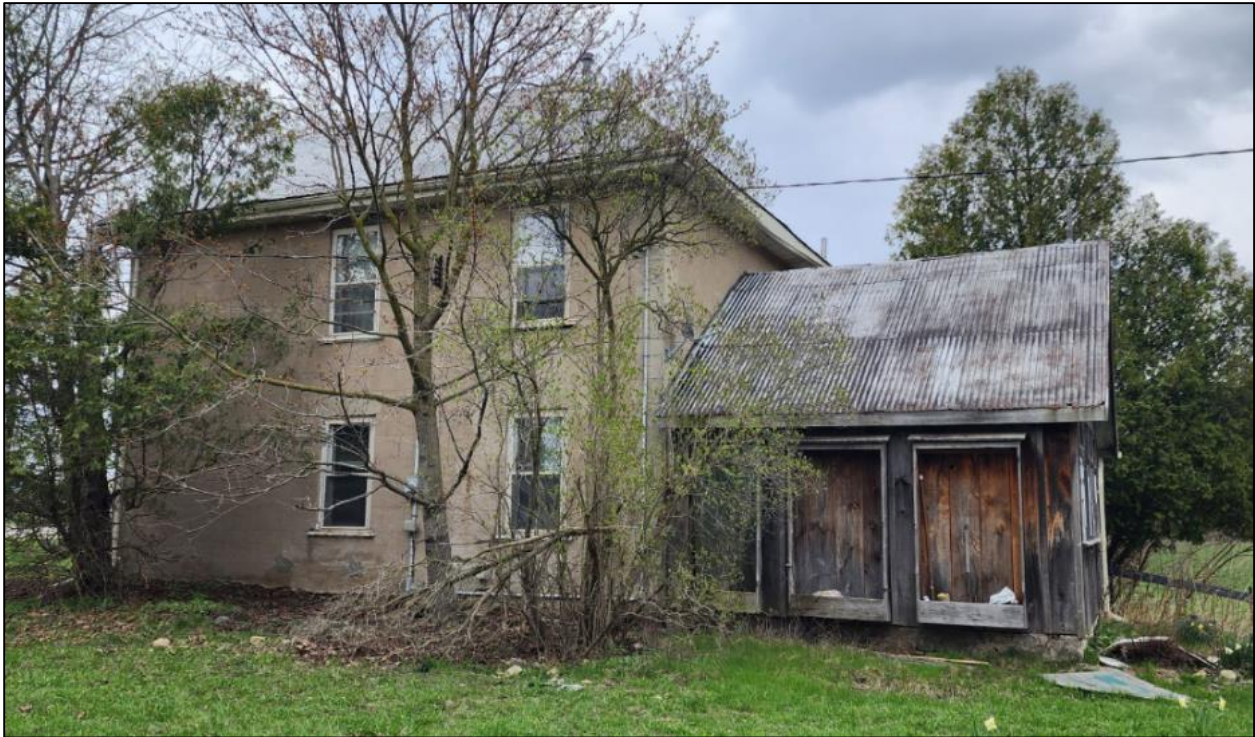
Figure 83: Photo of exterior of the farmhouse and extension. Taken April 25, 2023, by S. Robinson.
