**2187 Gordon Street, City of
Guelph, Ontario, Cultural
Heritage Resource Impact
Assessment**

Final Report

March 13, 2024

Project Number: 161423769

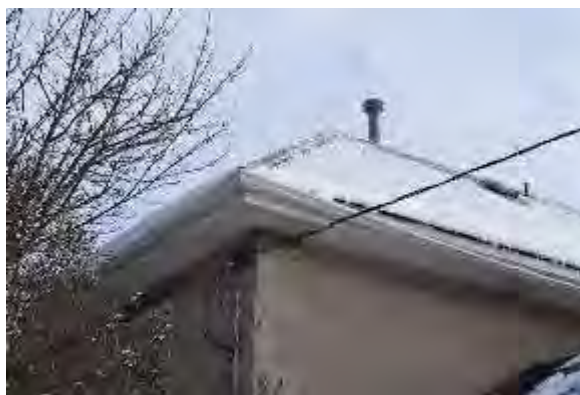
Plate 25: Metal chimney and wide eaves from northwest corner

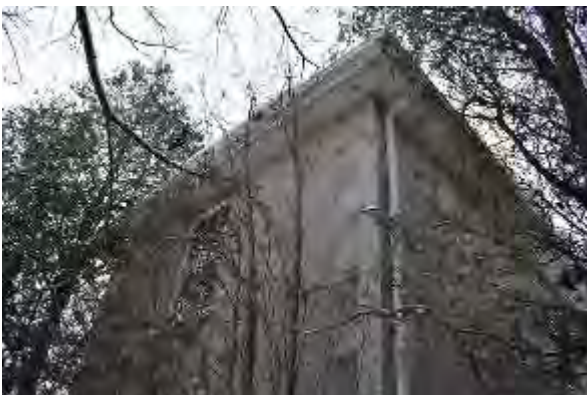
Plate 26: Wide eaves on southeast corner

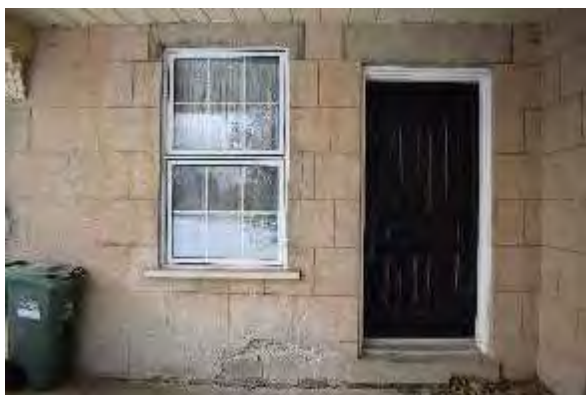
Plate 28: Front door and with concrete lintels and sills

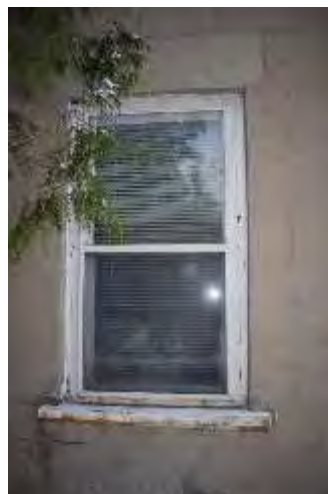
Plate 29: Wood 1/1 single-hung window on north elevation

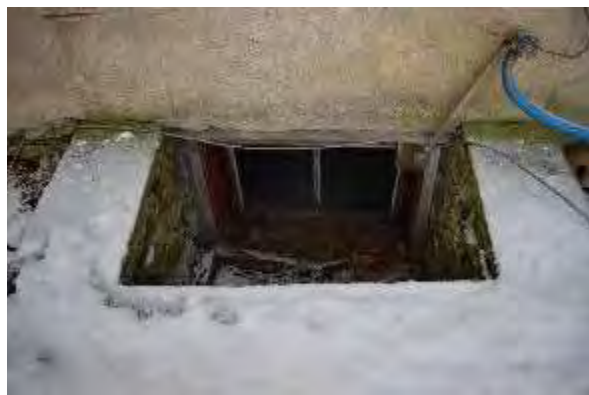
Plate 30: Stone window well on east elevation

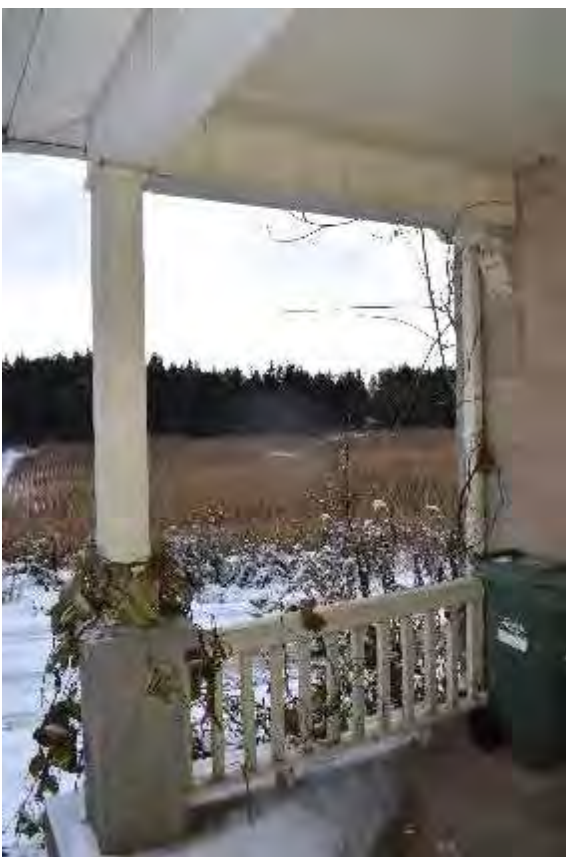
Plate 32: Front porch pier, column and railing looking southwest

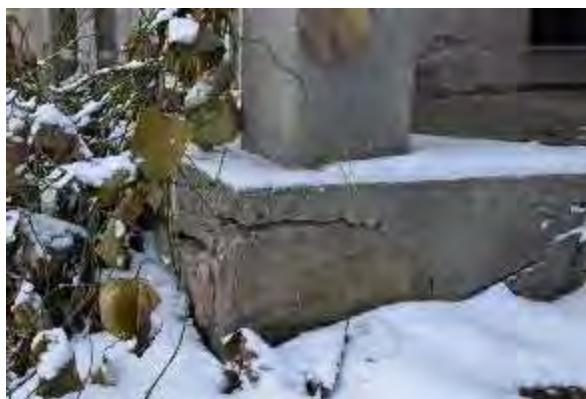
The front (east) elevation has a two symmetrically placed windows (Plate 24). It also has a set-back covered partial porch with a metal clad roof, wood column on a concrete base, and a wood railing (Plate 31 and Plate 32). The base of the porch is stone that has been parged with concrete (Plate 33). The porch also has two decorative wood brackets (Plate 34). The front entrance has a modern steel door (Plate 28). The north elevation has symmetrically placed windows and the utility hook-ups (Plate 35). The west elevation includes a single storey wood board and batten addition (Plate 36 and Plate 37). The addition has a medium-pitched gable roof that is clad with metal. Its exterior has wood multi-pane single-hung windows, each with a wood transom. The south elevation of the addition has a wood paneled half glass entrance door. The addition has a stone foundation (Plate 38). The south elevation has symmetrically placed windows, and a hatchway to the basement (Plate 39 and Plate 40).

Plate 33: Stone porch base

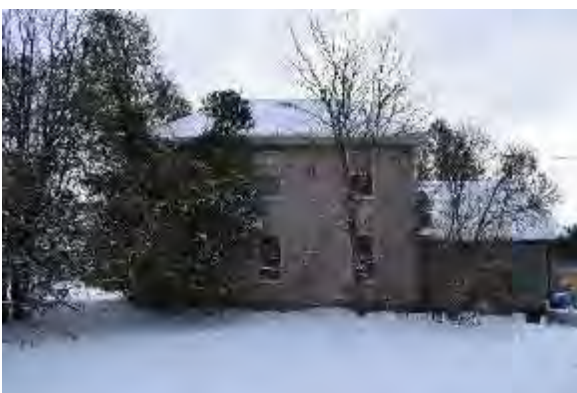
Plate 35: North elevation looking south

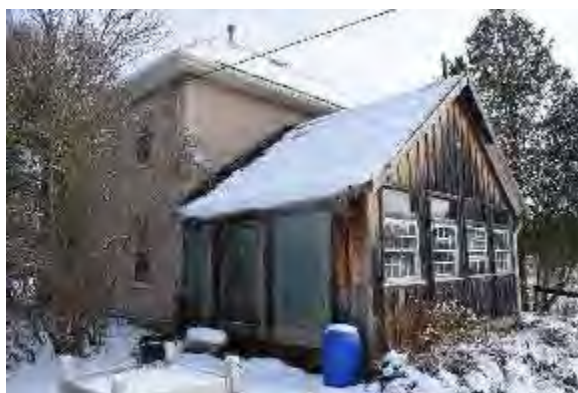
Plate 36: Northwest elevation looking southeast

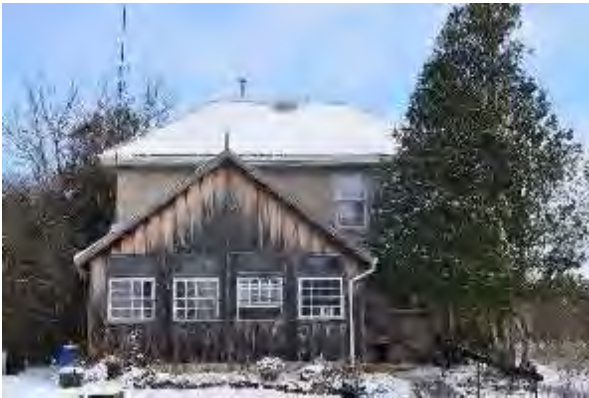
Plate 37: West elevation looking east

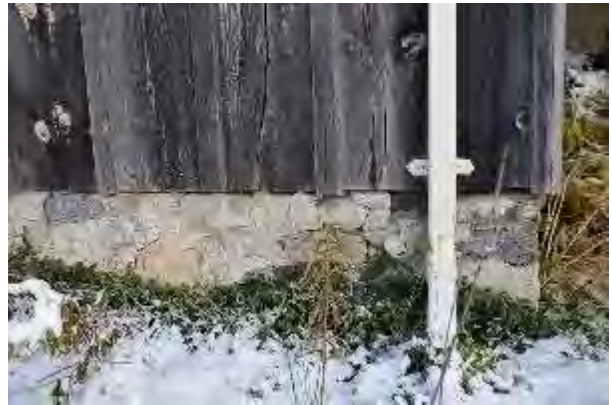
Plate 38: Close-up of addition foundation

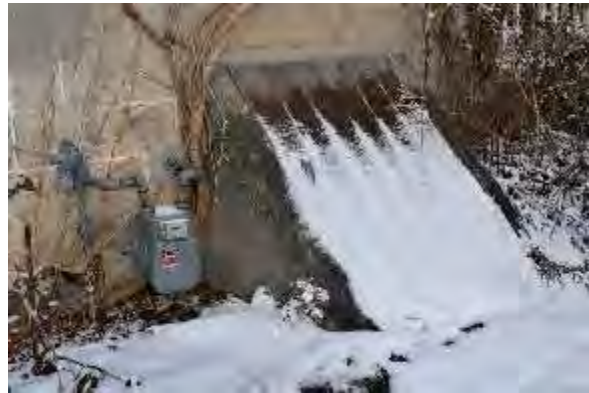
Plate 40: Exterior basement hatch

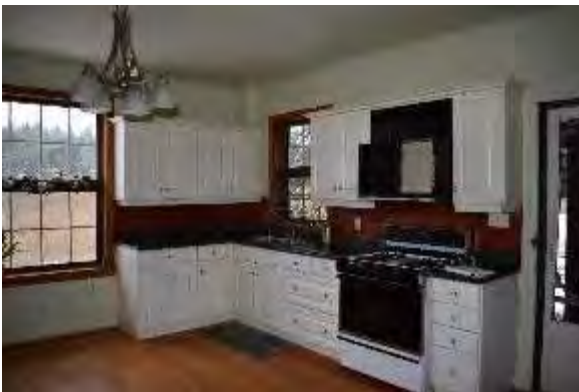
Plate 43: Kitchen looking southwest

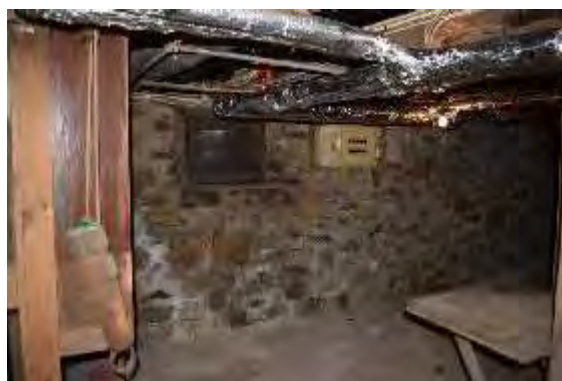
Plate 52: Basement looking northeast

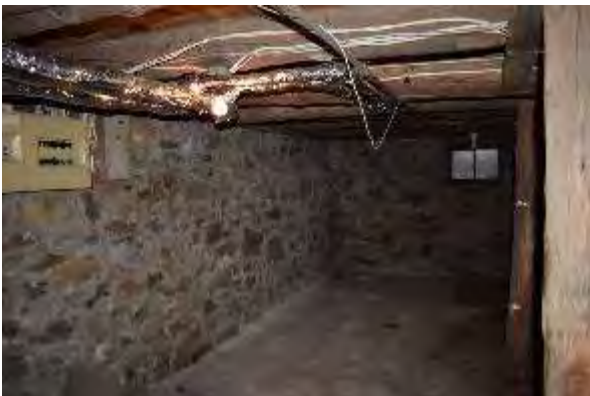
Plate 53: Basement looking east

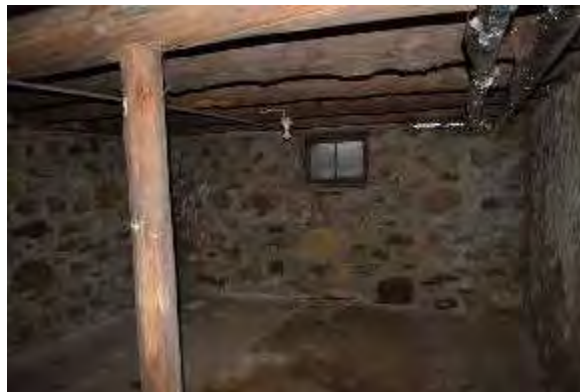
Plate 54: Basement looking east

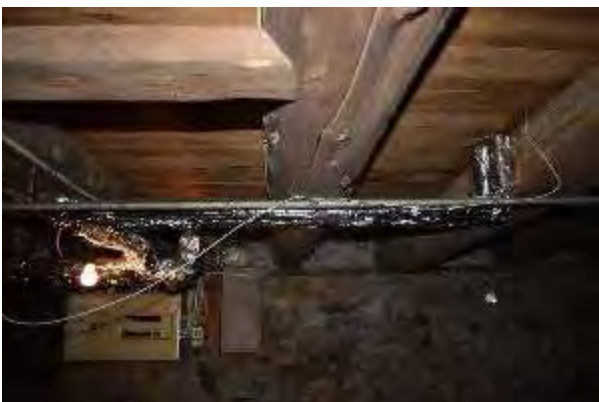
Plate 55: Wood beams looking north

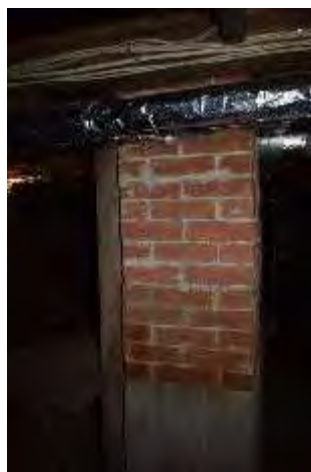
Plate 56: Interior brick chimney

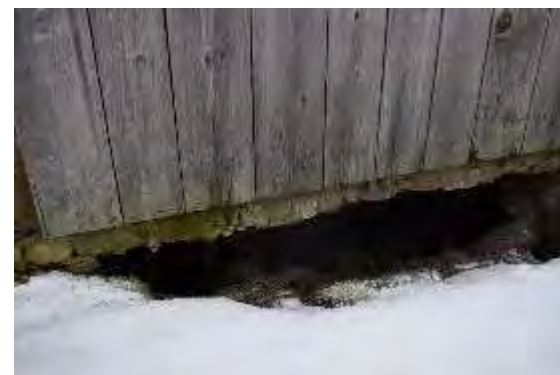
(Plate 76). The north elevation has two narrow vertical slit windows (Plate 77). The slit windows which widen inwardly towards the interior where designed to ventilate the building. The lower north elevation also has a small wood hinged door (Plate 78). The stone foundation wall underneath the doorway on the stone tail has collapsed (Plate 79 and Plate 80).

Plate 79: Collapsed foundation wall on north elevation

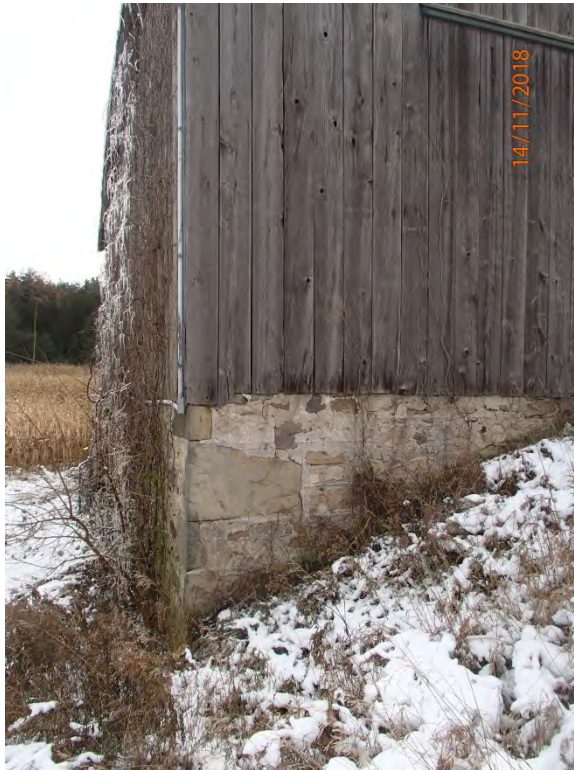
Photograph No. 20 – Northeast corner, fair condition

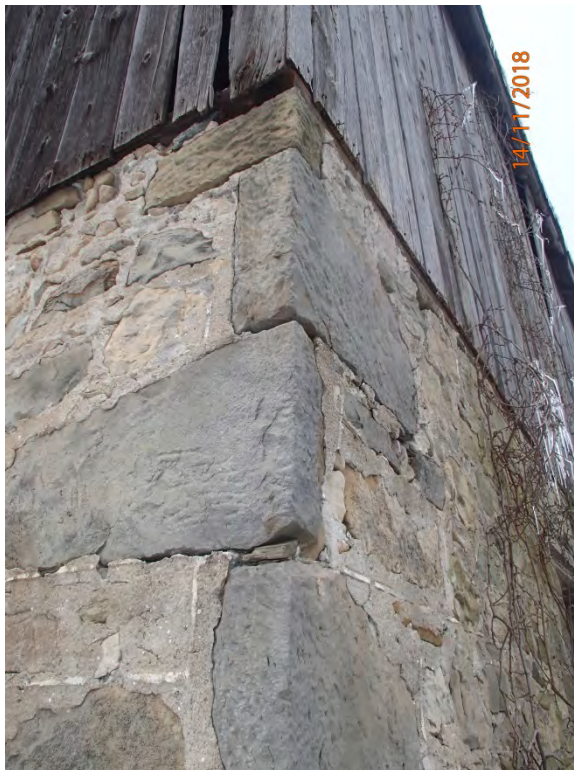
Photograph No. 21 – Southeast corner, fair condition

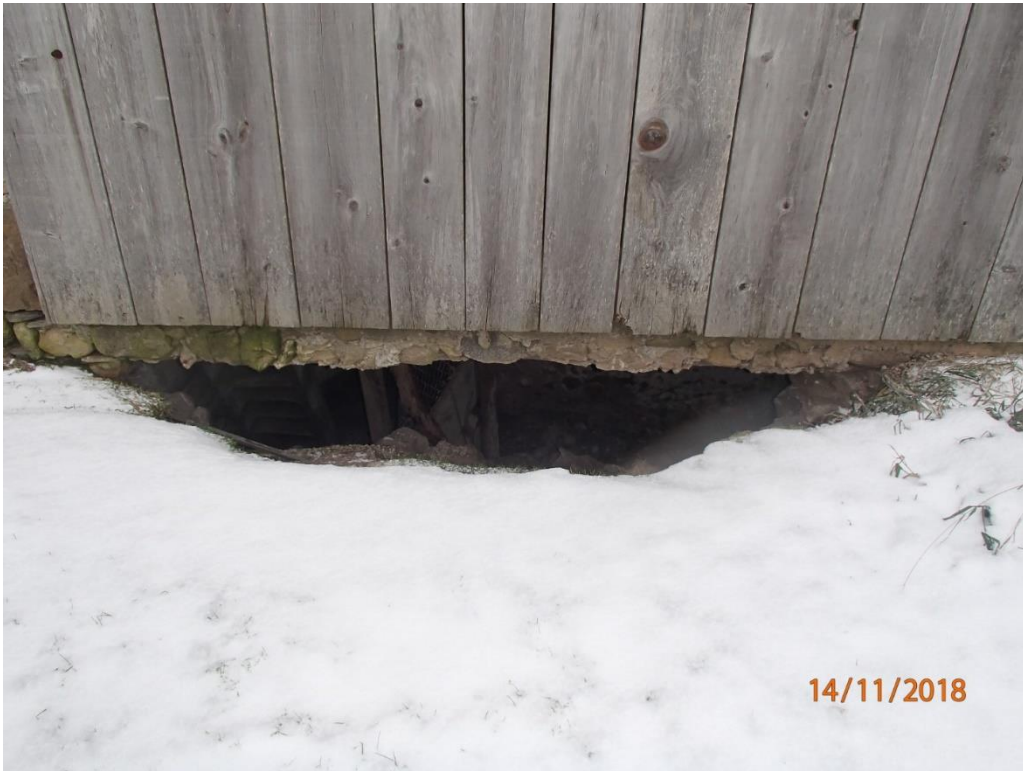
The condition of the stone foundation wall below the barn entrance door has worsened in that more of the adjacent wall at the door limits have fallen into the lower level (see Photographs 1, 2). The remnant of the top of the stone foundation wall that was suspended by the floor in 2018 has since collapsed (Photographs 3, 4). The floor framing has further sagged down and is unsafe to walk upon (Photograph 6). The damaged section of the foundation wall will need to be reconstructed if the barn is to be saved.

Photograph No. 1 – Foundation wall condition in 2018

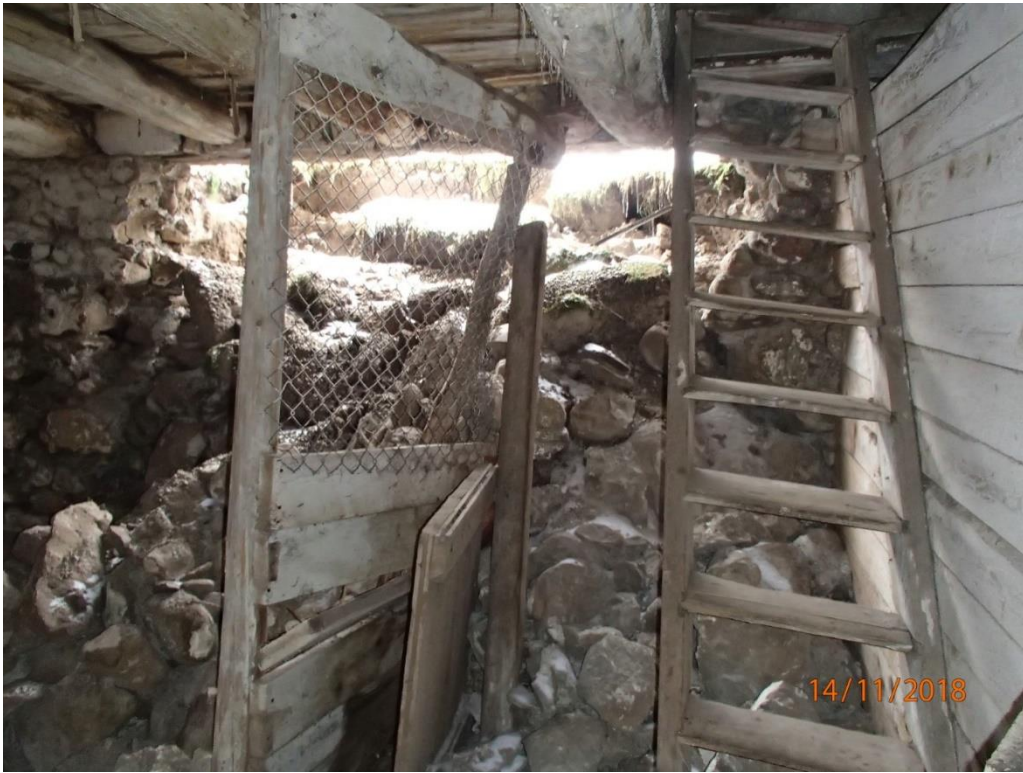
Photograph No. 3 – North wall (lower level) condition in 2018

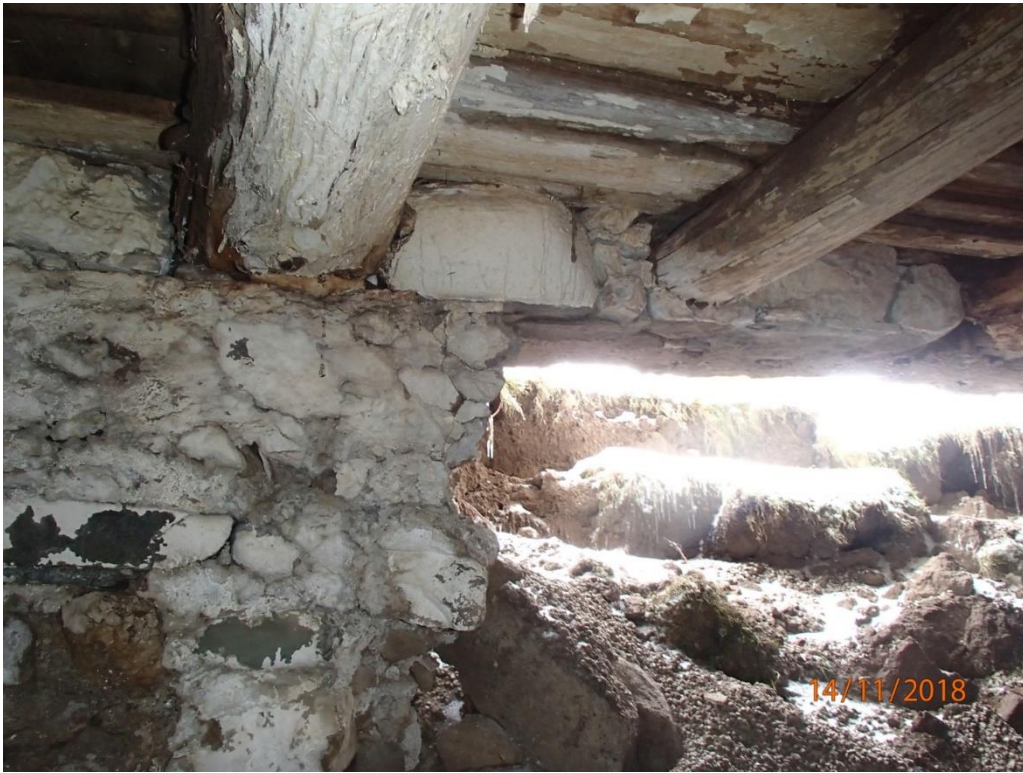
Photograph No. 5 – North wall (lower level – Left bearing) condition in 2018

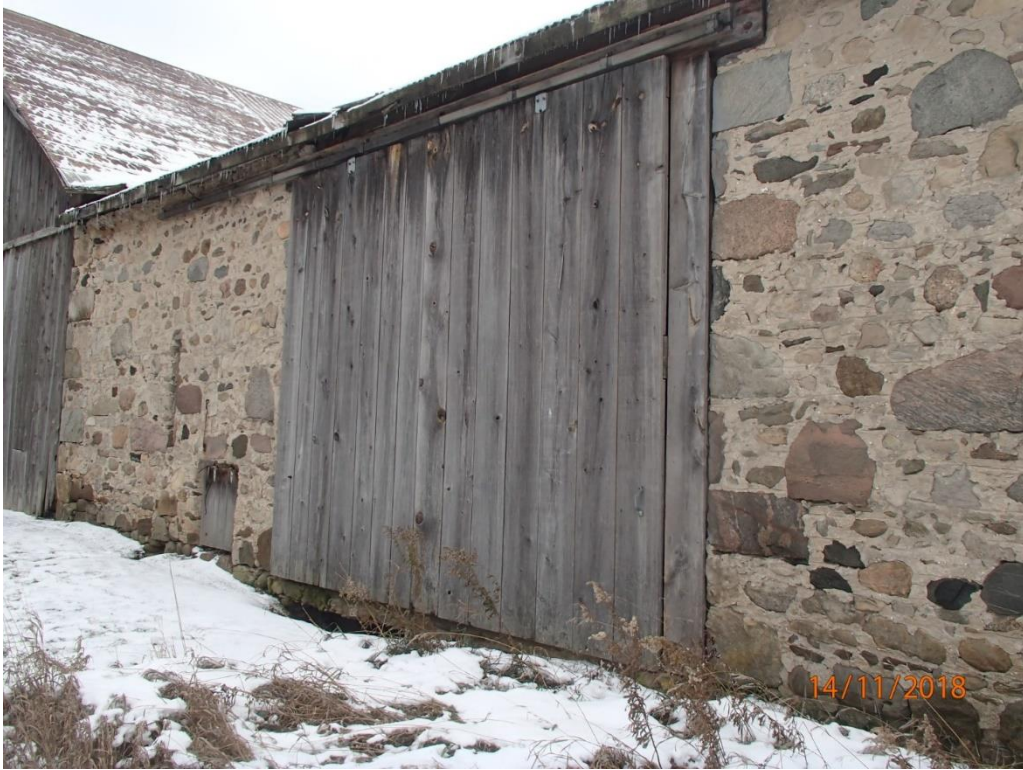
The upper stone wall at grade supporting the roof, east of the barn door and foundation wall failure site, has a significant diagonal crack and the wall is bowing inward (Photographs 7 to 10).

Photograph No. 7 – North Stone Wall (upper) condition in 2018

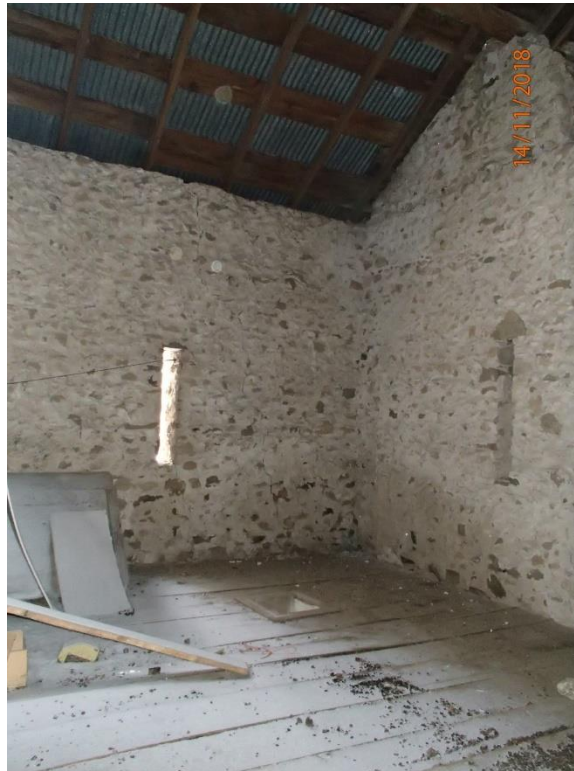
Photograph No. 9 – North wall (main floor) condition in 2018

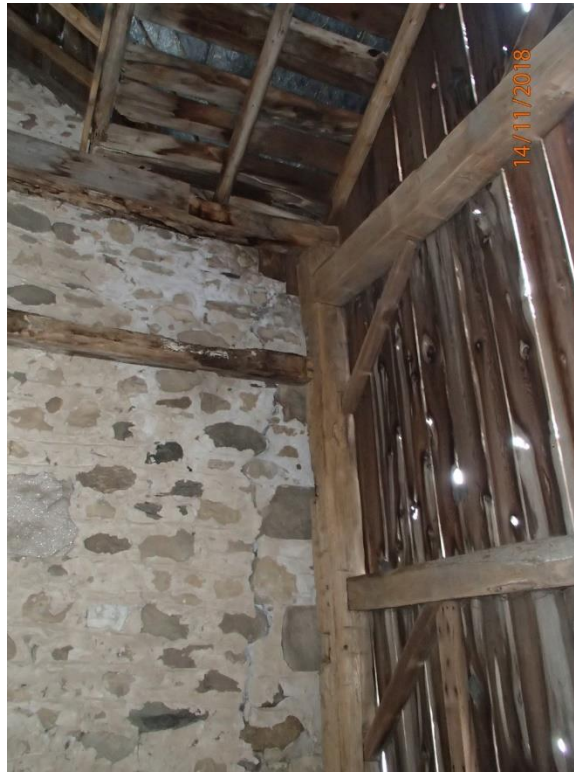
Photograph No. 11 – Crack interior, condition in 2018

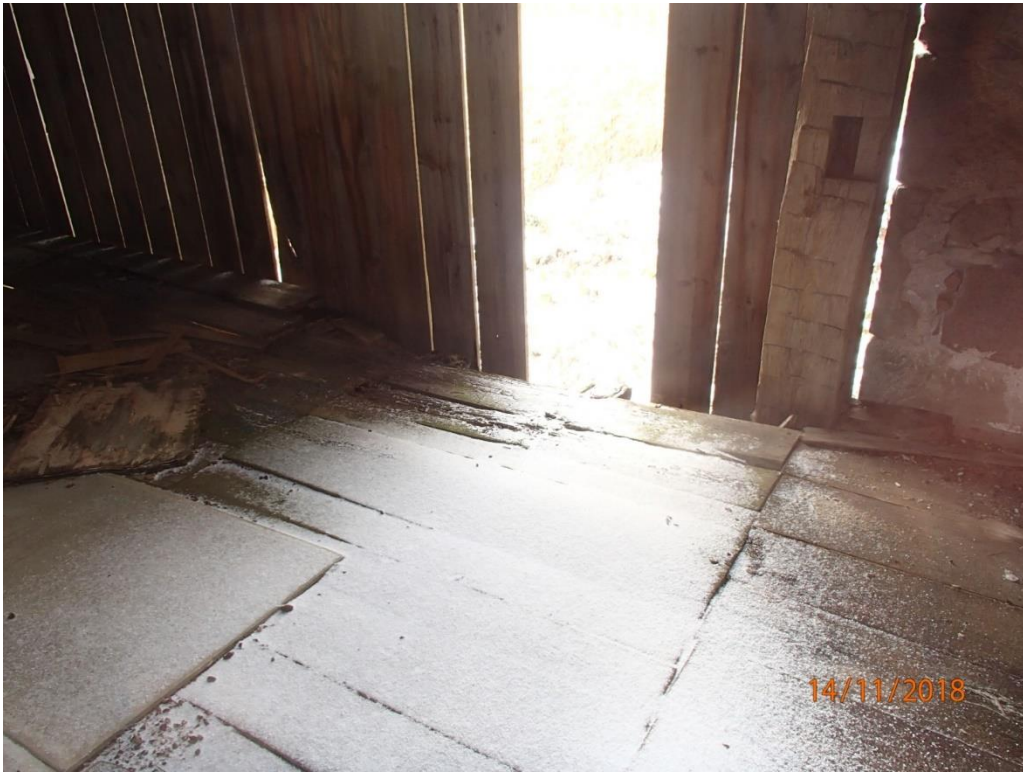
Several more exterior barn boards have fallen off. Again, these areas present a risk of people falling out (~8' drop) to grade below (Photographs 13, 14).

Photograph No. 13 – Condition of wall and floor in 2018

We recommend that, at a minimum, all doors and other openings for potential access be boarded up to prevent anyone accessing the building until the future of the barn is decided. A new wood framed hoarding wall should be erected below the overhanging floor shown in Photograph 13. This is needed to prevent anyone from accessing the space below this damaged floor area. The other deficiencies noted in the report should be addressed if the barn is to be maintained.
