Cultural Heritage Conservation & **Relocation** Plan

331 Clair Road East,
Guelph ON

Date:
May 2024

Prepared by:
**MacNaughton Hermsen Britton
Clarkson Planning Limited
(MHBC)**

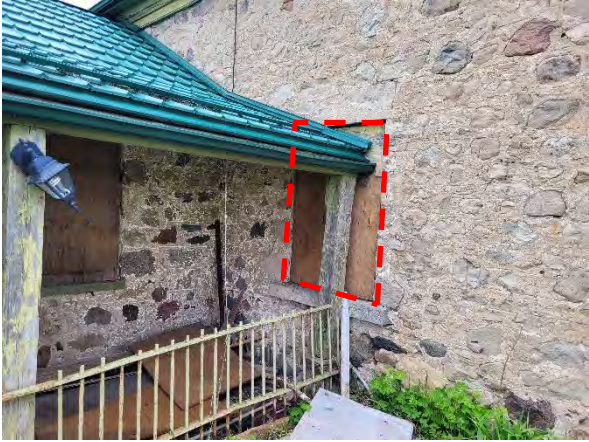
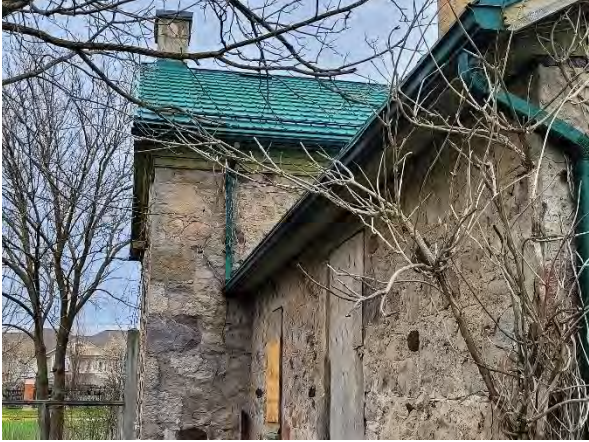
The rear (east) elevation includes a single window opening at the north side (See Figure 11). No window openings are located at the south side of the building (See Figure 12).

Figures 11 & 12: (left) View of the rear (east) elevation noting location of window opening, (right) View of rear (east) elevation, (Source: MHBC, 2023)

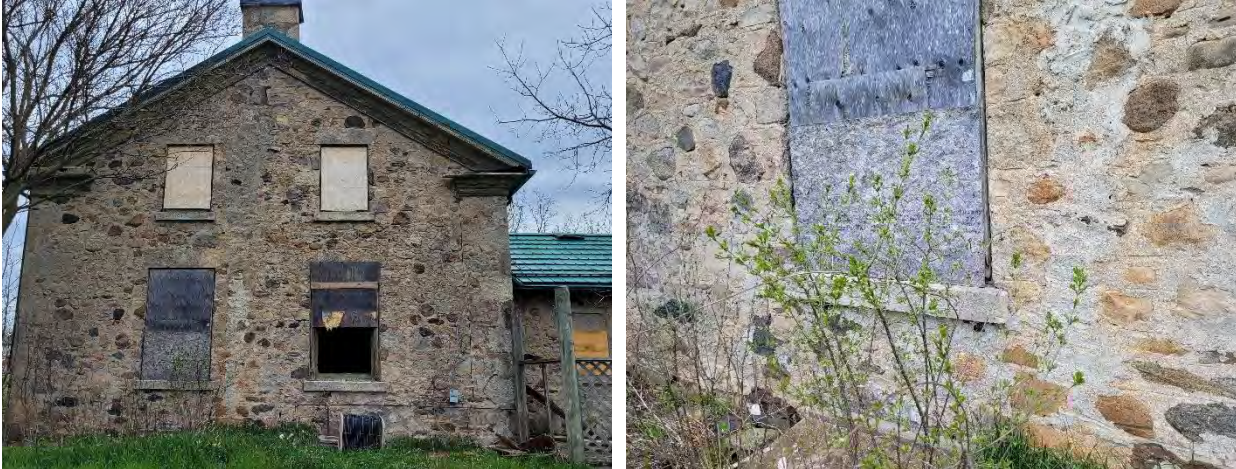
The south elevation includes features similar to the north elevation. The south elevation includes return wood eaves/frieze with dentils. Two large rectangular-shaped window openings are located at the north elevation. Two smaller rectangular-shaped window openings are located within the roof gable. All windows include stone sills and lintels.

Figures 15 & 16: (left) View of north elevation, looking south (right) Detail view of broken window and sill at north elevation, (Source: MHBC, 2023)

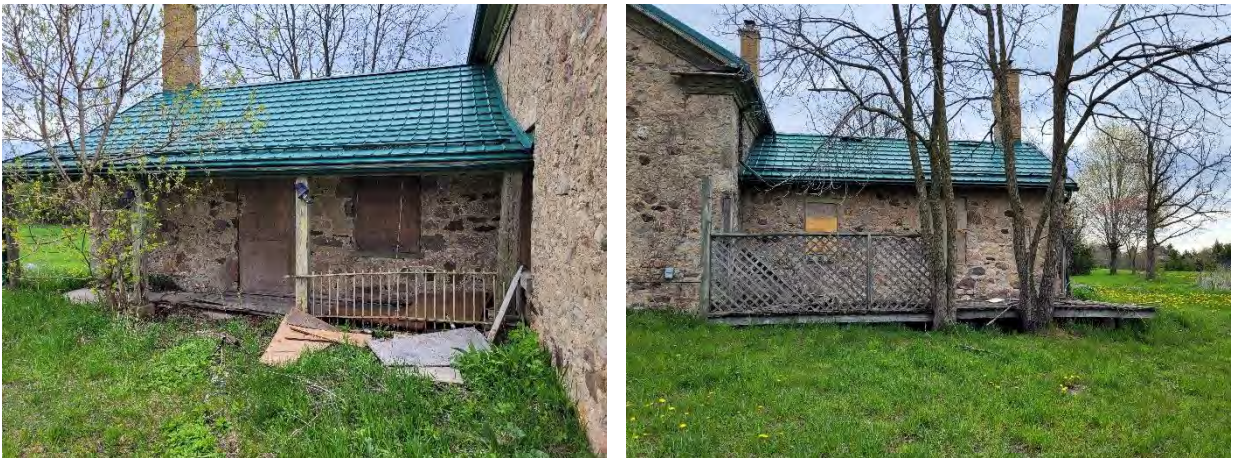
The north elevation includes a person door opening and a rectangular-shaped window opening west of the door with a wood sill (See Figure 17). The south elevation includes a large rectangular-shaped window opening towards the east which includes a stone lintel. A smaller rectangular-shaped window is also included at the south elevation. The smaller window opening includes a wood sill.

Figures 17 & 18: (left) View of north and west elevation of wood shed, looking south-east, (right) View of interior roof framing, (Source: MHBC, 2023)

- Repair of any structural elements and mortar/masonry which are required to *stabilize* the building for the purpose of safe re-location;
- **Removal of Section "B" (rear summer kitchen)** which was previously approved by the City of Guelph through a Heritage Permit;

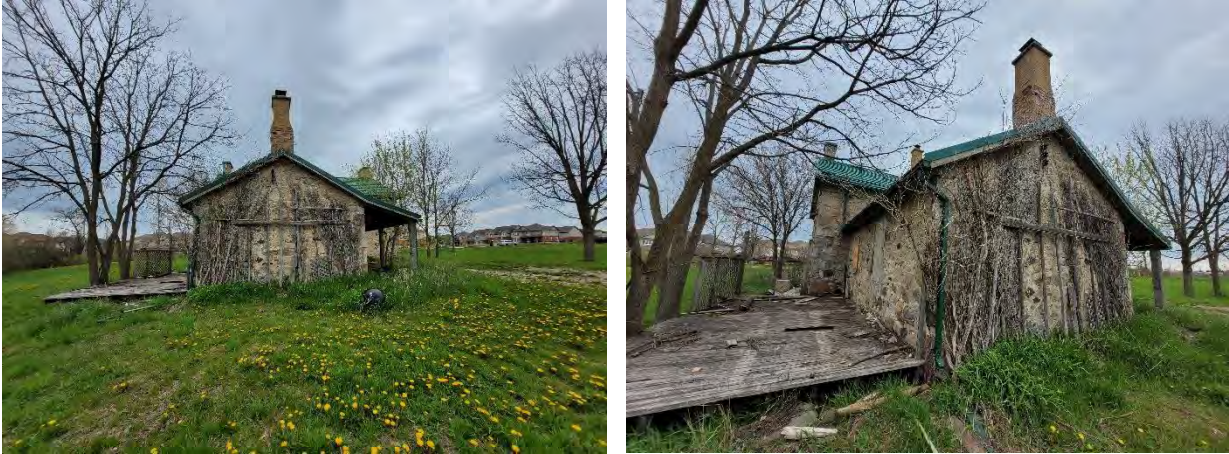
The rear (east) elevation does not include any window or door openings. The buff brick chimney is visible at the east elevation (See Figures 19 & 20).

Figures 19 & 20: (left) View of east elevation looking west, (right) View of east and south elevations, (Source: MHBC, 2023)

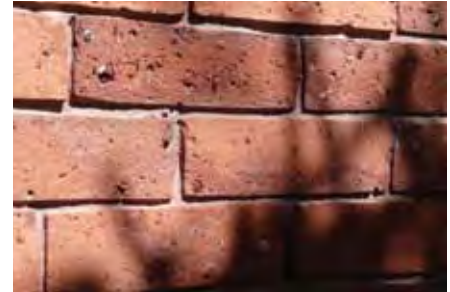
Sandblasting was once a popular method of removing paint from brick; however, it also removed the brick's outer hardened "crust" causing the brick to deteriorate.

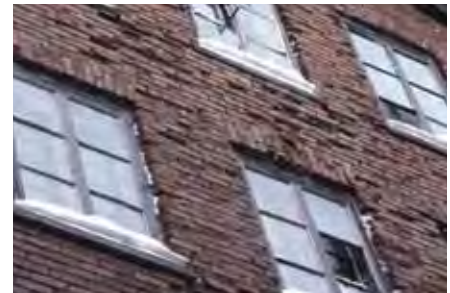
The harsh climate in many parts of Canada can seriously damage masonry elements. This wall has suffered irreversible damage from water penetrating the brick façade and freezing, causing the faces of many bricks to pop off. To avoid such damage, repair failed flashings, deteriorated mortar joints or other mechanical defects, but do not apply water-repellent coatings, which can trap moisture inside the masonry.

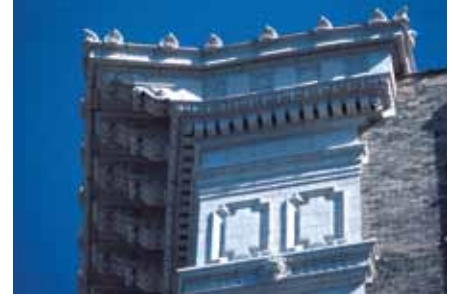
One of the primary causes of deterioration of glazed architectural terra cotta, like that shown on the Confederation Life Building in Winnipeg is water. Water-related damage to the glazed units, mortar, metal anchors or masonry backfill can be repaired only after eliminating the sources of that water. In order to ensure that the actual root problem is being solved, investigation work would need to be completed prior to any repairs in order to identify that source.

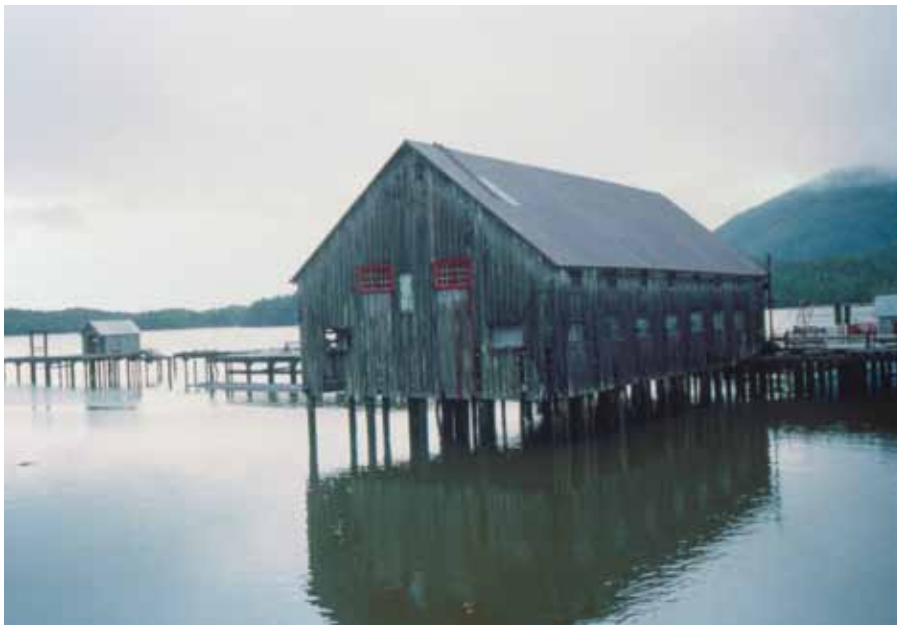
It is important to identify the cause of any damage to a wooden building element before beginning a Preservation treatment. For the former machine shop of the North Pacific Cannery in Port Edward BC, exposure to marine conditions caused the exterior wood cladding to deteriorate.

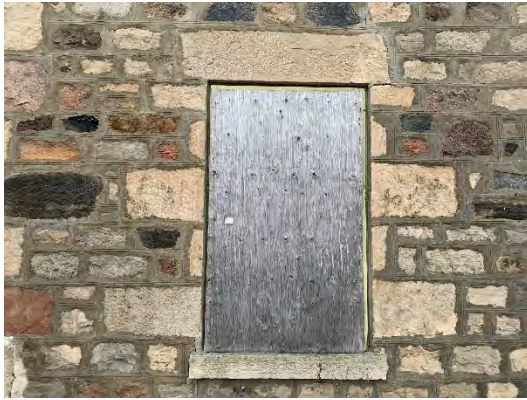
Photo 5: Typical Coursed Ashlar Wall with Dressed Jamb and Lintel

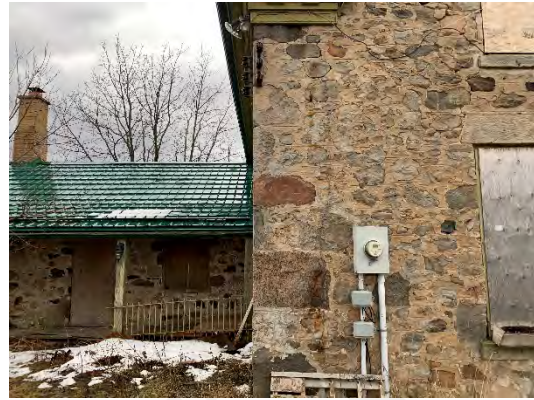
Photo 6: Typical Un-coursed Rubble Wall with Ashlar Granite Quoins

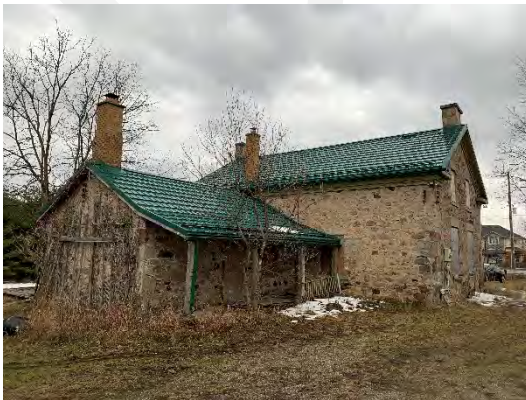
A wooden covered porch is attached on the north side of the summer kitchen and is supported on timber newel posts with concrete foundations. It is not believed that the portico is original to the building given the finish of the timbers used.

Photo 8: Summer Kitchen and Covered Porch

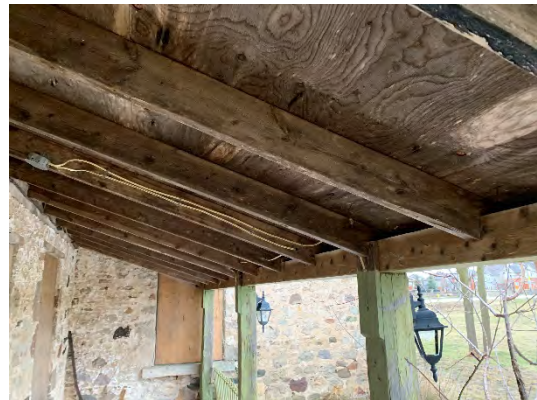
Photo 9: Underside of Covered Porch

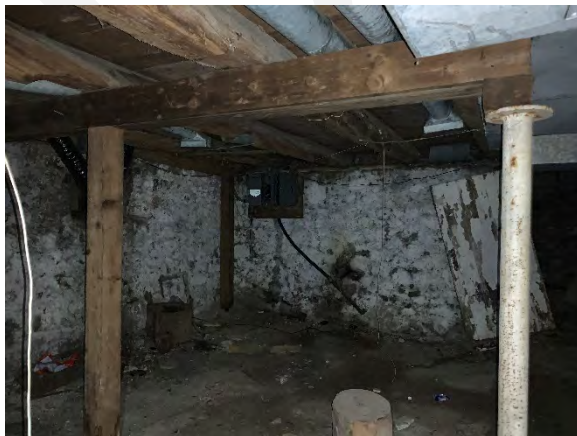
The interior side of the foundation walls were inspected from the basement, and generally appeared to be in good condition. All joints were well mortared, without signs of cracking or de-bonding of the mortar.

Photo 14: Typical Rubble Foundation Wall

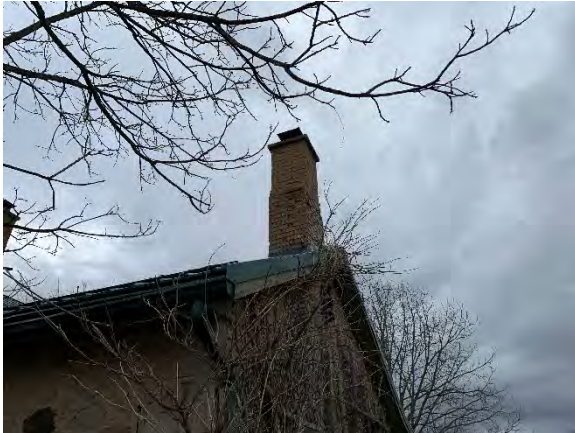
Four chimneys are present on the building, one stone on each the north and south walls of the main house, as well as one brick chimney at the shared wall between the main residence and the summer kitchen. One final brick chimney is located at the end of the summer kitchen on the east wall. From the interior there was no evidence of deterioration at the stone flues in the main house. The brick chimneys appear to be in poor condition with significant mortar loss in the brick joints.

Photo 16: Summer Kitchen Brick Chimney

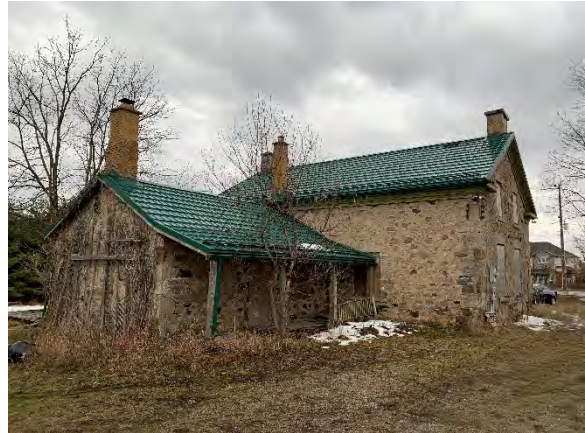
Photo 17: View of House showing all four chimneys
