Attachment-1 Property location and photos taken by Heritage Planning staff

2023 July 27 – Photos taken by S. Robinson of Heritage Planning during site visit with Property Standards staff.

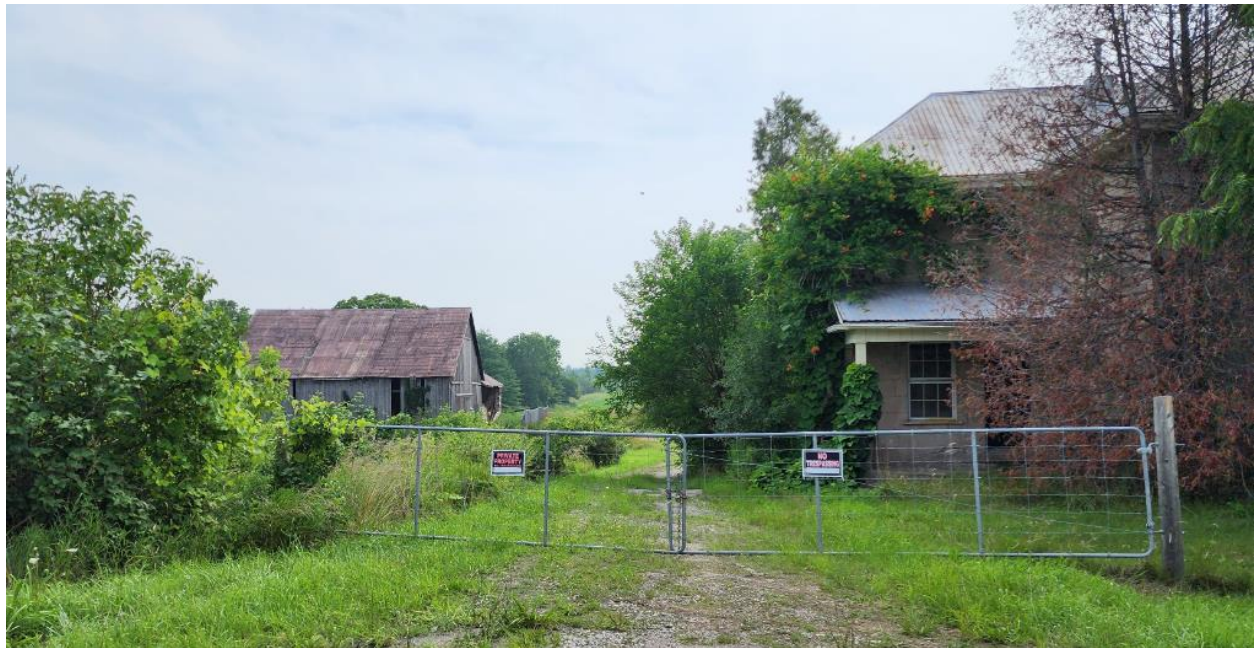
Figure 4 - View west from Gordon Street. (Photo: S. Robinson of Heritage Planning taken July 26, 2023)

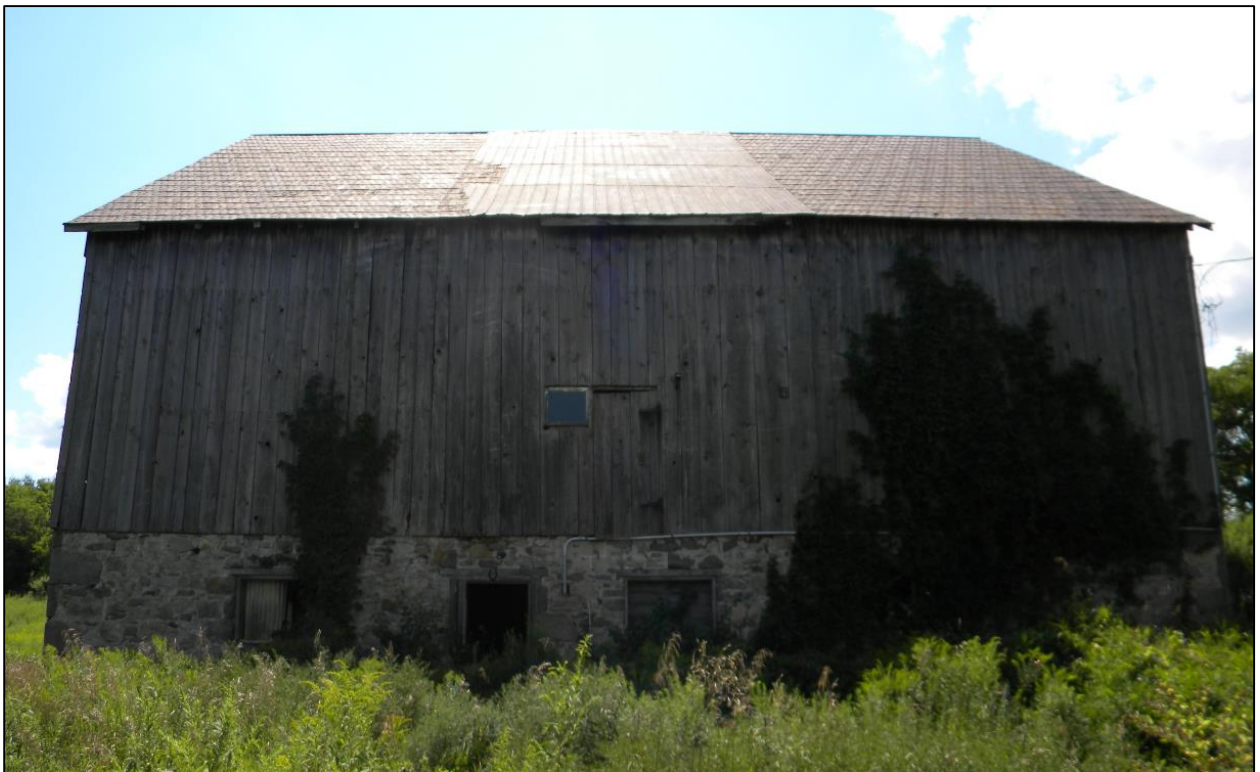
Figure 62: Photo of the wooden extension exterior. Taken August 15, 2011, by S. Robinson.

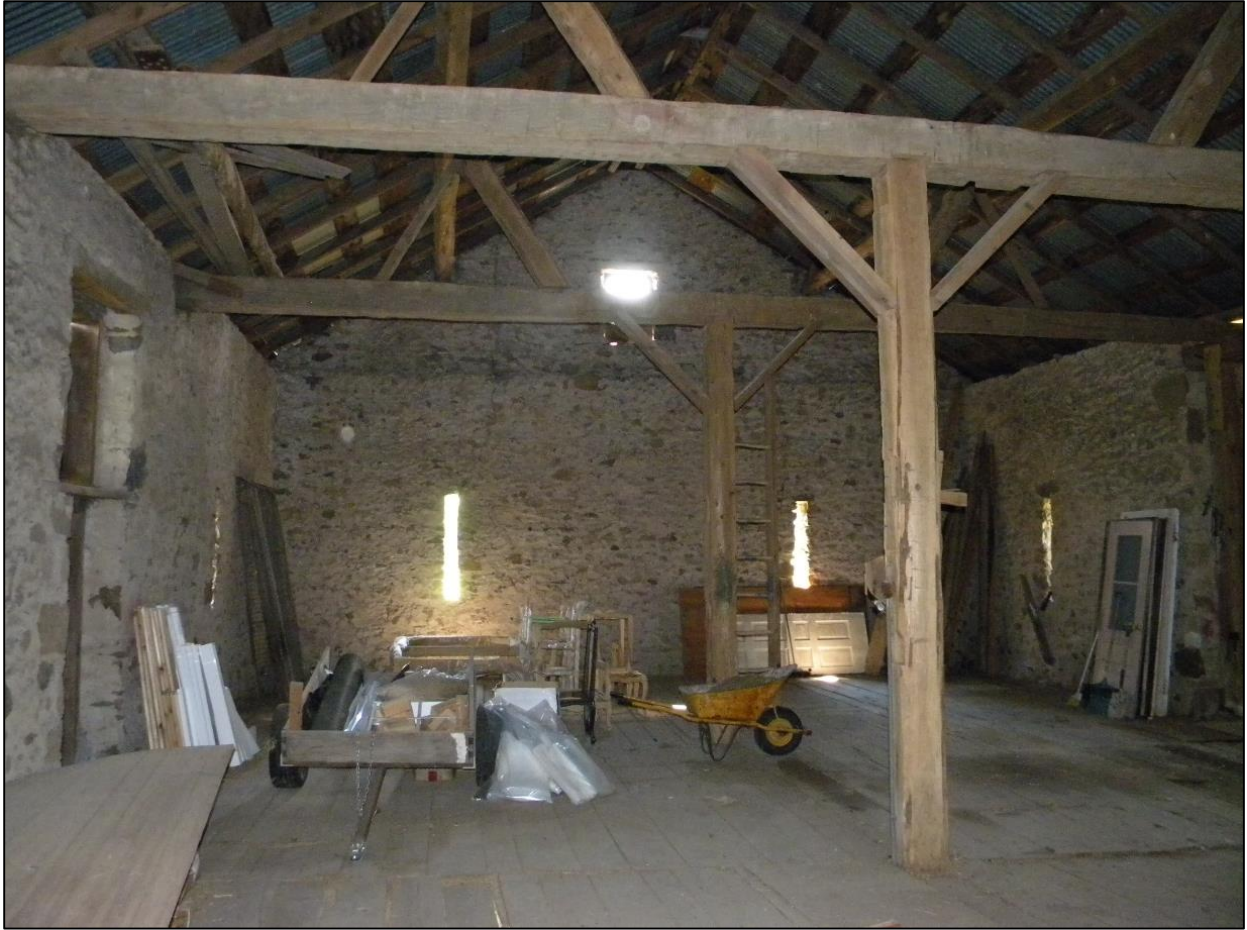
Figure 64: Photo of the stone barn interior. Taken August 15, 2011, by S. Robinson.
