**2187 Gordon Street, City of
Guelph, Ontario, Cultural
Heritage Resource Impact
Assessment**

Final Report

March 13, 2024

Project Number: 161423769

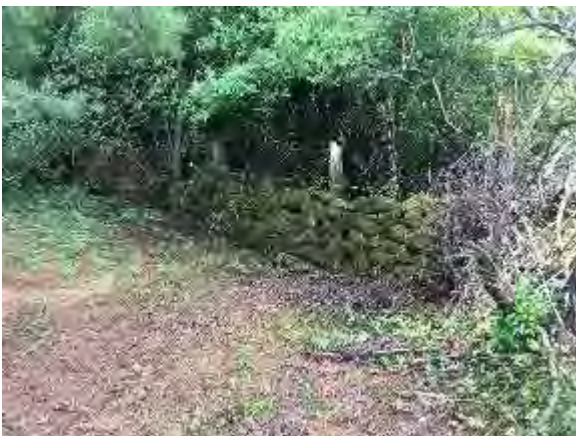
Plate 22: Built stone foundation (Stantec 2018)

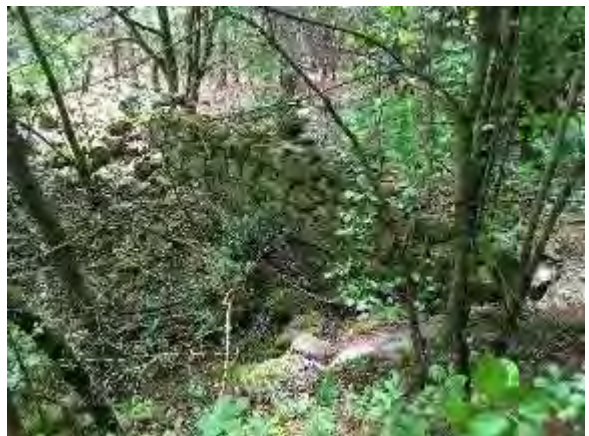
Plate 23: Built stone foundation (Stantec 2018)

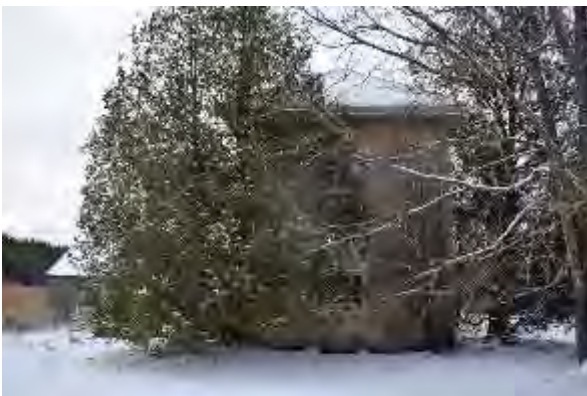
Plate 24: Front (east) elevation looking west

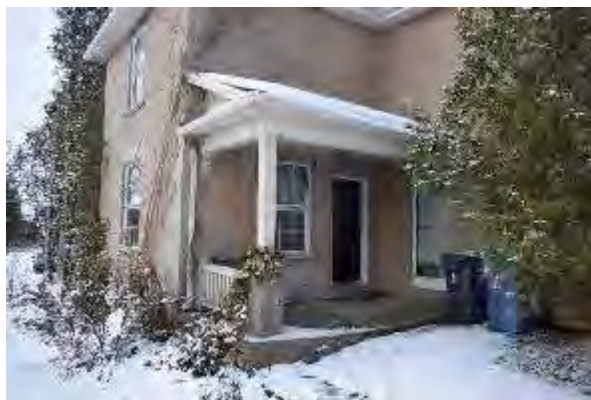
Plate 31: Front partial porch

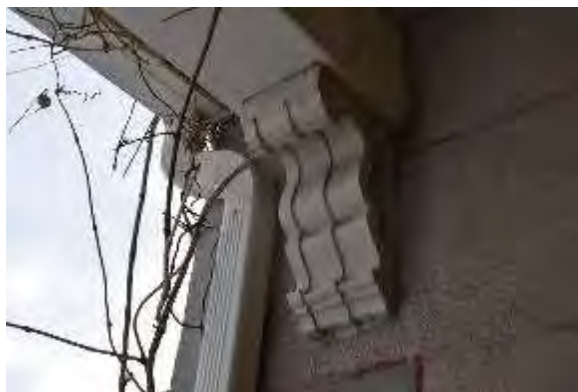
Plate 34: Bracket on porch

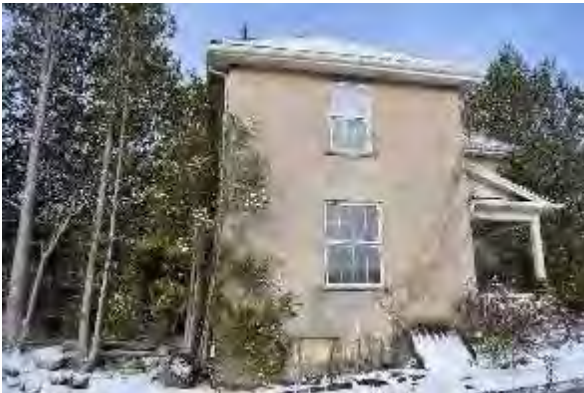
Plate 39: South elevation looking northeast

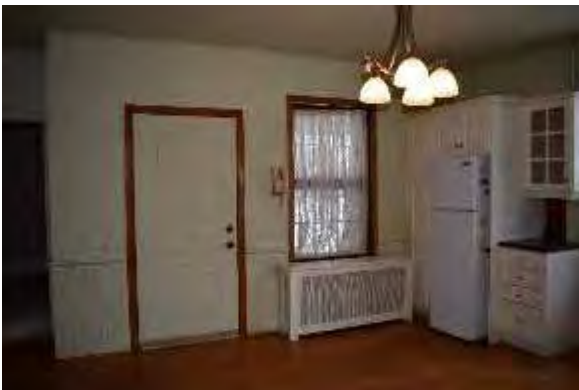
Plate 41: Front entrance off kitchen

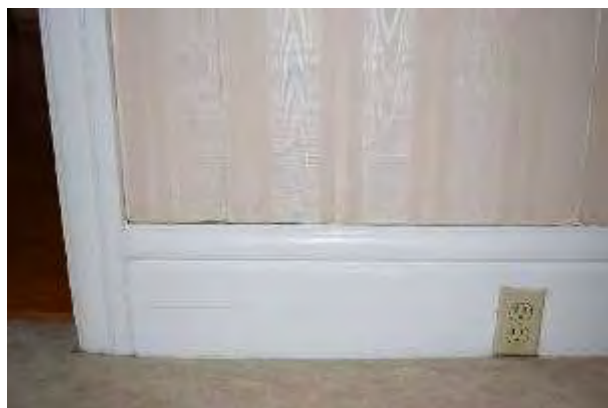
Plate 45: Wood moulding in front living room

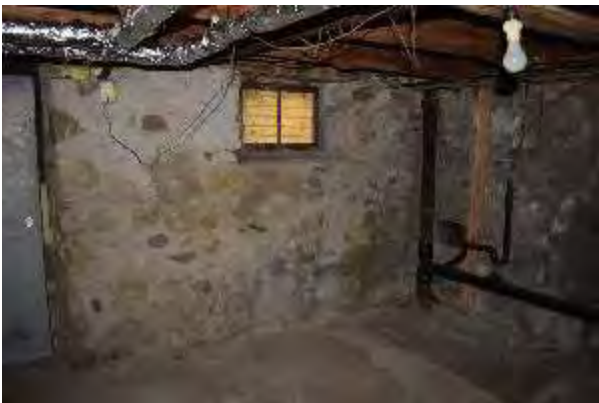
Plate 57: Basement looking southwest

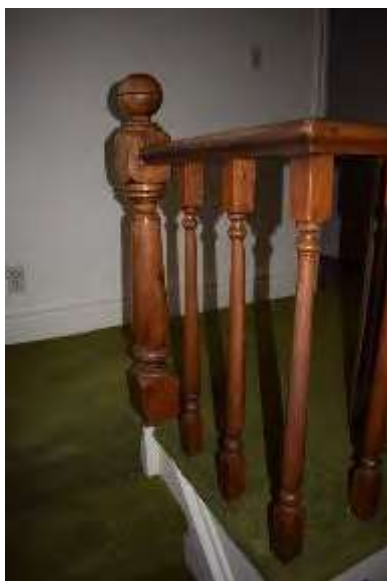
Plate 61: Wood newel and

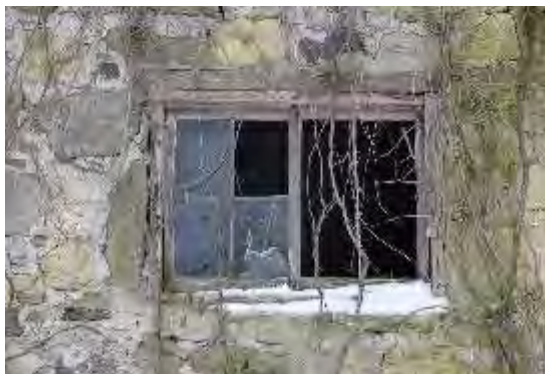
The east elevation of the barn has three wood frame windows set within the stone foundation (Plate 81). The windows have either been boarded-up or are missing panes (Plate 82). The foundation also has a wood stable door set within a wood frame with original hardware (Plate 83). The upper threshing storey of the barn also has hinged door and an adjacent wood frame window (Plate 84).

Plate 82: Window on east elevation
